#### Out of Sight, But Not Out of Mind: Using Satellites to Find Leaks

Watersmart Innovations October 2021

## **Irving Water Utilities**

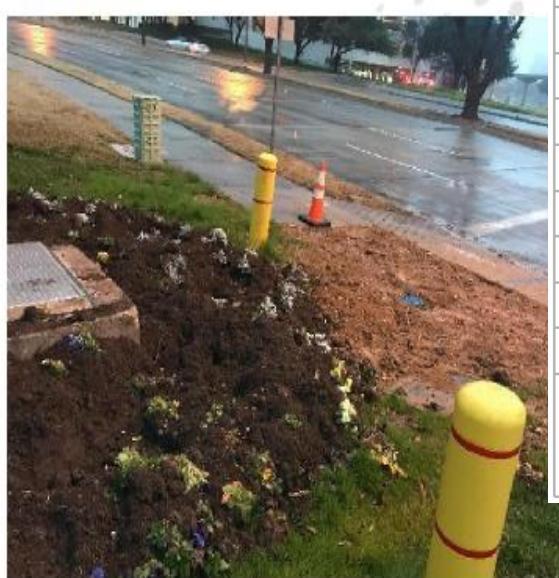
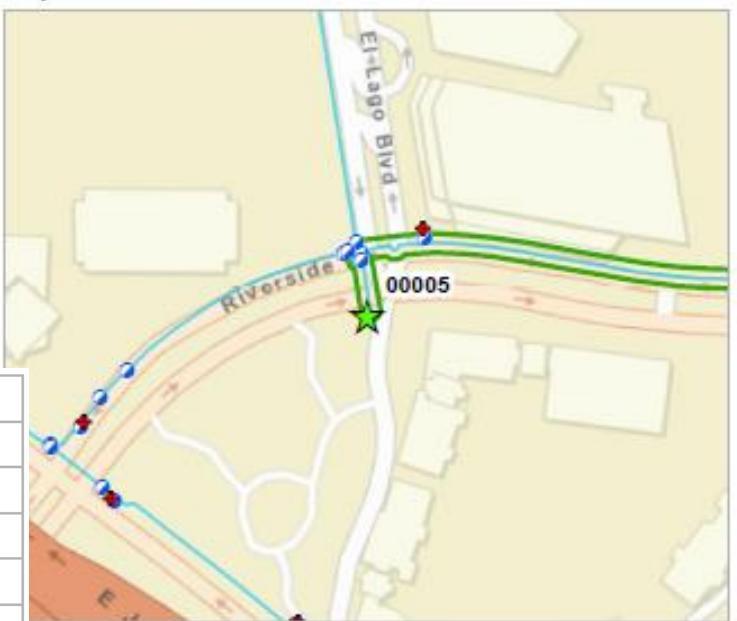
#### Main Leak: Cast Iron

- 8" Line
- Location required multiple repairs

100			
Leak ID: 00005	Date: 2/1/2019			
Leak Status: Leak	Type of Leak: Main			
Pipe Size (in): 8	Pipe Material: Cast Iron			
Leak Subtype:				
Address: 5002 Riverside Dr				
Cross Street:				
Location Description:				
Surface Material:				
Sound Strength:				
Surfacing:				
Comments: Appears to have been recently repaired

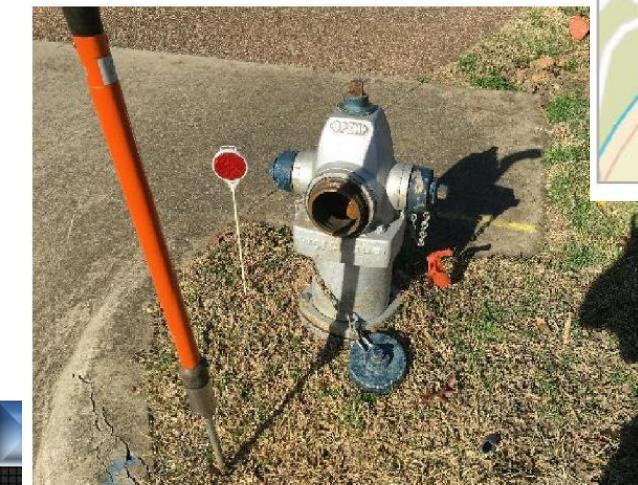
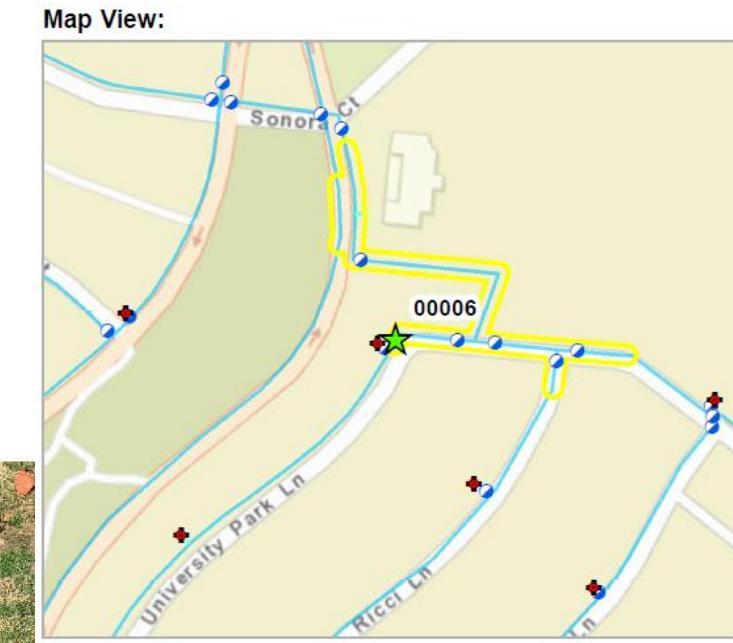
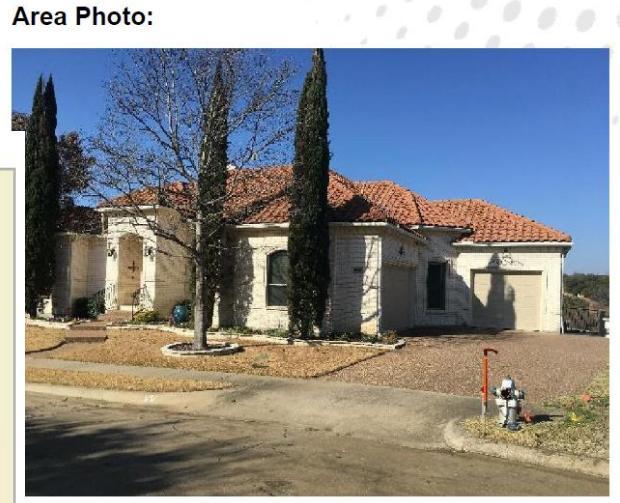
## Main Leak: Ductile Iron

Leak ID: 00006	<b>Date:</b> 2/4/2019			
Leak Status: Leak	Type of Leak: Main			
Pipe Size (in): 6	Pipe Material: Ductile Iron			
Leak Subtype: Hydrant				
Address: 3349 University Park Ln				
Cross Street:				
Location Description:				
Surface Material: Dirt/Grass				
Sound Strength: 426				
Surfacing: No - Unable to Visually Confirm

Comments: Possibly leaking from weep hole

- 6" Line
- Work order submitted to Fire Hydrant Crew

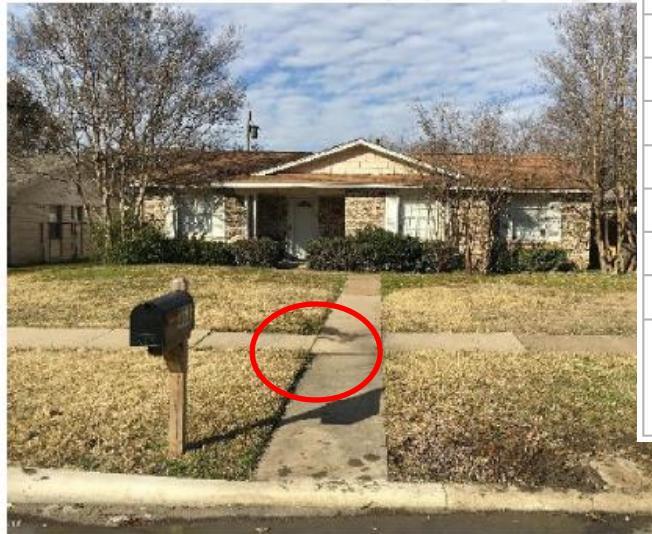
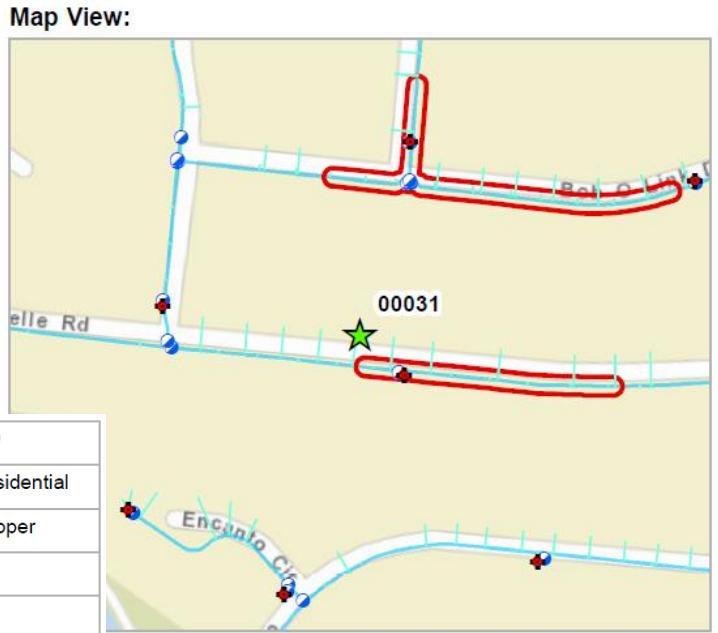
## **Residential Leak: Copper**

apresent of
Leak ID: 00031	Date: 1/28/2	2019
Leak Status: Leak	Type of Leak:	Residentia
Pipe Size (in): 3/4	Pipe Material:	Copper
Leak Subtype: Outside Meter	Pit (Unknown)	
Address: 3609 W Rochelle Ro	1	
Cross Street:		
Location Description:		
Surface Material: Dirt/Grass		
Sound Strength: 222		
Surfacing: Yes - Surfacing		
Comments:

- ¾ inch line
- Repairs made by resident; follow-up by utilities staff

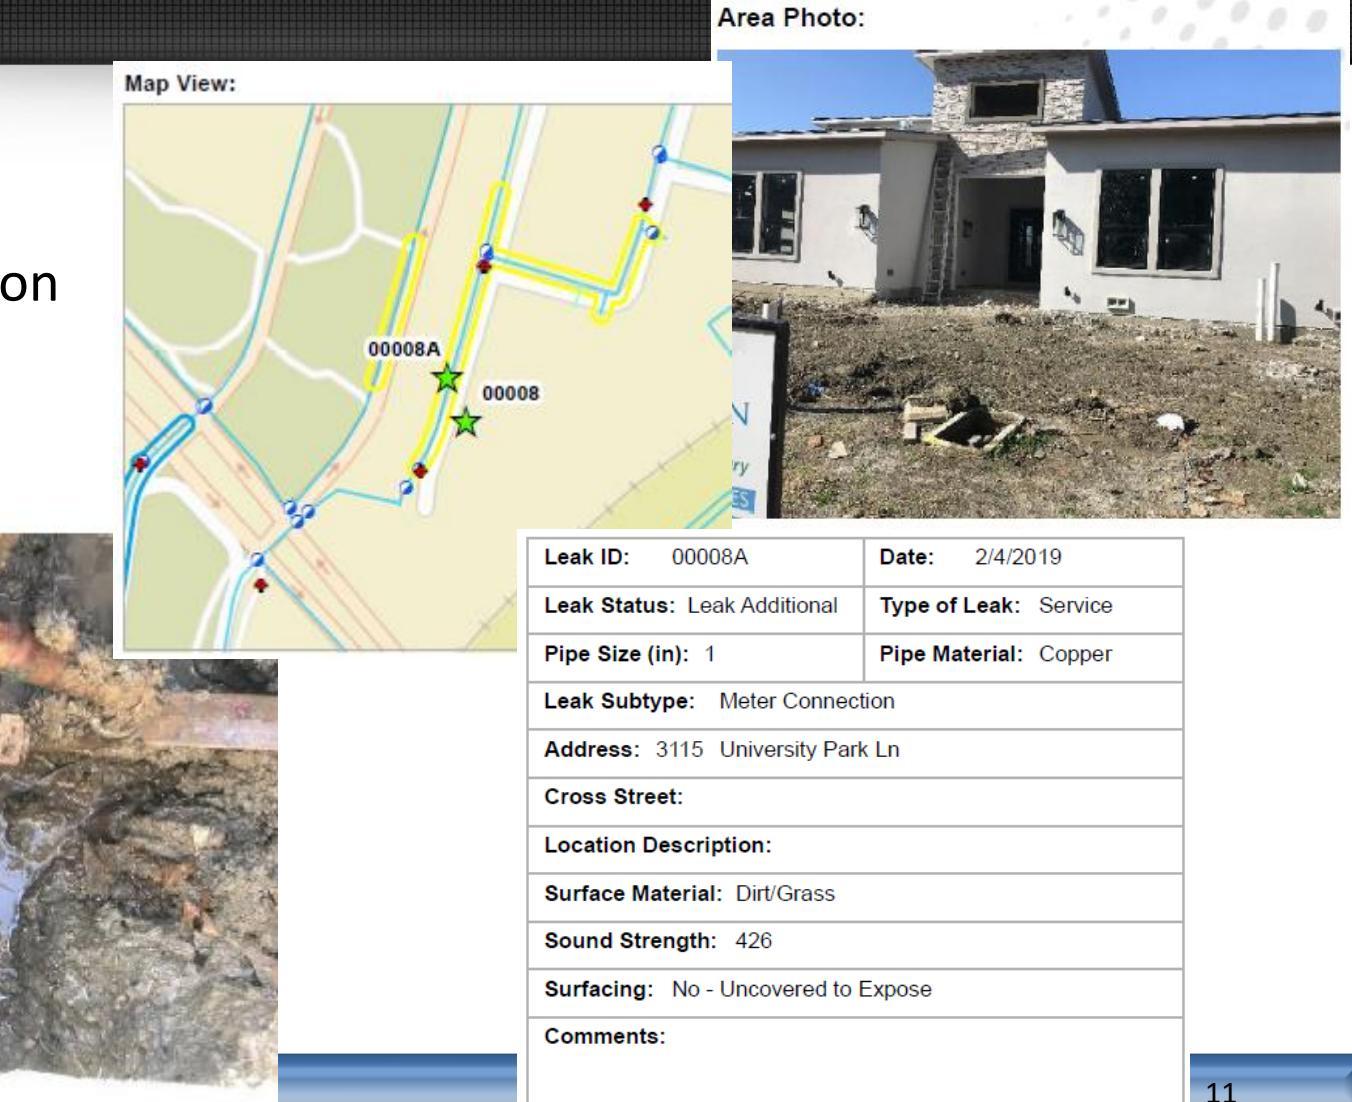
## **Residential Service Leak: Copper**

- Meter Connection
- Improper Installation repaired by contractor

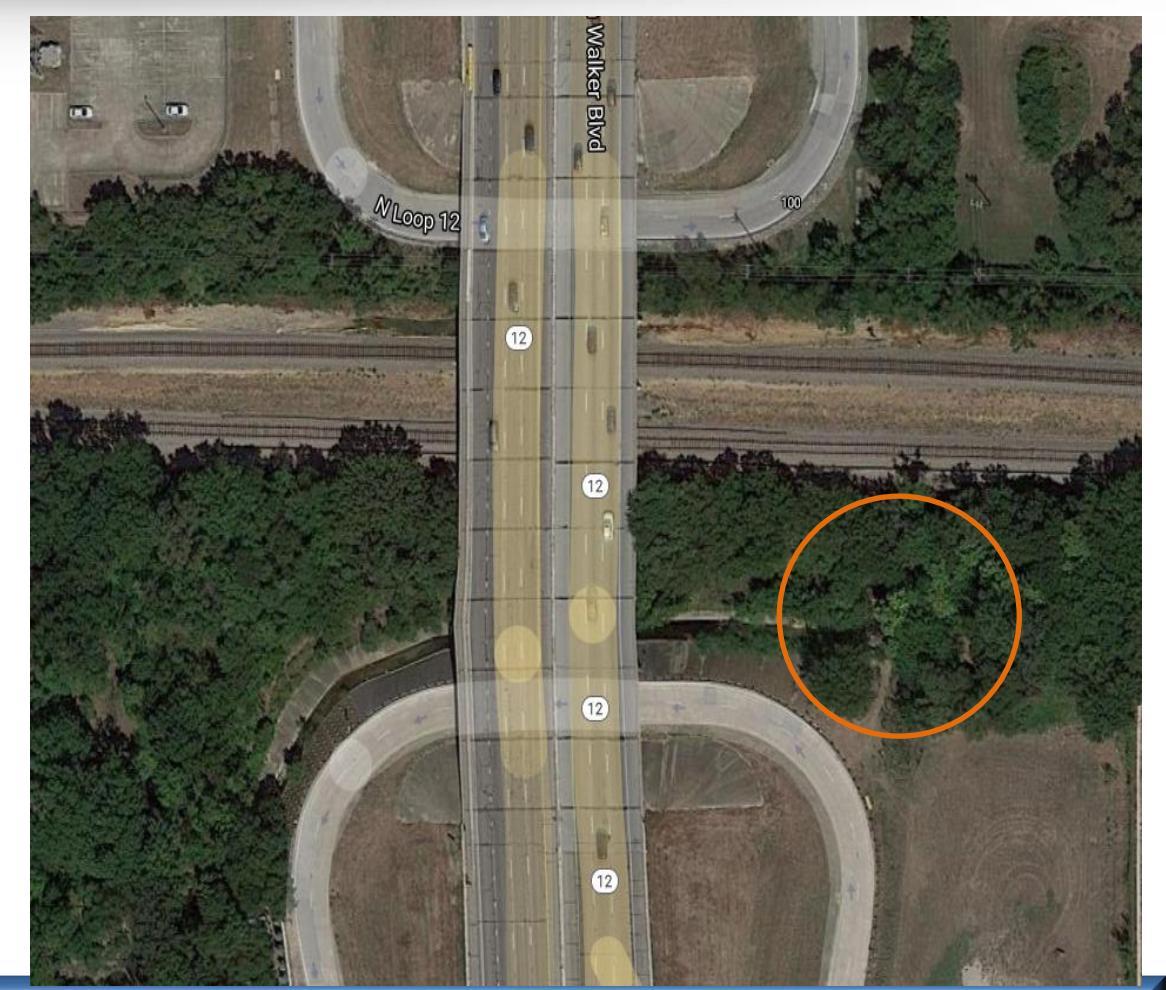
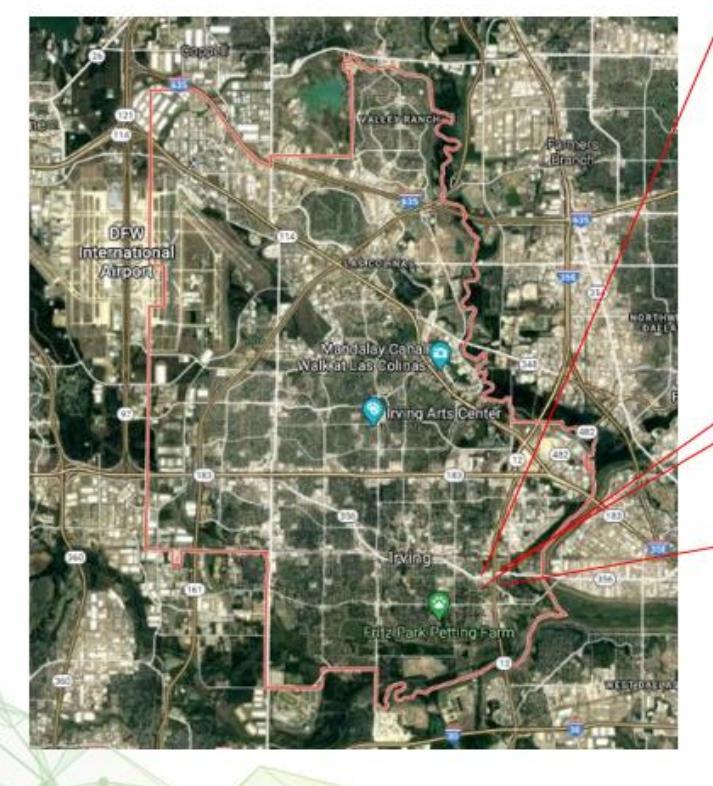
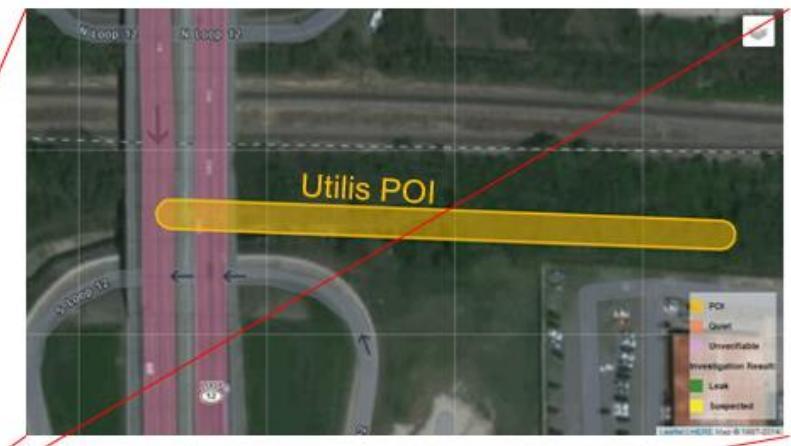
## The Unfindable: A Game-changer

- 50-year old 16" main
  - Inaccessible by vehicle
  - Under Loop 12
  - In Wooded area
  - Between creek and railroad tracks
  - No listening points
  - No visible leak
  - Audible water flowing into the creek

A Hidden Leak is Discovered by leak detection staff: *"I would have never found the leak without the POI being there."*
