# **Outdoor Water Conservation Program Integration** for Maximum Water Savings

#### **Targeting Properties for Audits**

## Dana Hult, Denver Water

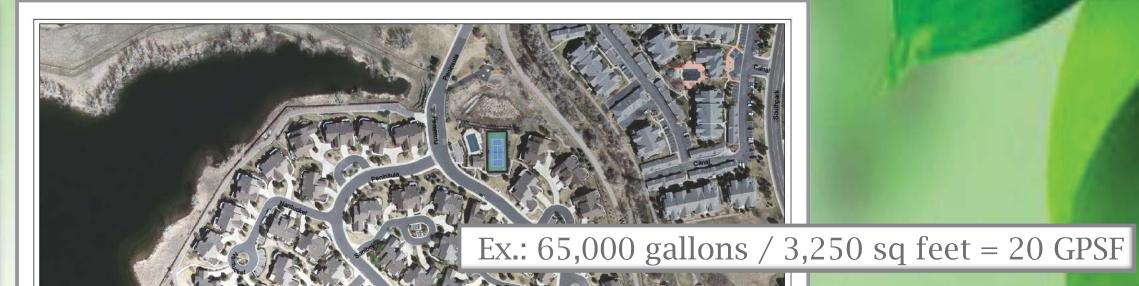
**Denver Water's process for targeting inefficient irrigation use begins** with using G.I.S. A map is created of the property boundaries showing the square footage of the irrigated area.

Then the annual irrigation consumption total is divided by the square footage of the irrigated area. This figure is referred to as GPSF (gallons per square foot).

Denver Water targets properties using more than 18 GPSF.

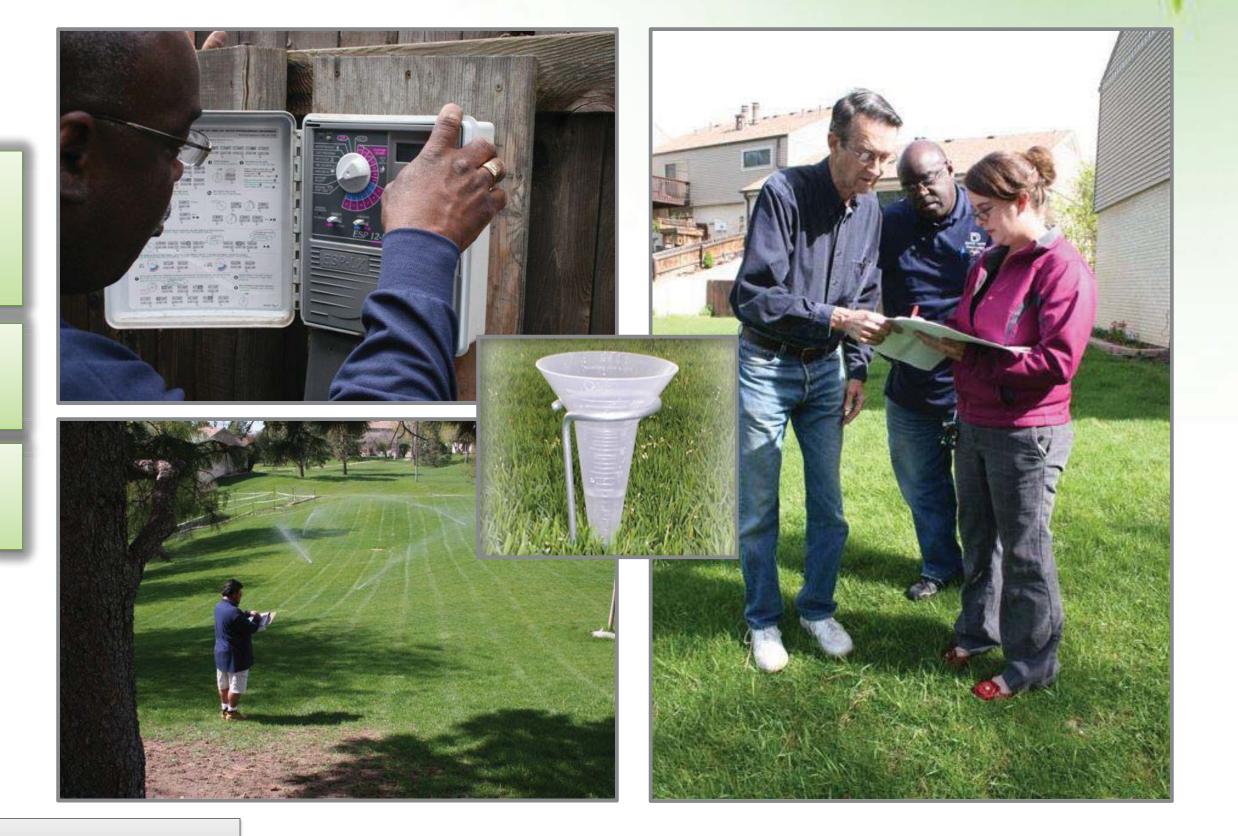
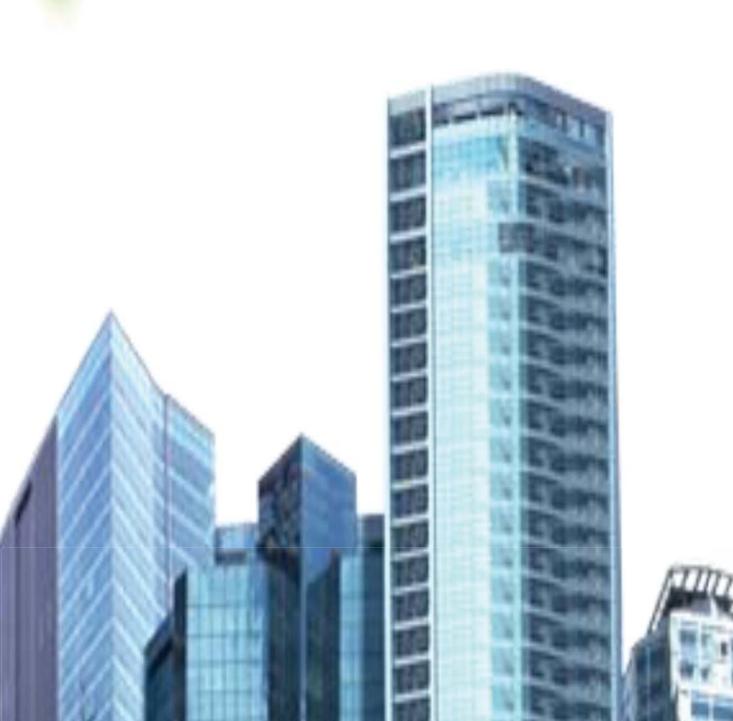
The targeted properties are offered a free irrigation system audit. The audit consists of zone-by-zone inspections of the sprinkler heads and irrigation controllers.

Issues such as line breaks, valve leaks and misaligned heads are discussed with the customer.

Free rain sensors are given to those who do not have a rain sensor installed on each of their irrigation controllers.

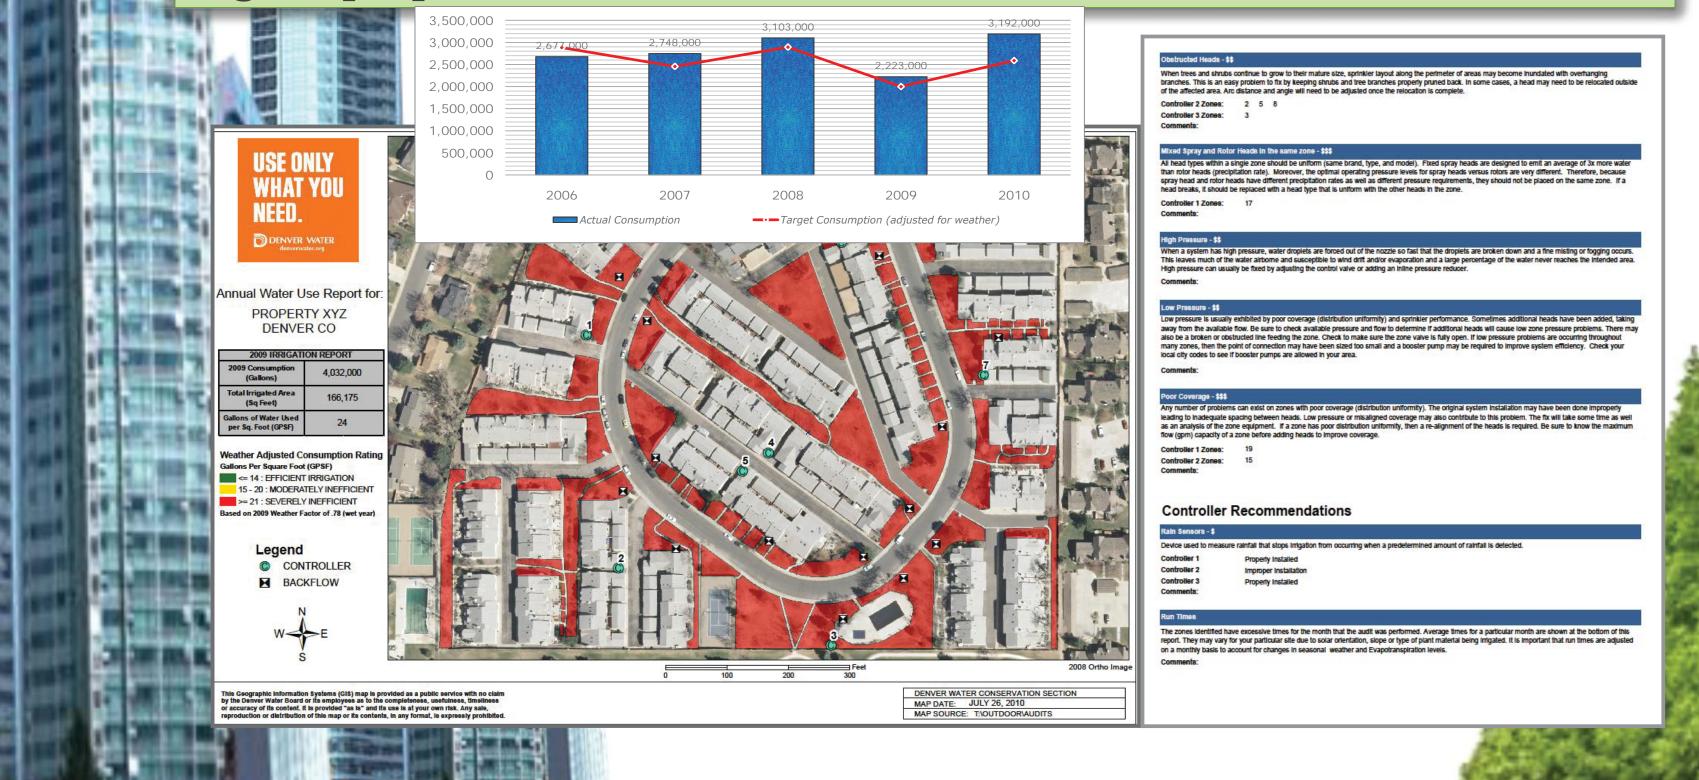
A report which lists the system problems and the costs/benefits of fixing these problems is created and distributed to the customer.

The report explains DISTRIBUTION UNIFORMITY and how this plays into efficient irrigation.

Graphs showing current and historical consumption are presented and are compared to the 'target' consumption for that property.
