Tailored to Fit:
The Essentials of
Designing a Successful
Water Conservation Program

Carolyn Sawai, P.E.
Lisa Maddaus, P.E.
Jenny Gain, P.E.

Case Study: Honolulu Board of Water Supply

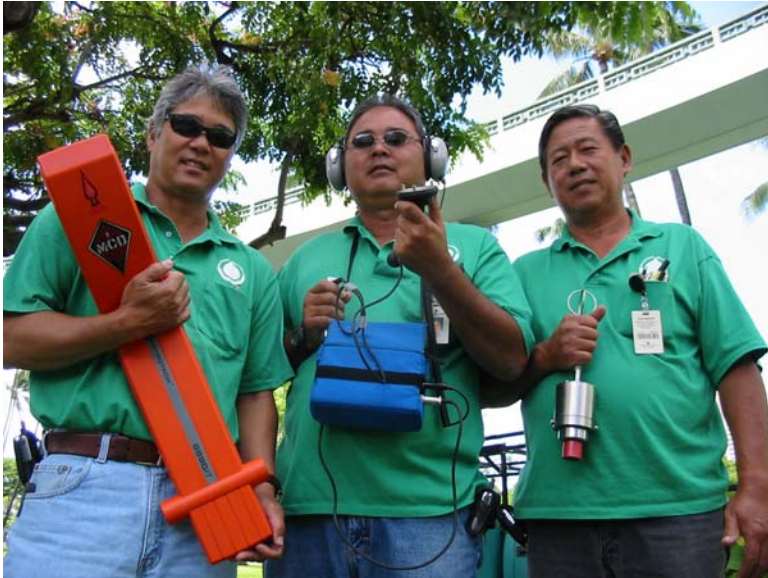
Current Internal BWS Efforts - Leak Detection Program

Statistics for 2007:

- 56 leaks totaling about 829 MG/yr
- \$265,000 savings

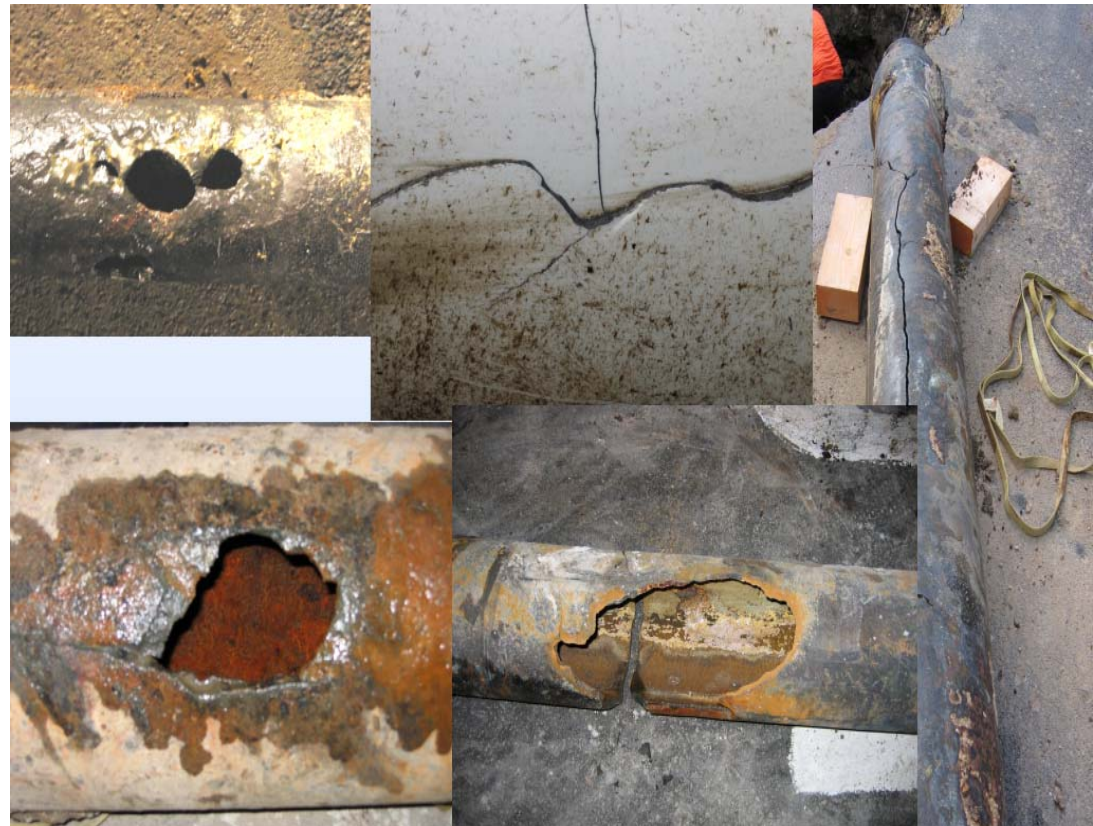
Current Internal BWS Efforts - Main Repair Statistics 2005-2007

2005		2006		2007	
	No.	%	No.	%	No.	%
Defective Pipe	1	0	0	0	0	0
Corrosion	164	43	163	44	165	58
Contractor in Area	8	2	15	4	7	2
Settlement	29	8	33	9	15	5
Rock	8	2	5	1	2	1
Expansive soil	0	0	0	0	0	0
Pressure	11	3	12	3	4	1
Tree roots	7	2	8	2	1	0
Unknown	132	34	114	31	89	31
Other	29	8	10	3	1	0
TOTAL BREAKS	385		373		284

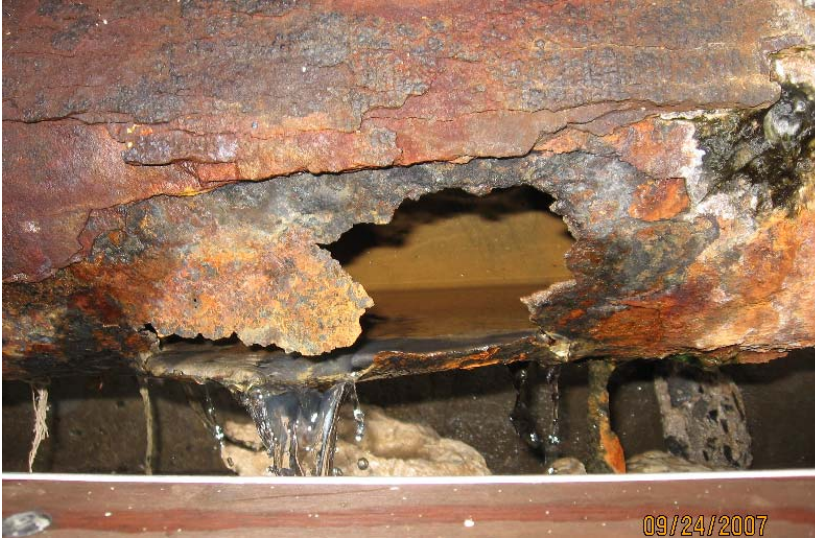
Redline Data

Title:
87-770 FARR. HWY. (MC)

Notes:
CUT & SPliced 8' OF 8" D.I. WITH SAME TO REPAIR BLOWOUT SECTION OF MAIN NEXT TO C.I. SLEEVE AND 3/4" ARV. W.O. M07-38436 (9/24/07). SEE "DOCUMENTS" BELOW FOR PHOTOS OF BREAK.

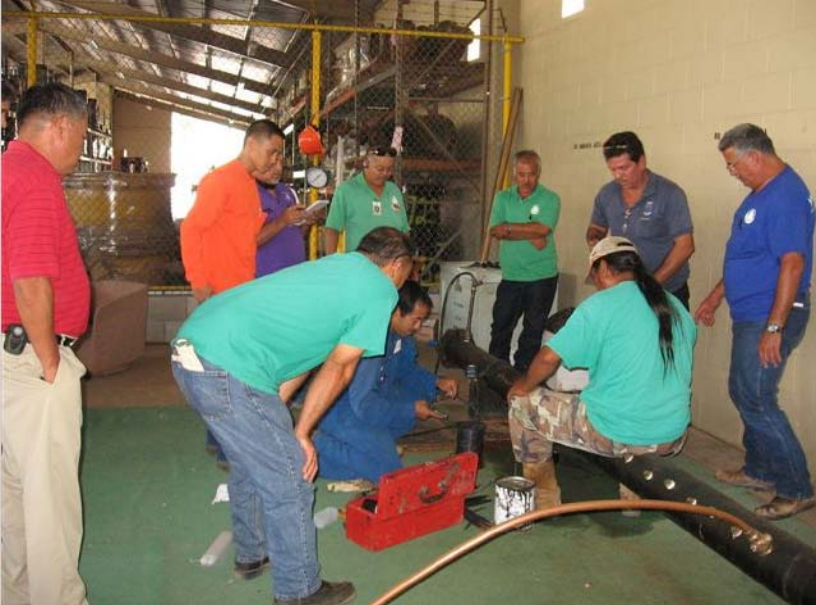
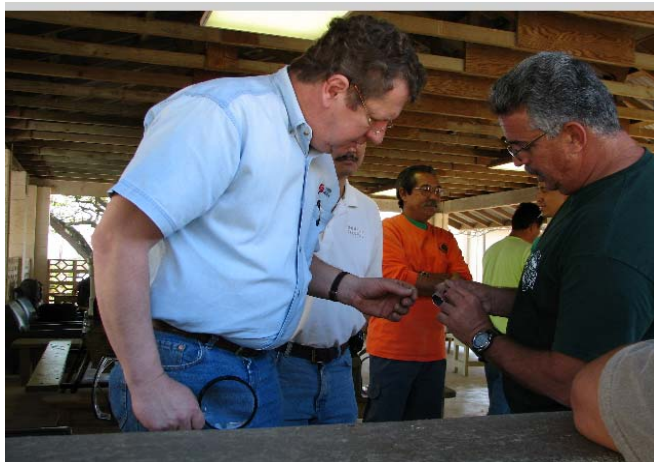
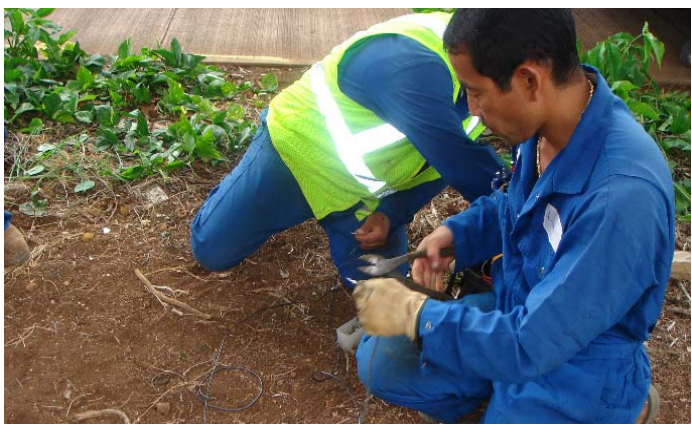
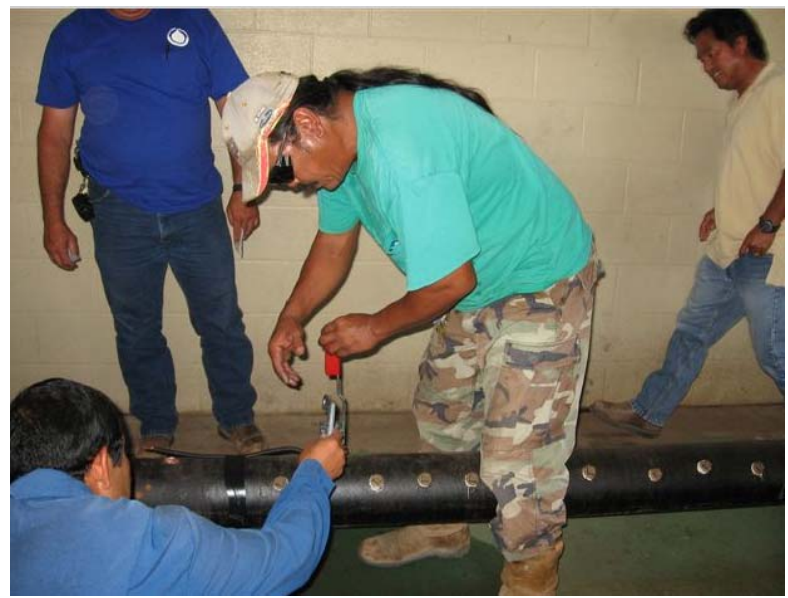
Current Internal BWS Efforts - Response Plan

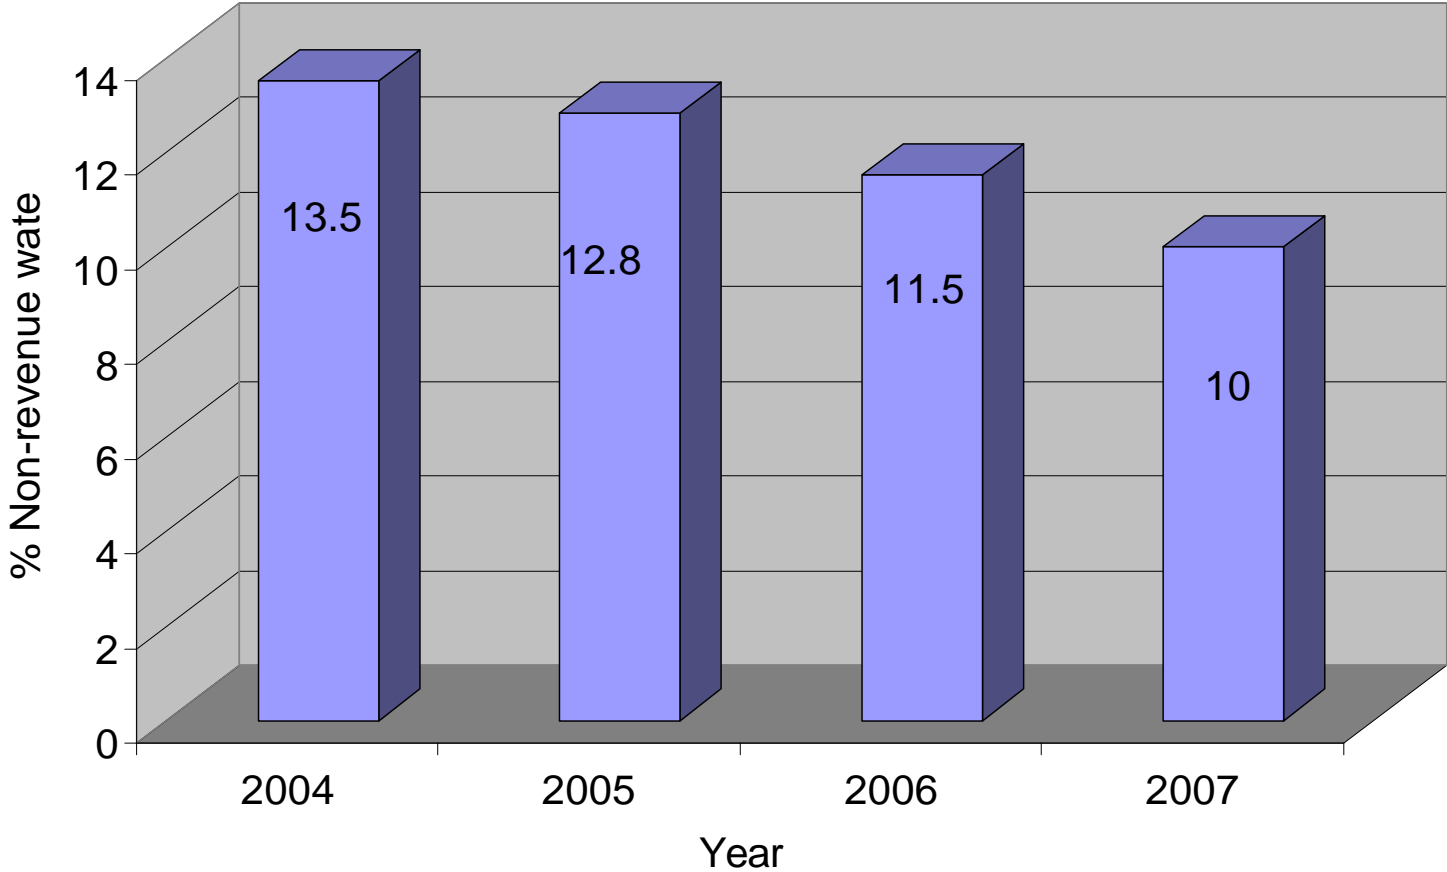
Non-revenue Water Trend 2004-2007

Current Internal BWS Efforts - Water Trend

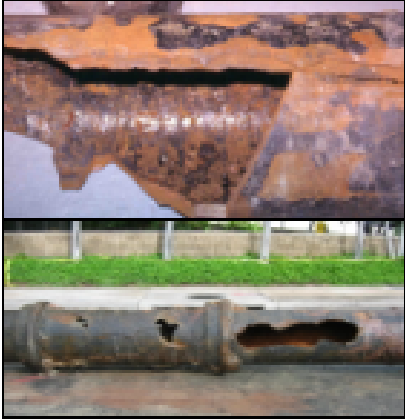
Type of Main	Type of Failure & Description	What to Look For / What to do	Photo Examples
Cast Iron & Ductile Iron	<p>Electrolytic Corrosion</p> <p>Driven by oxygen, soil chemistry, and resistivity of soil.</p>	<ul style="list-style-type: none"> • Shows wastage of metal • Look for thinning of wall thickness from outside-in or inside-out • Big pits or interconnected pits will typically be present • Scrape pipe from outside with a sharp, blunt tool – see if metal is soft and can be removed. Probably not if it is electrolytic corrosion. • Look for sharp knife-like edges • Get a soil sample

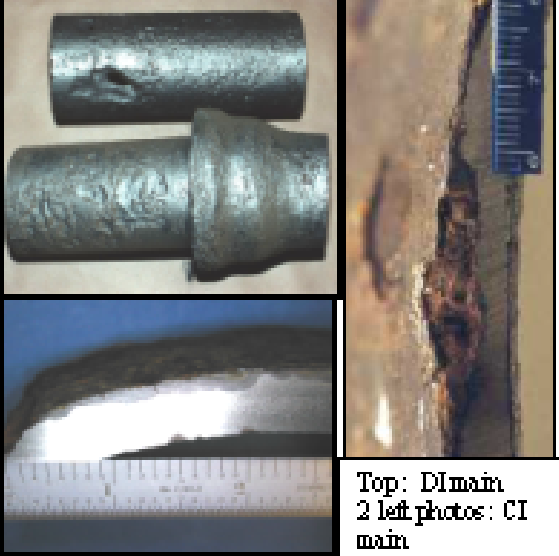
<p data-bbox="1493 1246 1686 1332">Top: DI main 2 left photos: CI main</p>

<p data-bbox="1338 732 1512 761">Cast Iron main</p>
Cast Iron & Ductile Iron	<p>Graphitic Corrosion</p> <p>Preferential leaching out of iron from the metal matrix leaving the graphite flake network. Slow corrosion mechanism – so pipe will probably be quite old (40 years or more). Driven by slightly acidic soil or ground water conditions.</p>	<ul style="list-style-type: none"> • Won't show pitting • Scrape the pipe from the outside with a sharp, blunt tool and the metal will be soft and easily removed. • There will not be sharp knife-like edges • Saw through the pipe and look at the cross section of the pipe wall. You will see a color variation due to graphitic corrosion (see photo below) • Get a soil sample

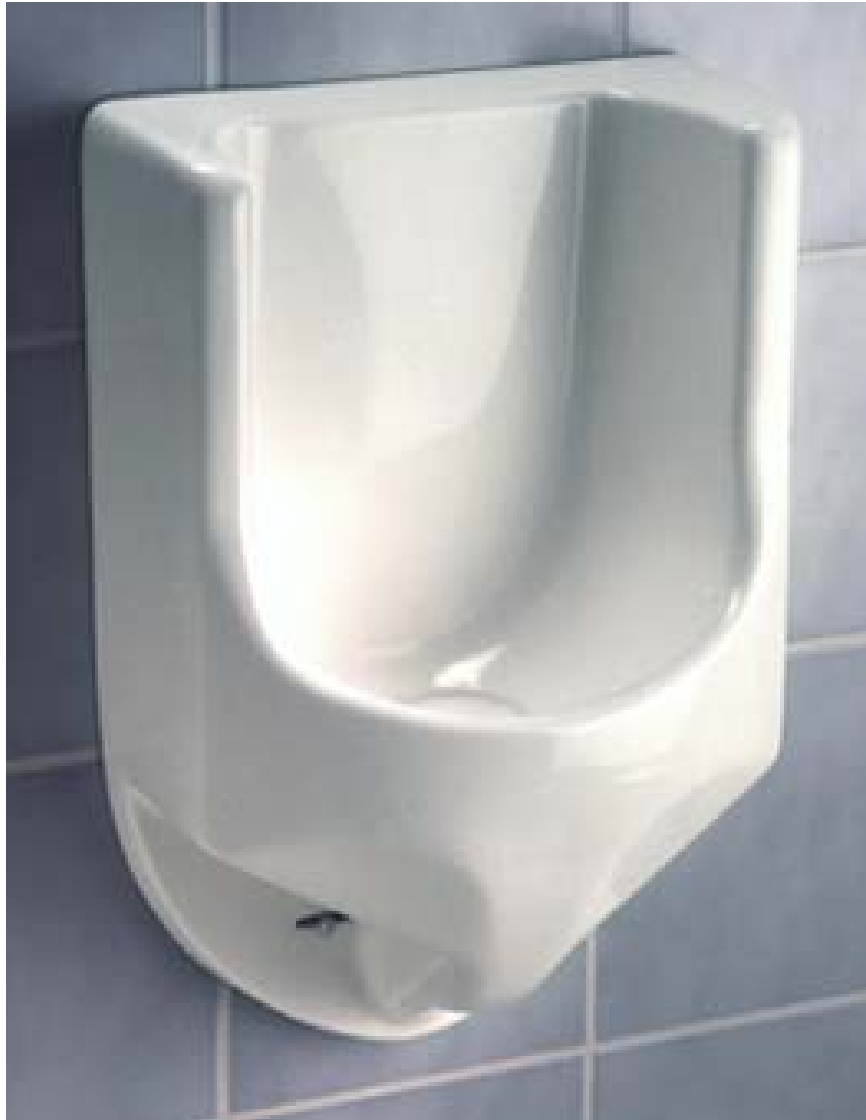
Current External BWS Efforts - Green, Green Building – Commercial Pilot

- Retrofit of indoor fixtures
- Pilot site: BWS Public Service Building (PSB)
- Benefits:
 - BWS leading by example
 - Buy-in from custodians with new purchases
 - Water, energy, and financial savings
- Starting point for potential LEED certification

Photo Source: <http://www.waterless.com/>

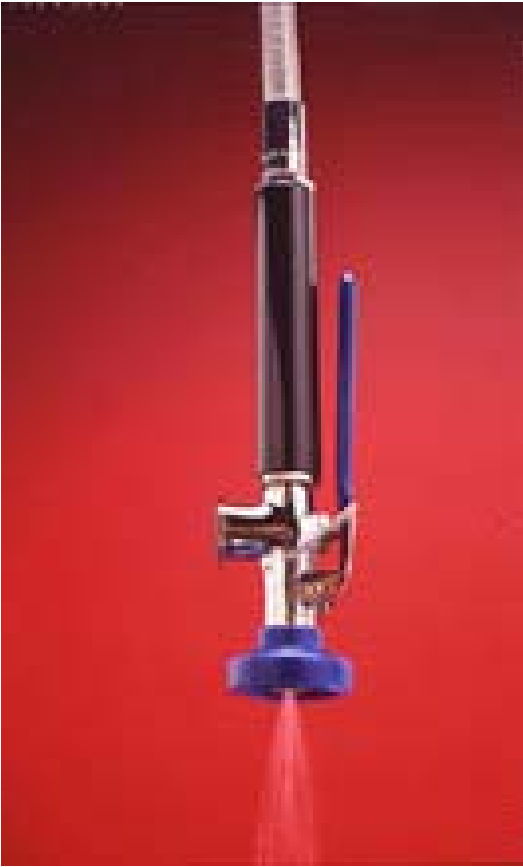
Current External BWS Efforts - Pre-rinse Spray Valve Retrofit

- Retrofit of commercial pre-rinse spray valves
- Pilot sites: Two school cafeterias and one private business
- Documented water savings with flow meters
- Up to 50,000 gal/year – water savings
- Up to 21 kWh/year - energy savings
- Less than 4 month payback by private business customer
- Local business serves as example to others
