# What Side of the Meter Are You On?

**Proactively Looking and  
Listening for Leaks on  
Pipes and Aqueducts**

**2010 Watersmart Innovations  
Conference & Exposition**

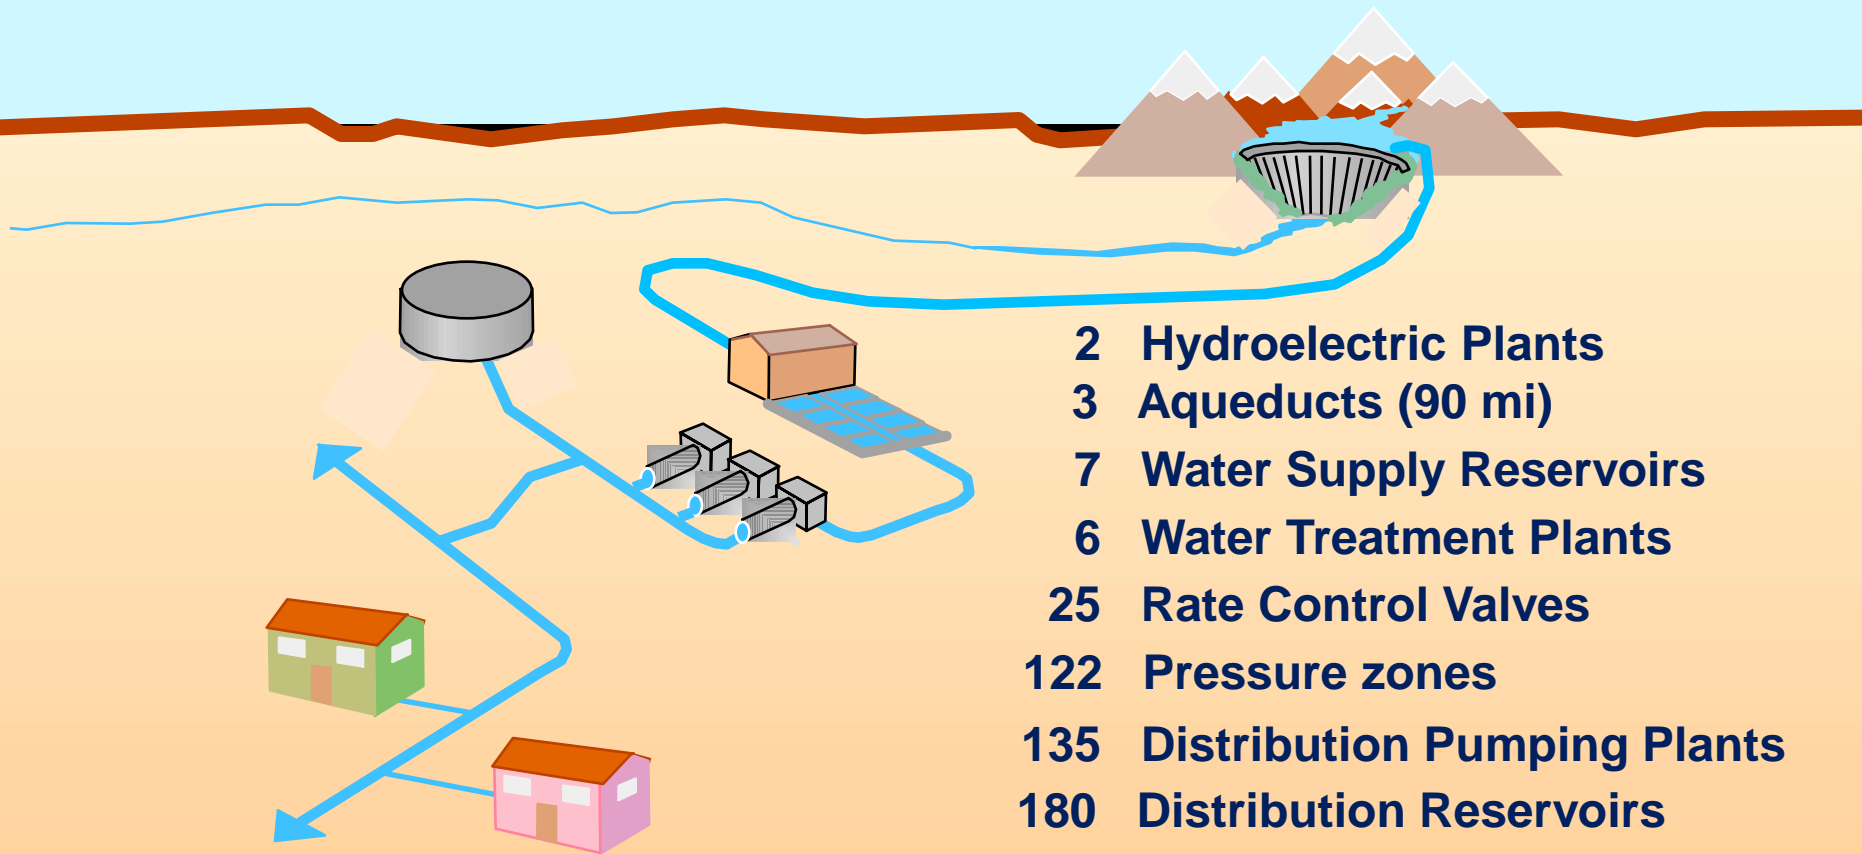
# EBMUD Water System Facilities

- 2 Hydroelectric Plants**
- 3 Aqueducts (90 mi)**
- 7 Water Supply Reservoirs**
- 6 Water Treatment Plants**
- 25 Rate Control Valves**
- 122 Pressure zones**
- 135 Distribution Pumping Plants**
- 180 Distribution Reservoirs**
- >4,000 Miles of Distribution Pipeline**
- Elevation: MSL – 1,450 ft**

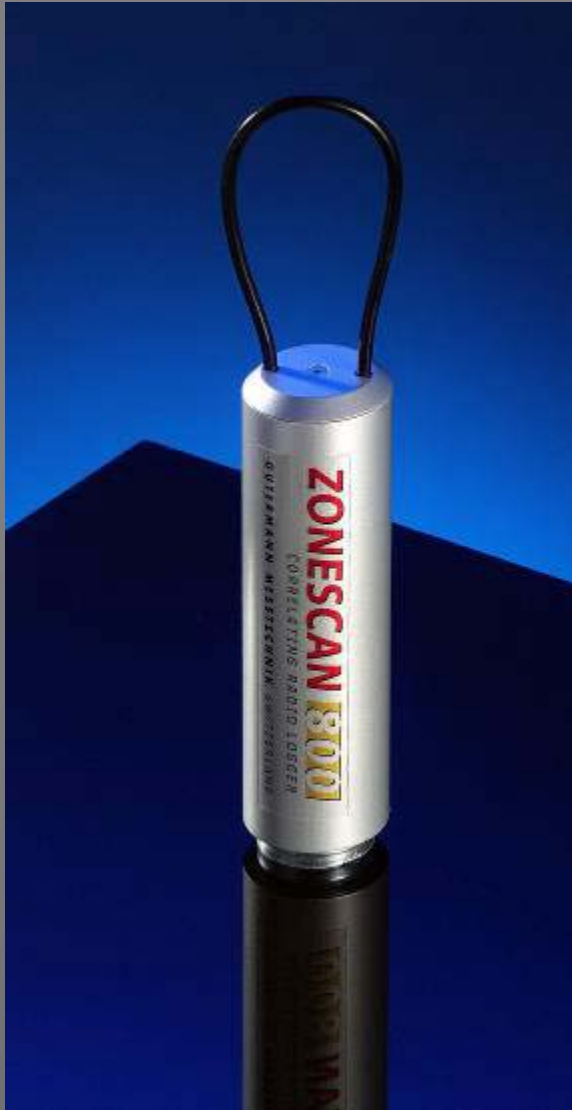
# How does a logger work?

- Magnetically attaches to valve pots
- Records sounds every 5 seconds (2-4 a.m; 2 hours = 1,440 reads daily)
- Based on distribution of leak sounds determines leak index from 0-100
- Loggers store leak numbers and graphical data
- Data recovered by a 2-way receiver
- Leak status announced on drive-by

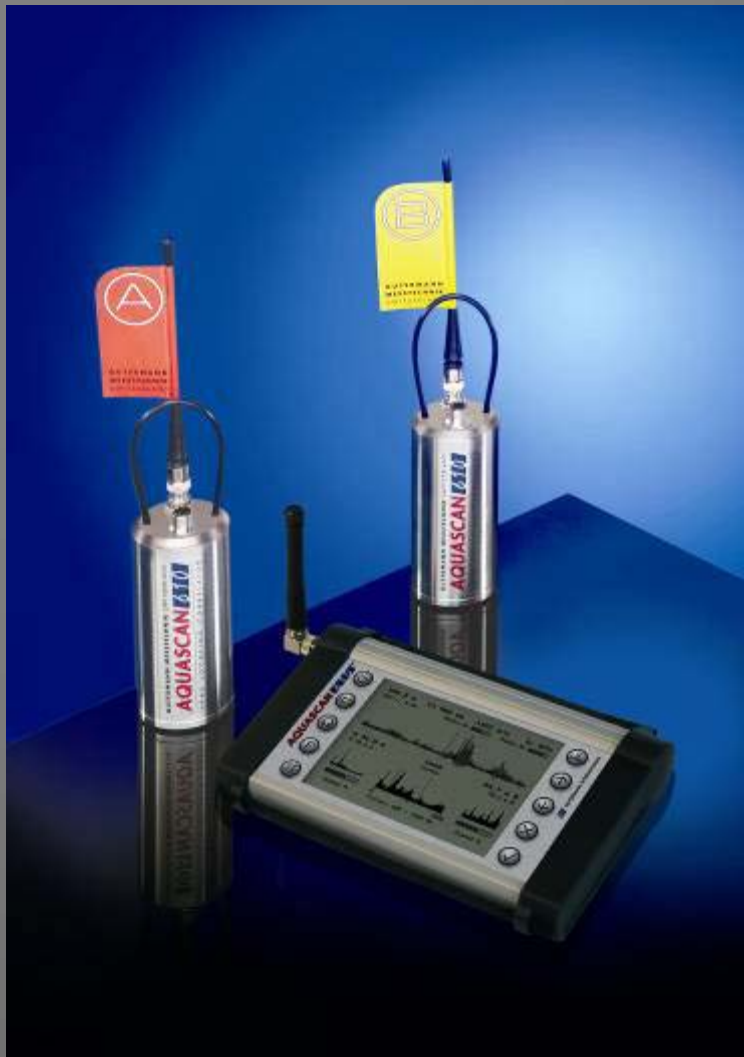
# How does a correlator work?

- Compares the sounds heard at 2 stations on either side of a leak
- Uses the sound velocity multiplied by time lag to calculate distance
- Sound velocity dependent on pipe:
  - Diameter
  - Material
  - Wall thickness
  - Pressure/Temperature-minor effects

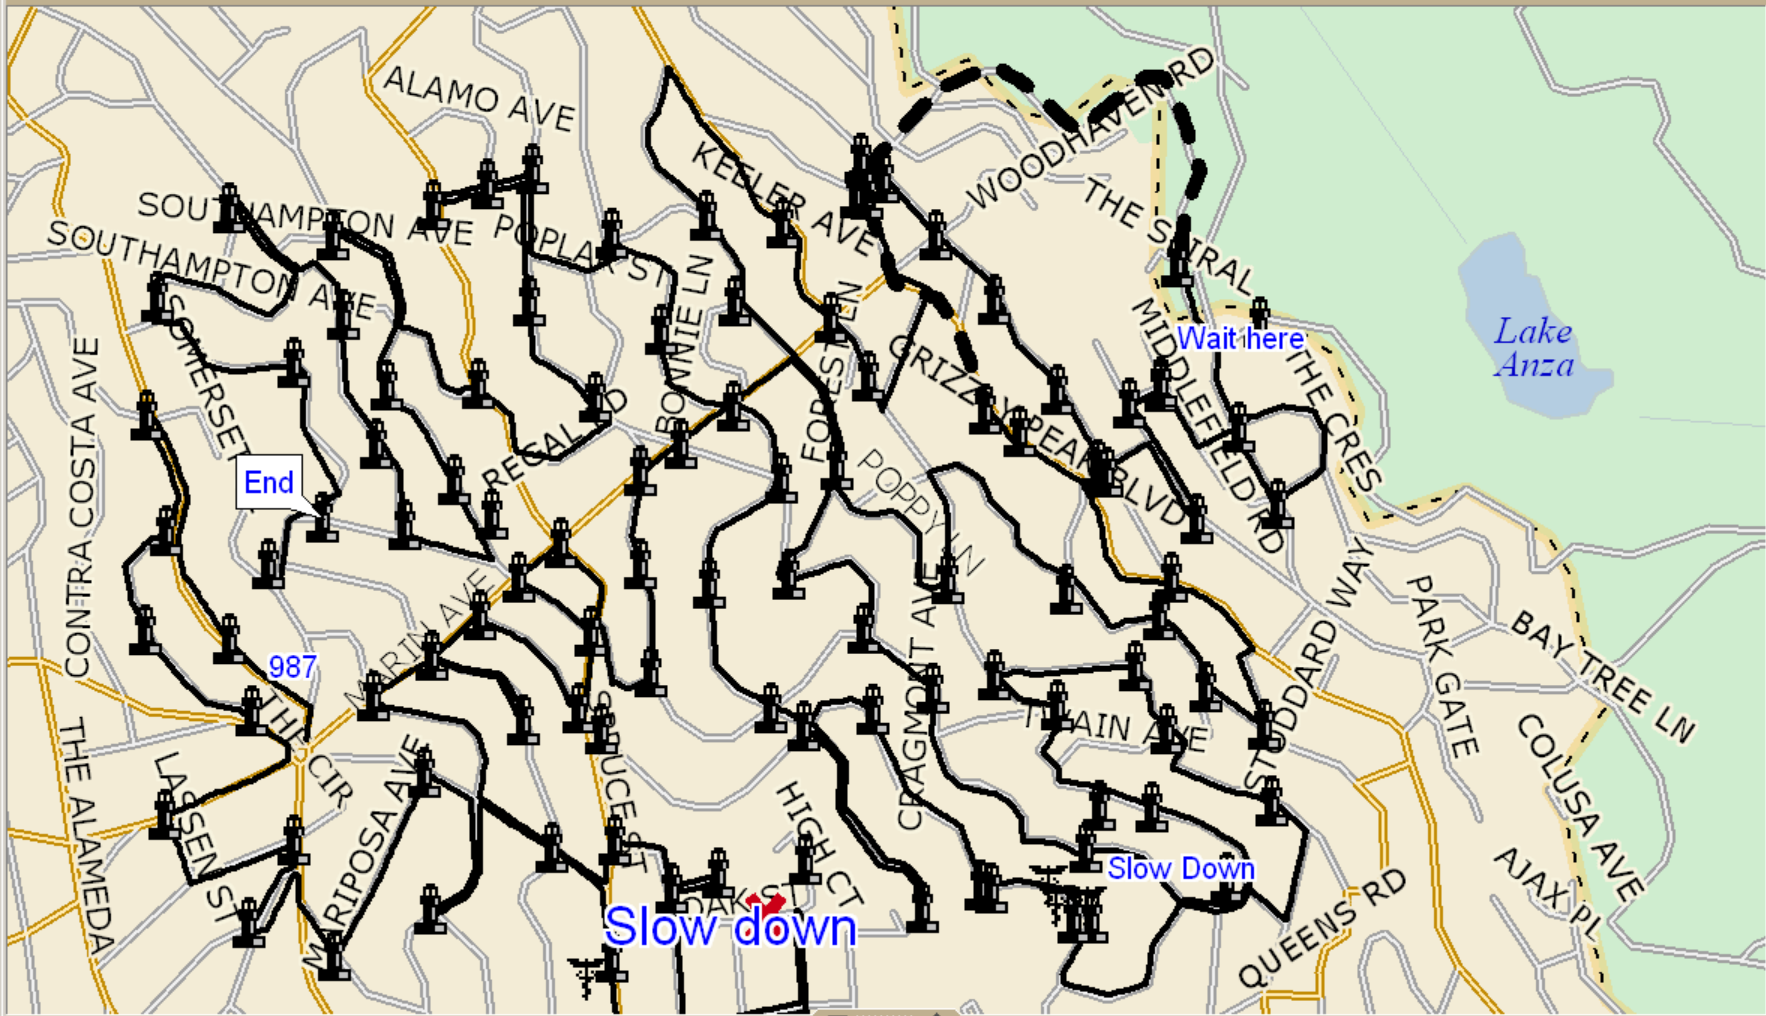
# Logger Operations

- Biweekly/monthly patrols takes 3 days
- Using GPS system and programmed route requires only 1 person
- Extension loggers installed on flooded pots
- Results reviewed and prioritized by Water Conservation and delivered to Operations

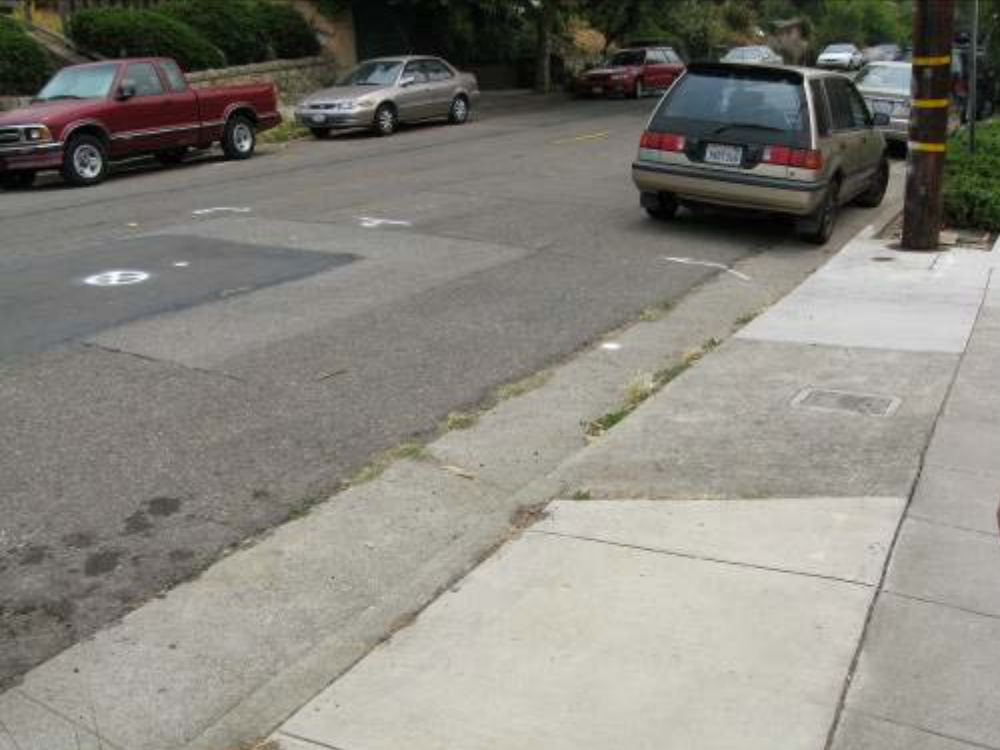
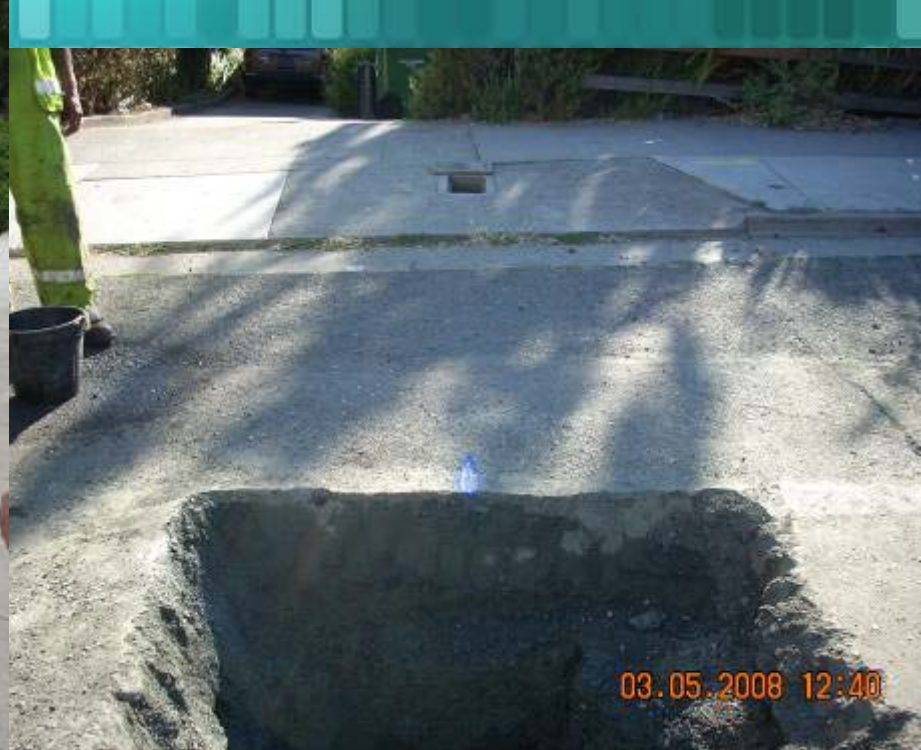
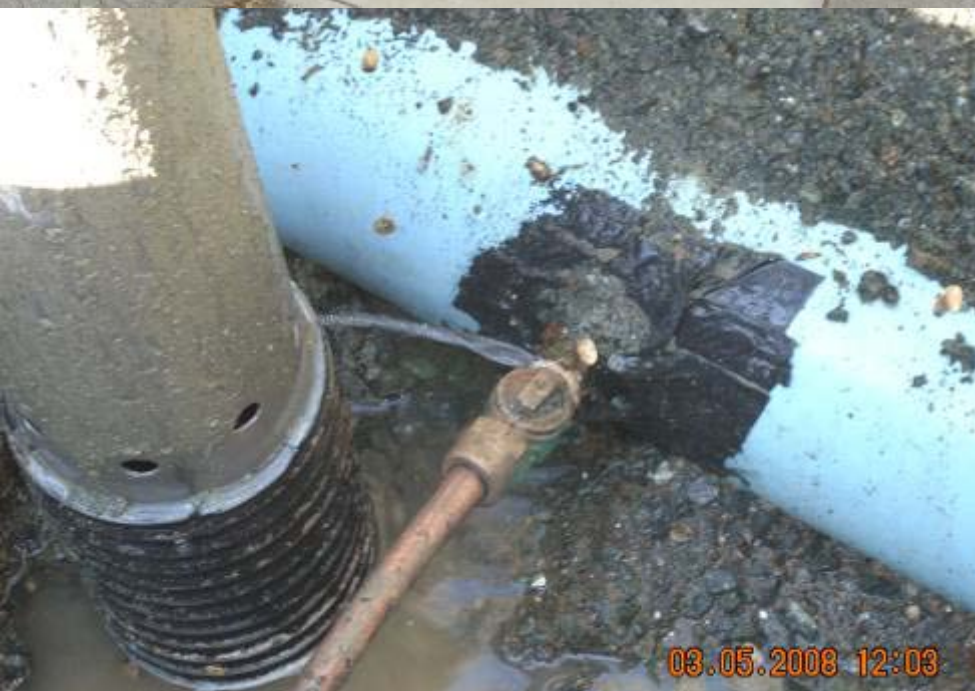
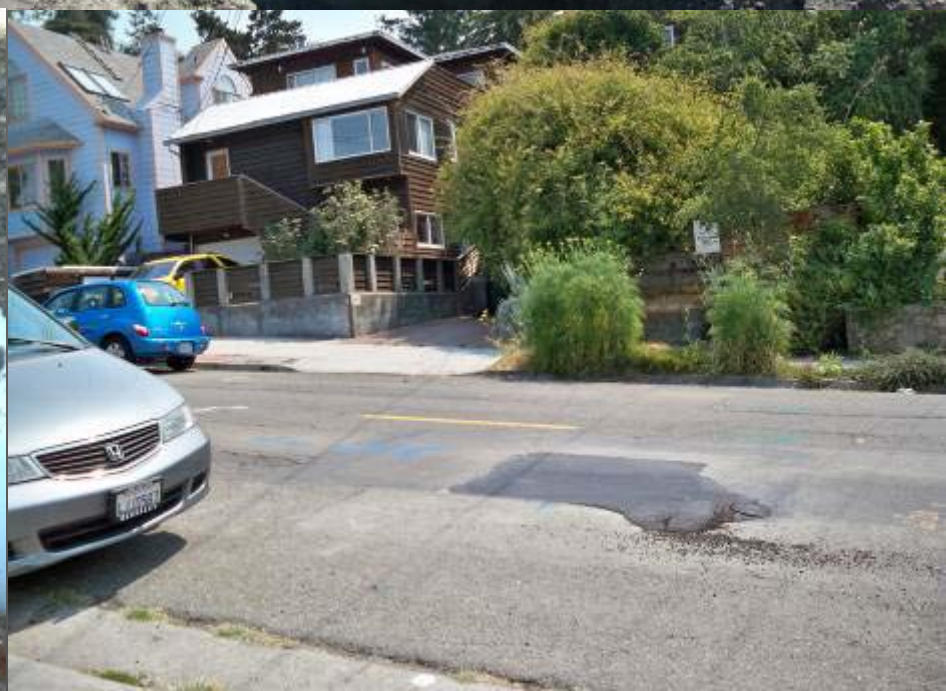
Cause    CORRECTIVE MAINTENANCE    Priority 4 ?    Pipe Ext E-22784    Backbone/Critical? N

Problem Description    STREET LEAK>>USA EXP DATE 10/30/09 UPDATE BY 10/28/09

Action	Device	Device #	Assign To	Org	Issue Date	Comp Date	Pgm/Proj	Est. Hrs	Act. Hrs
REPAIR	MAIN	E-22784	DGUARAGL	723	10/02/2009	10/06/2009	5761	28	27.5
Size 6	Comments REPAIR FULL CIR BREAK ON 6" CI MN W/ 6 X 7.5 FULL CIR CLAMP						Qty 1	Delete <input type="checkbox"/>	
Action	Device	Device #	Assign To	Org	Issue Date	Comp Date	Pgm/Proj	Est. Hrs	Act. Hrs
INVESTIGATE			HWELCH	722	10/02/2009	10/02/2009	5729	0.5	0.8
Size	Comments LEAK ON THE 6 IN CI MN						Qty 1	Delete <input type="checkbox"/>

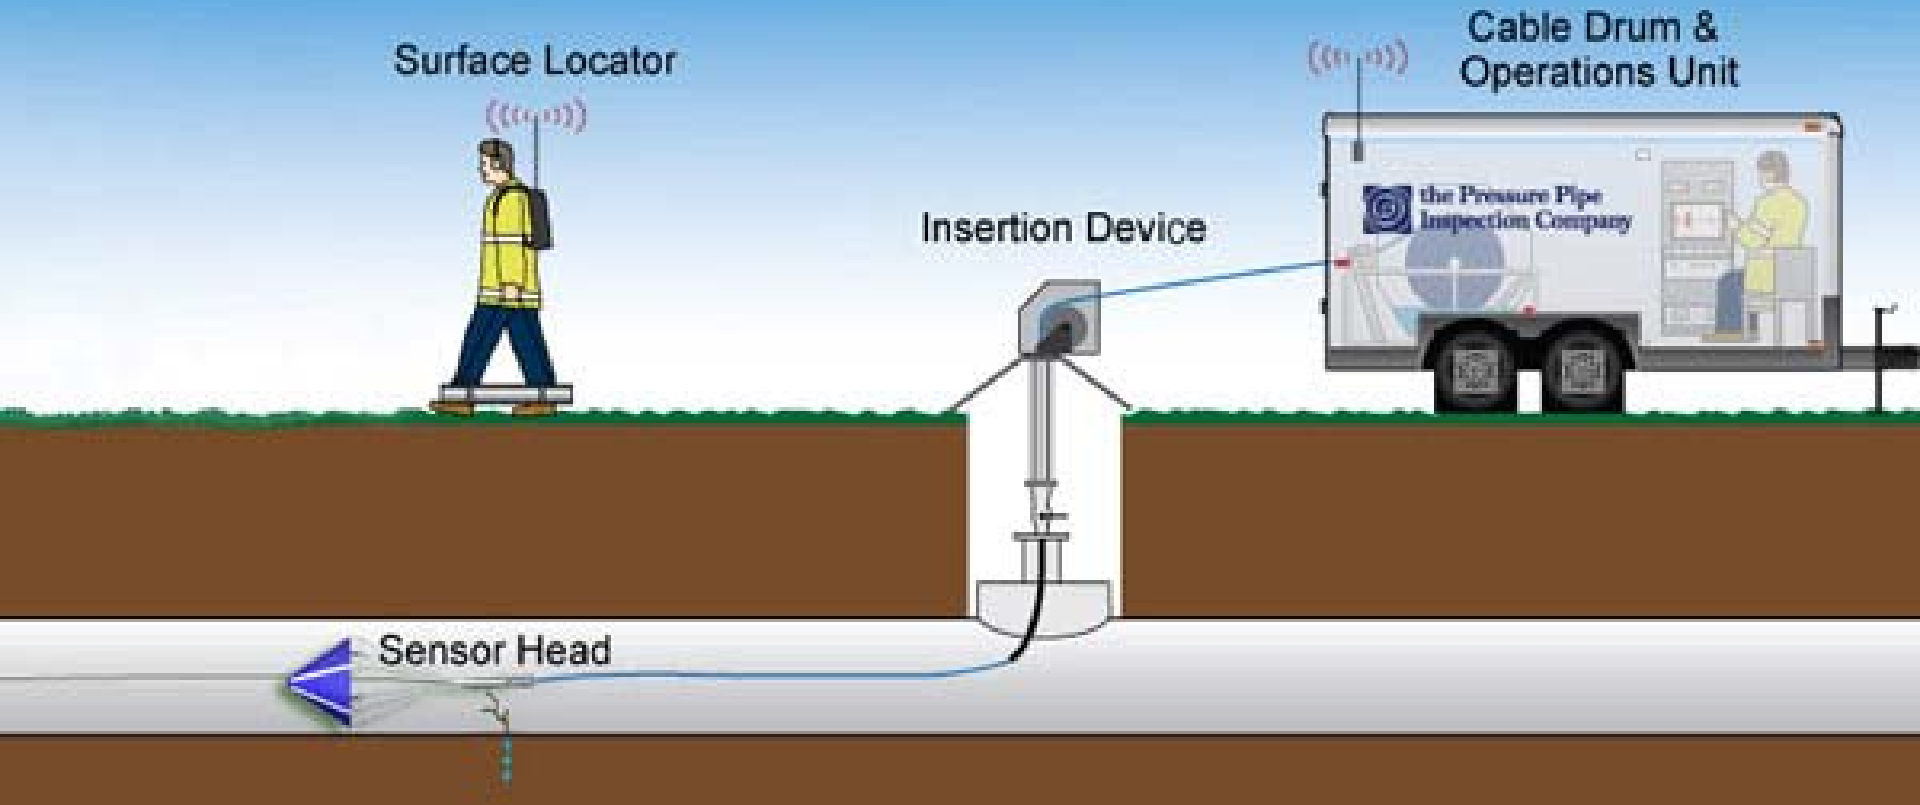
# PPIC "SAHARA" Acoustic System

- Pressure Pipe Inspection Company "SAHARA" System
  - Tethered acoustic sensor drawn by parachute
  - Capability to 5,000 feet/run or 270 degrees of bends
- Pure Technologies U.S. Ltd. "Smart Ball"
  - Free-rolling Ball (not tethered)
  - Capable of 12-15 hours at about 90% of water velocity ( $> 1$  ft/s)
  - Can pass through "some" obstructions
- Echologics Engineering "Leakfinder RT"
  - Acoustic and auto correlation functions
  - Capable of 300-5,000 foot spans in steel pipe

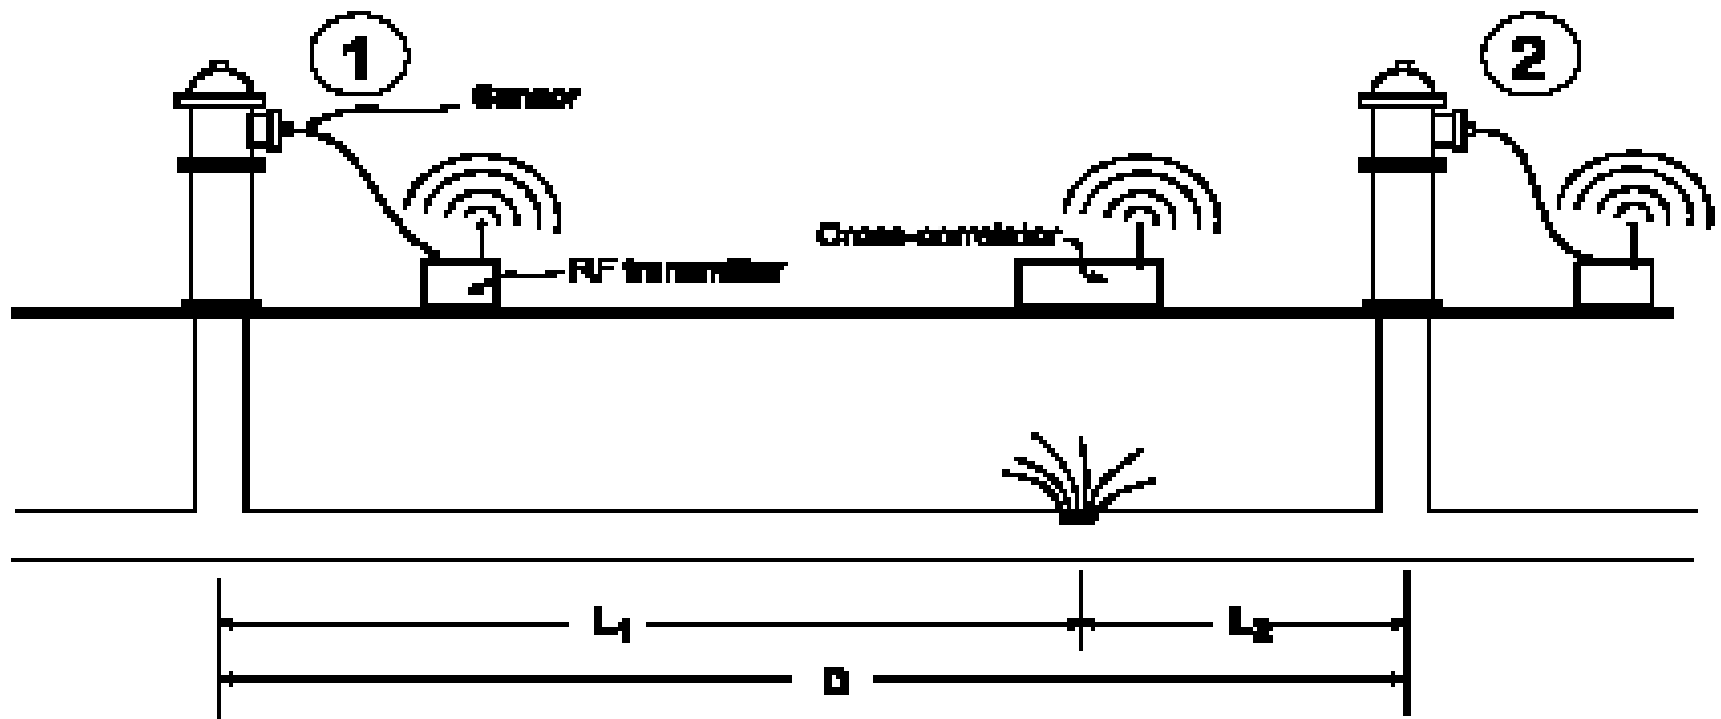
Figure 1 Schematic illustration of the cross-correlation method
