USGBC Stormwater Grant

Multi-Variate Study of Stormwater BMPs

USGBC WebEx | 23 August 2011

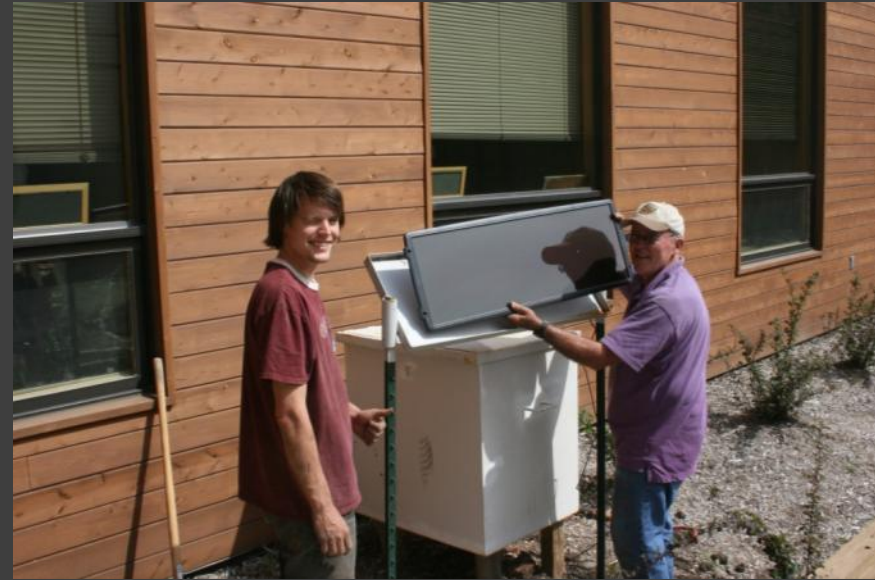
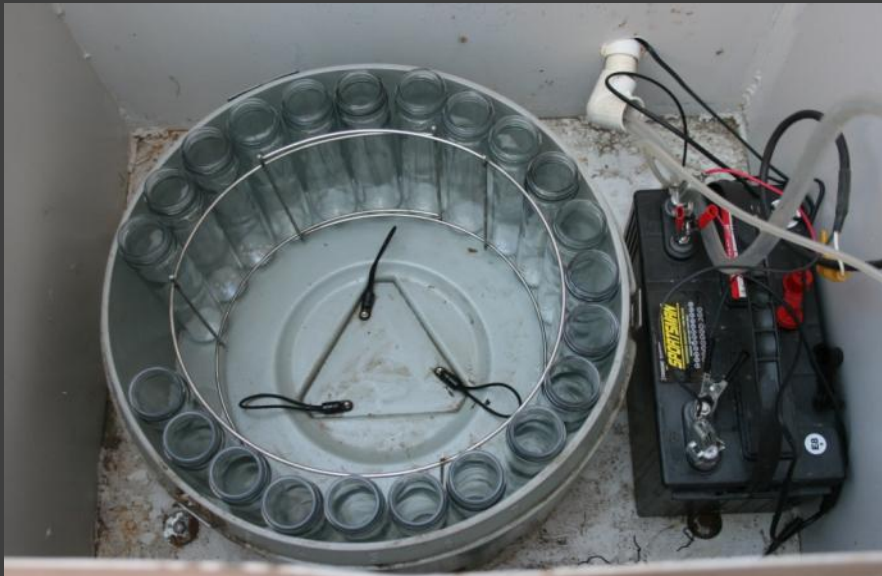
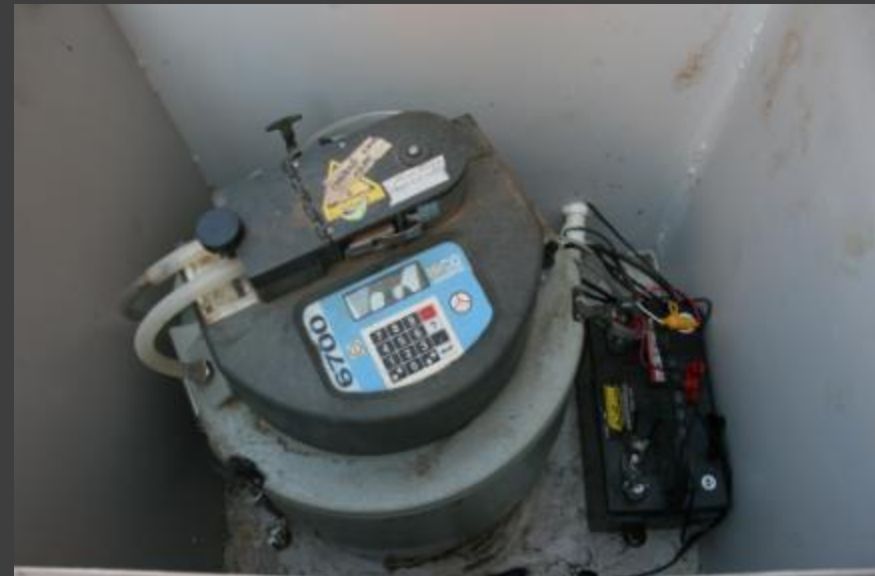
- **Teledyne ISCO 6712 Portable Samplers**
 - Monitors flow and takes samples of runoff for lab quality tests.
 - Flow Measured by Bubble Tube and logged into the ISCO computer.

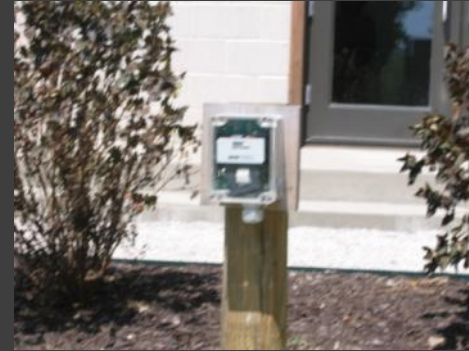
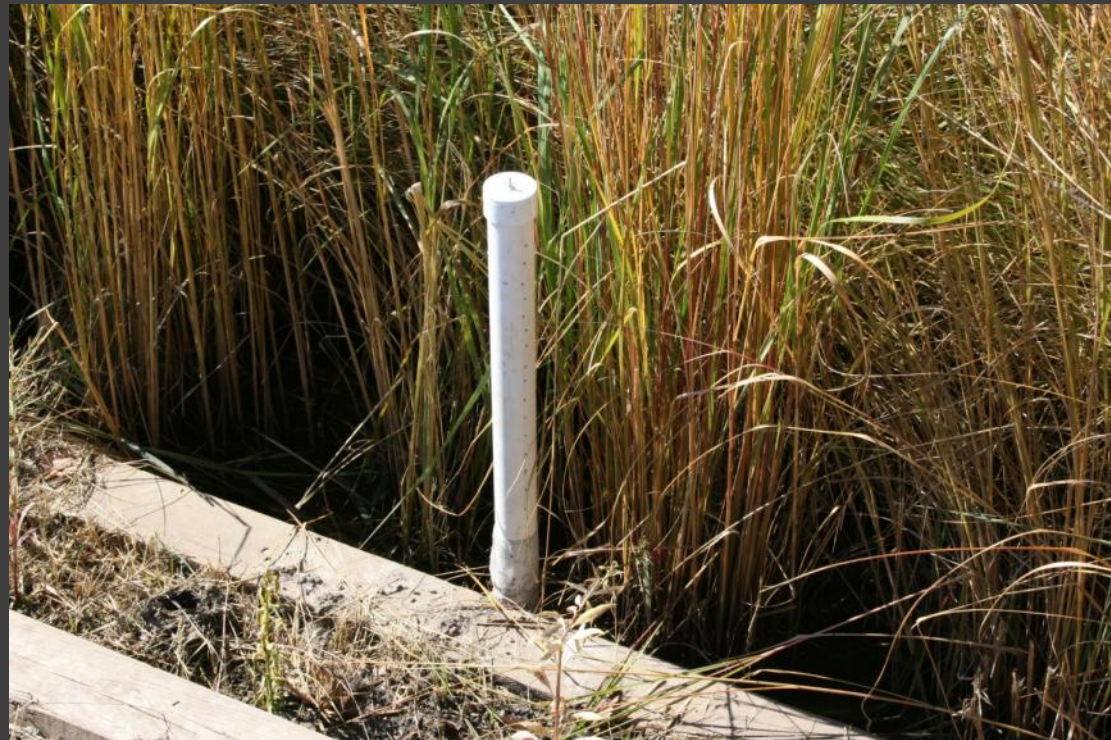
- **Infiltration Testing**
 - Piezometer: Measures and logs water level in detention area.

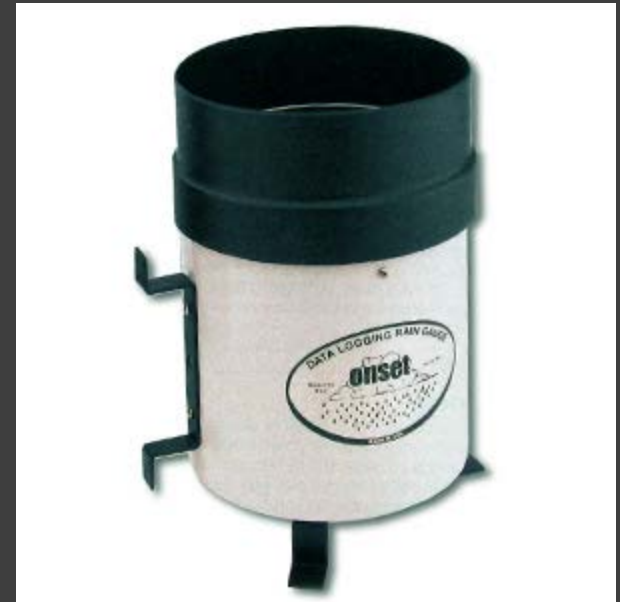
- **Onset Data Logging Rain Gauge (Rooftop Tipping Bucket)**
 - Monitors Rainfall Intensity
 - Rainfall Quantity Measurements and Logging
 - Total Volumes
- **Software**
 - Flow Link (ISCO)
 - HOBOWare (Tipping Bucket & Piezometer)

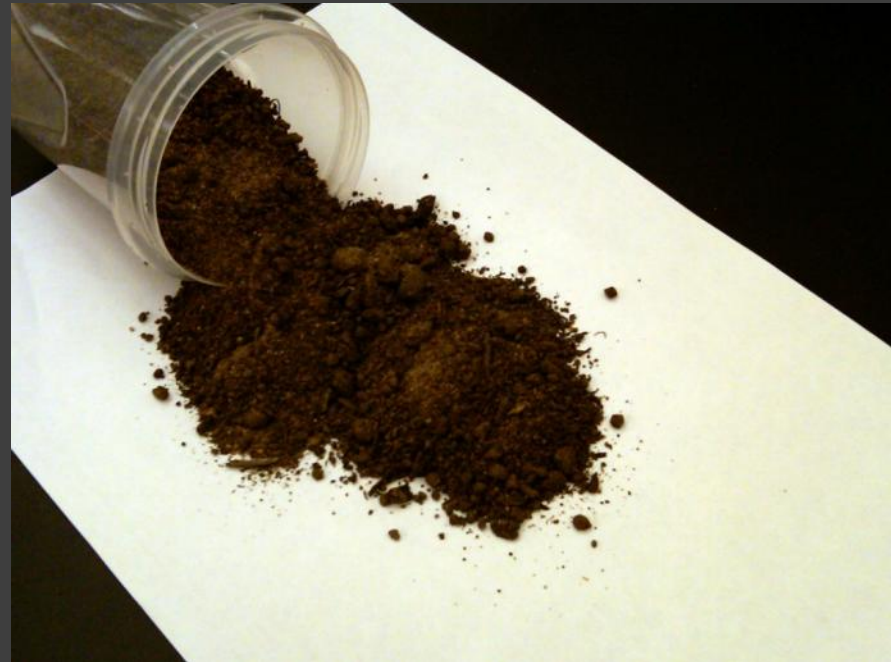
- **Soil Sampling**
 - Test Particle Size Distribution
 - pH
 - Zinc
 - Organic Mater
- **Soil Moisture**

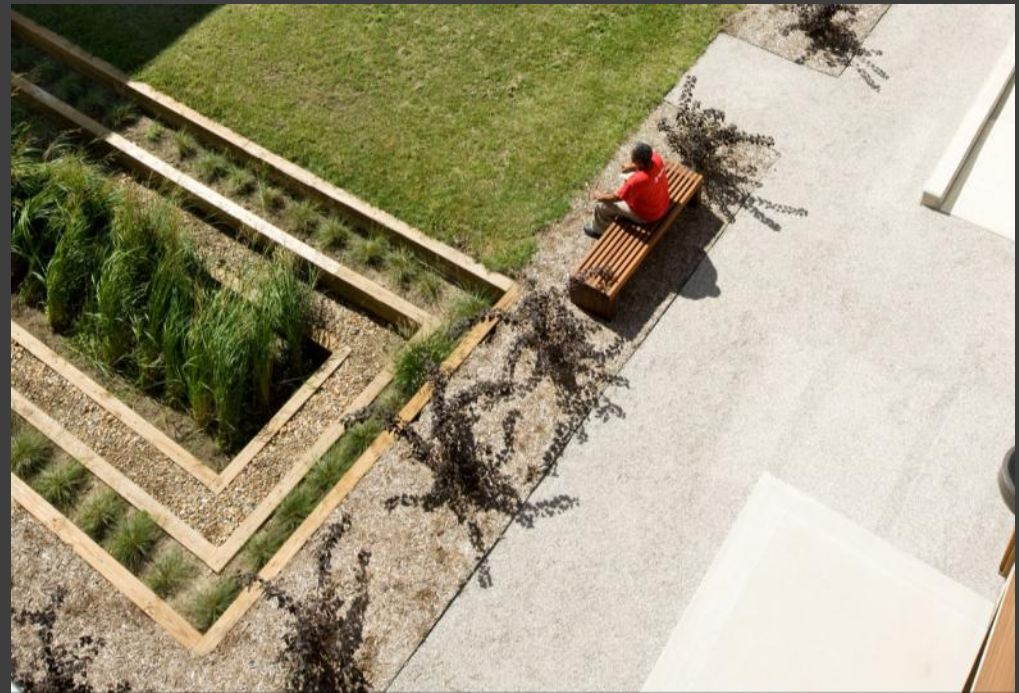
Section

- Inlet Pipe
- Level Spreader
- 3' Engineered Soil
- 787 CF

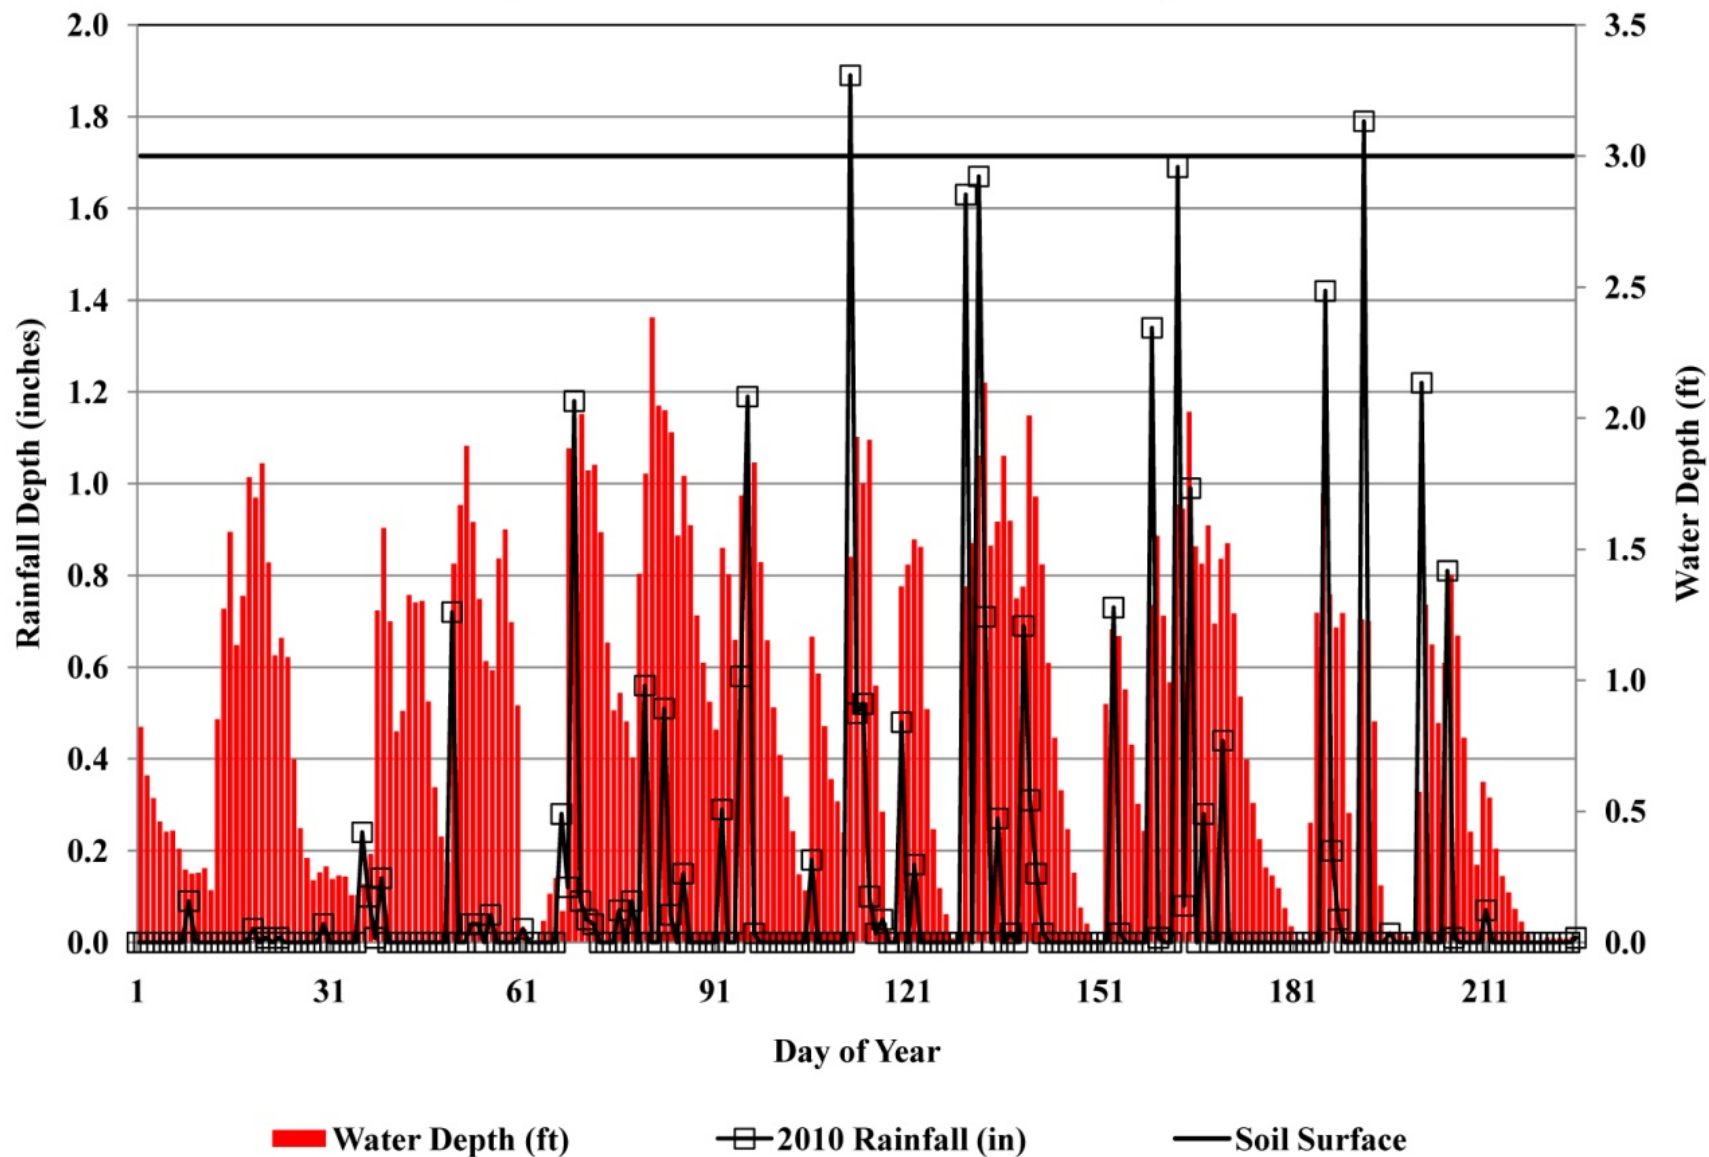
Union City Mission 2010 Rainfall and Water Depth in Cell 1

According to this calculation we should have had standing water on 9 of 20 sampling events (with overflows on 5 of 20).

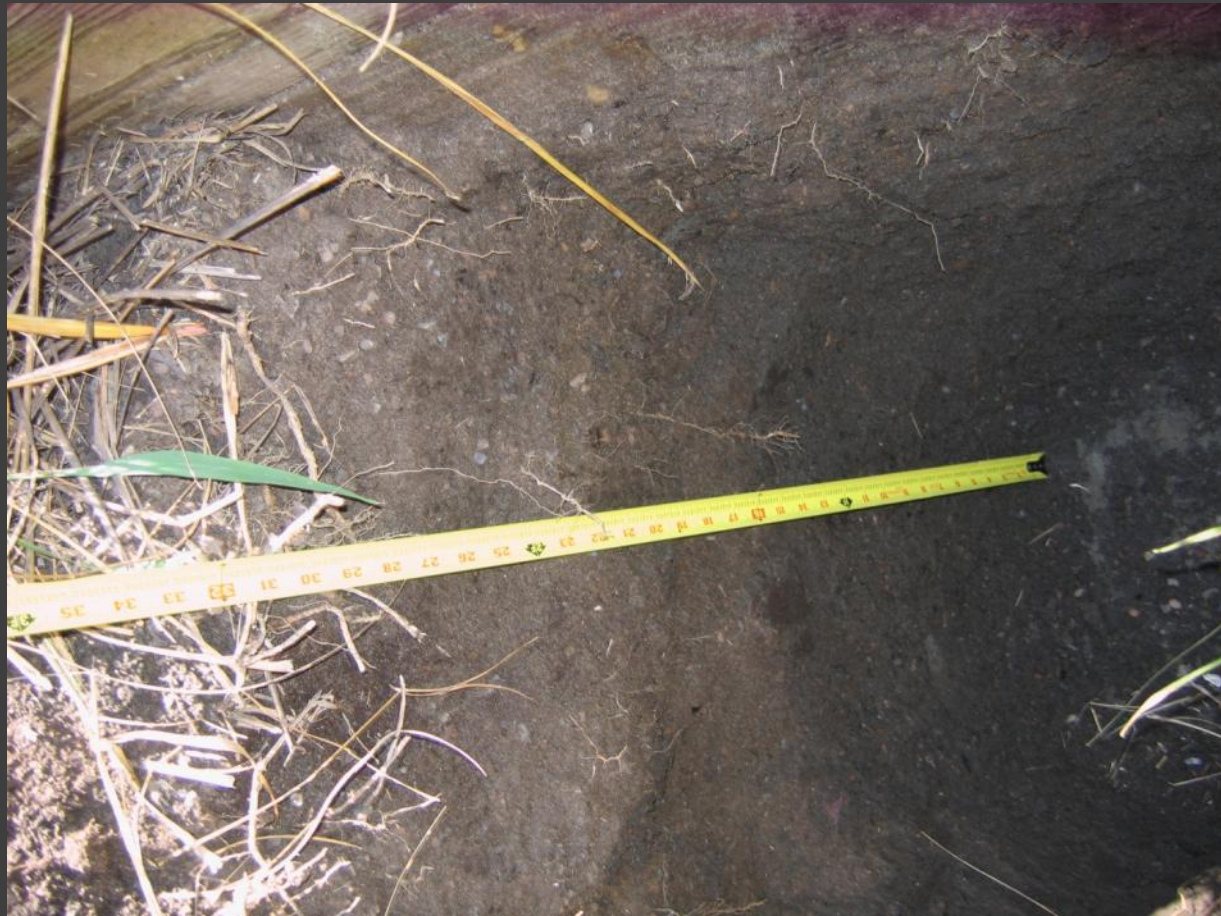
Root Growth

- Cordgrass roots reach 30 inches deep.

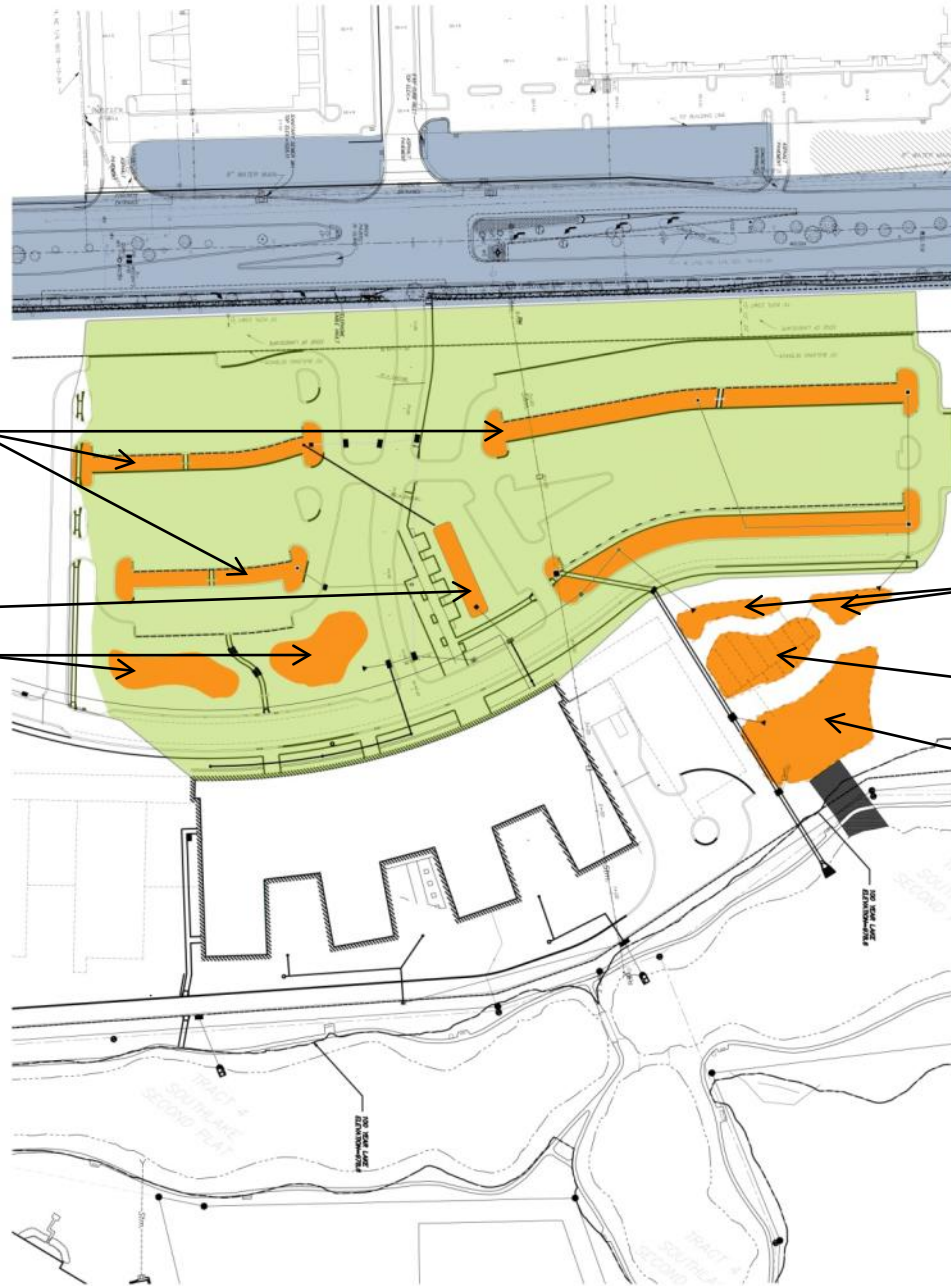
Water Flow Diagram

Watershed

Vegetated Swales

Raingarden
Bioretention Cells

Sediment
Forebays

Sand Filter

Wetland

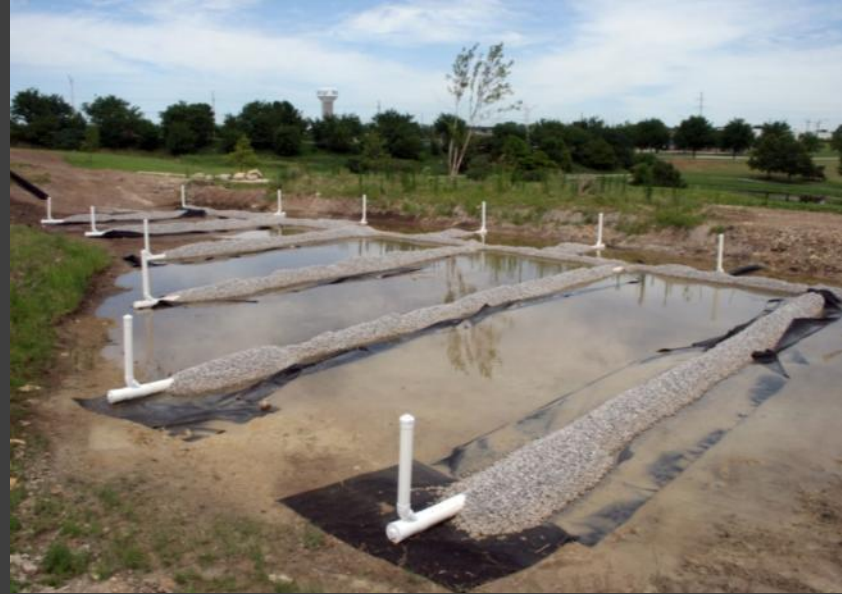
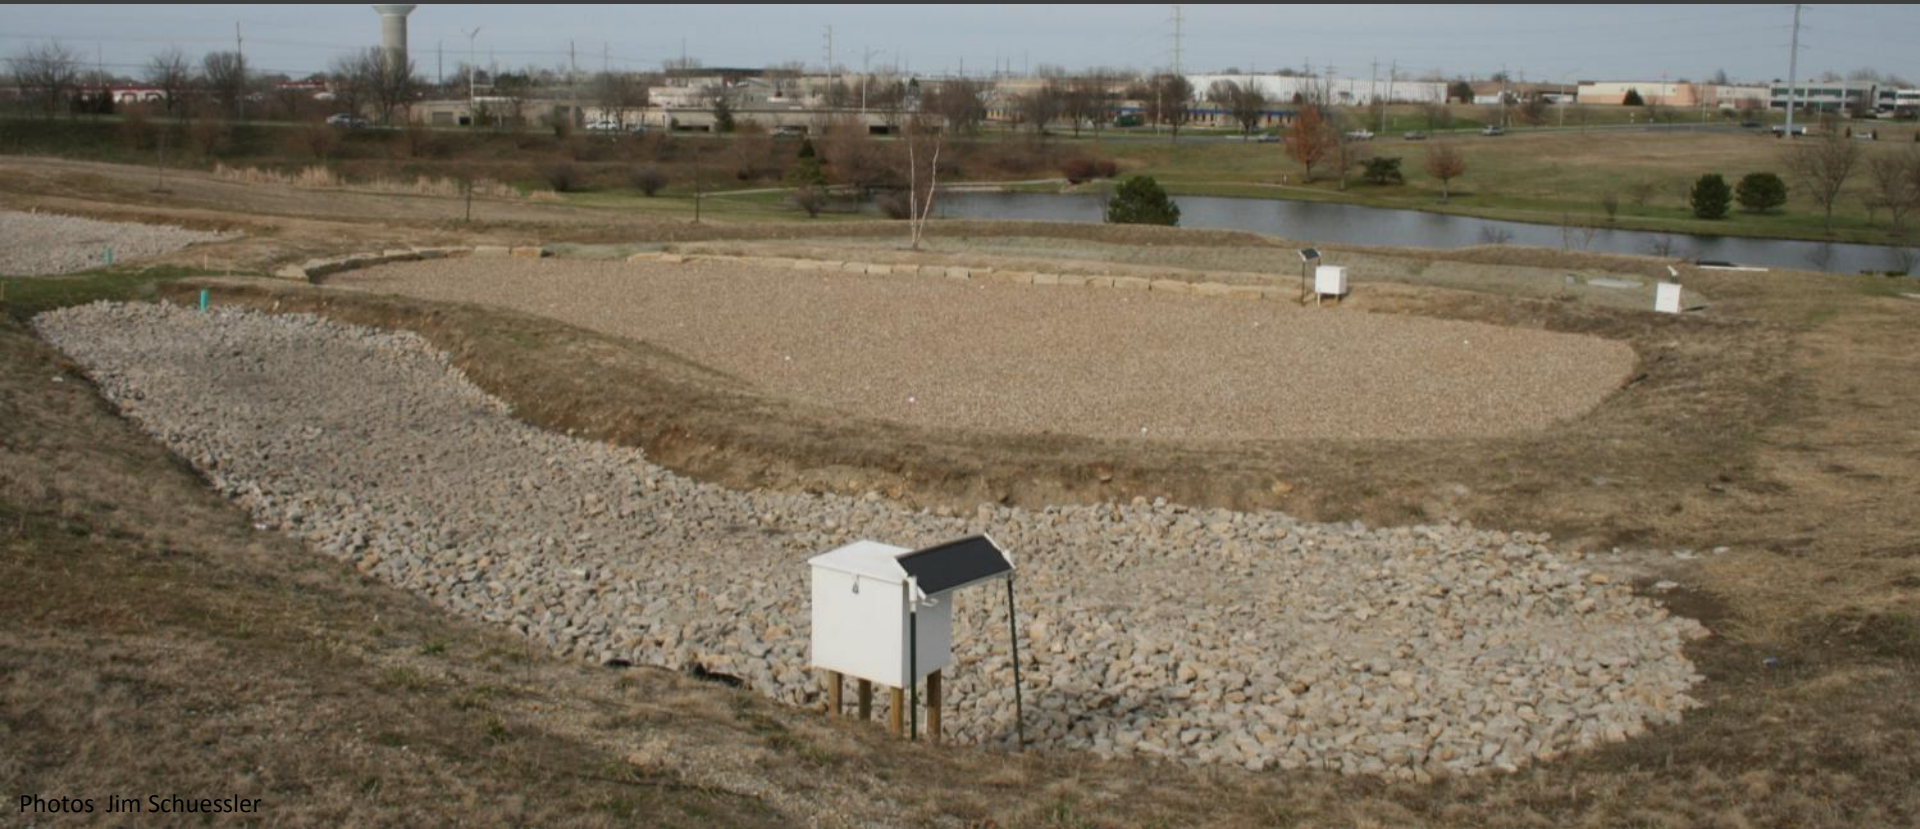
Sand filter w/ Sediment Forebay

30" Inlet from Parking Lot

Sand Filter and Sediment Forebay

■ Removal

Average of 117 mg/l of TSS

Reduction of TN and TP

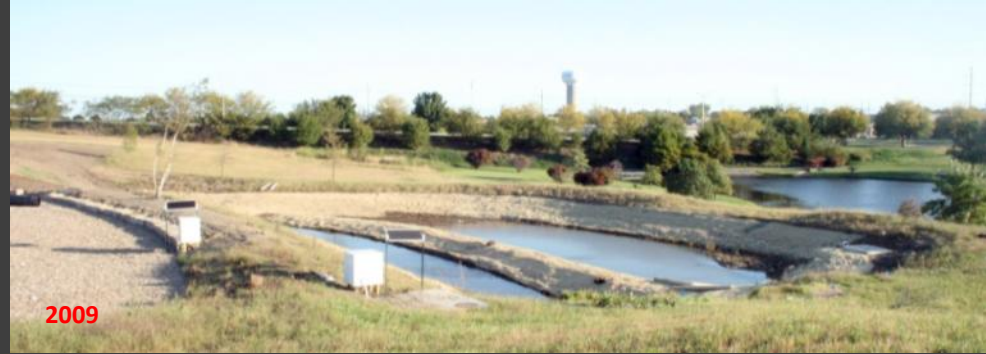
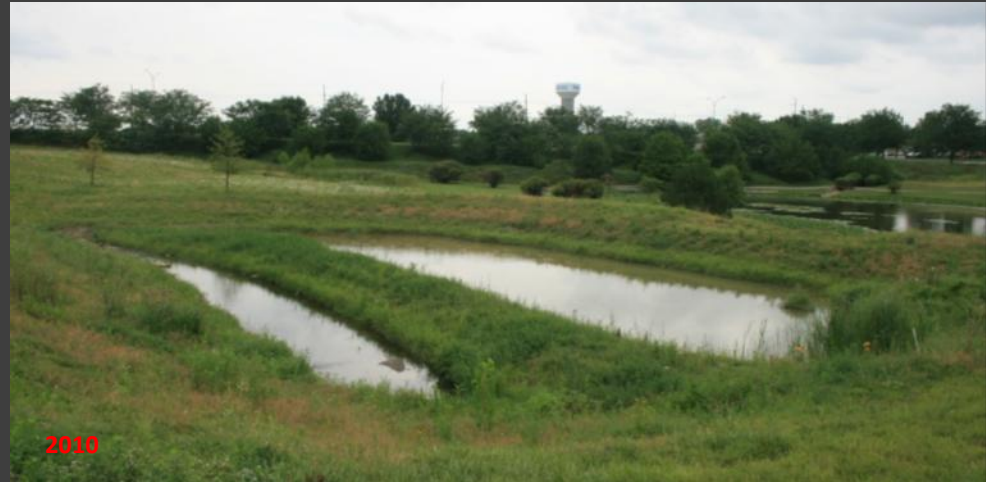
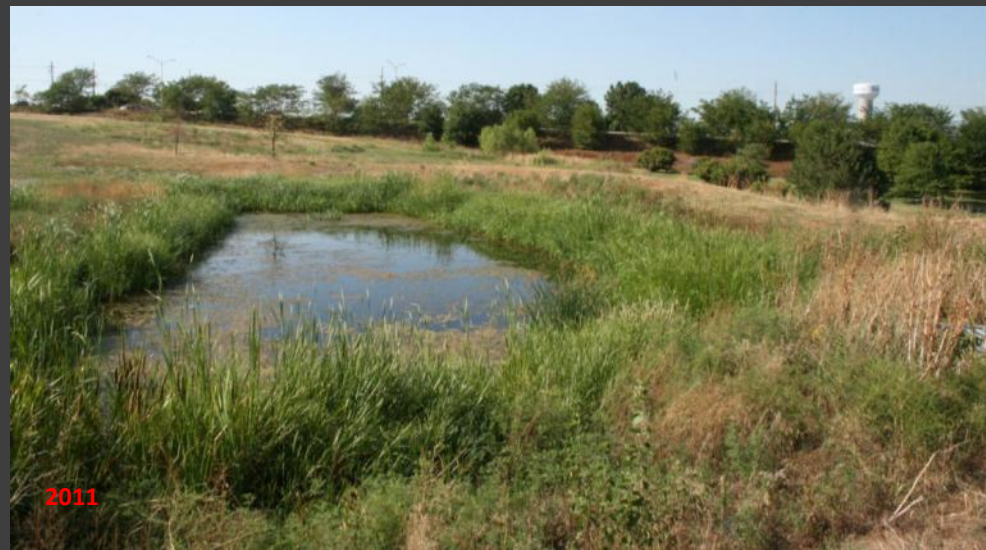
Wetland

½ Acre

- Sand Filter Runoff
- First Flush from Renner Road

■ Poor Performance

Unstabilized spillway

Newly planted vegetation

Water fowl

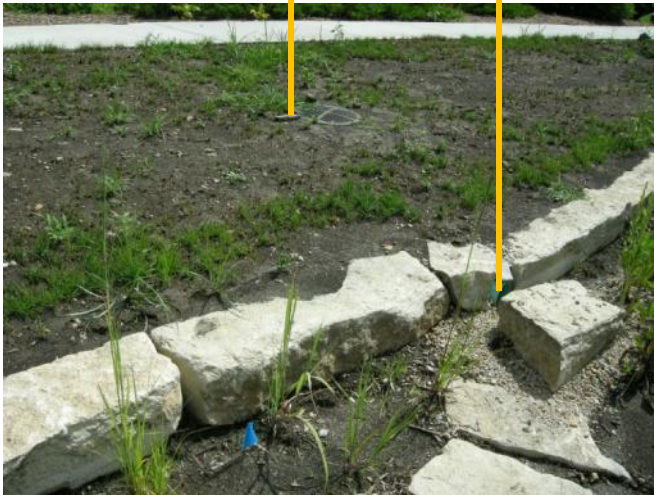
Manhole with Multiple Outlets
Outlet into Raingarden
