Building the Teams That Build Green Infrastructure

2013 WaterSmart Innovations
2 October 2013

Elmer Avenue Neighborhood Retrofit Project

Elmer Paseo Stormwater Improvement Project Goals

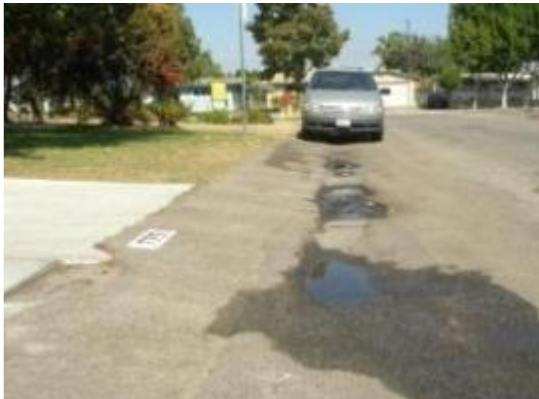
40 acres drain to Elmer Avenue

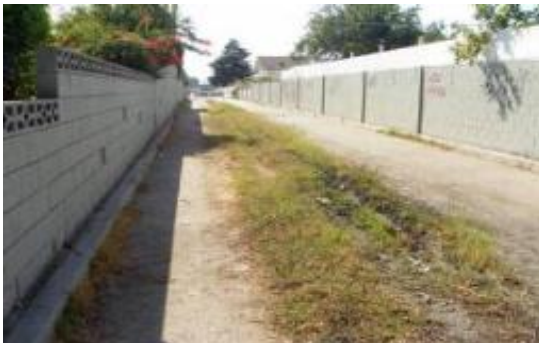
20 acres drain to Elmer Paseo

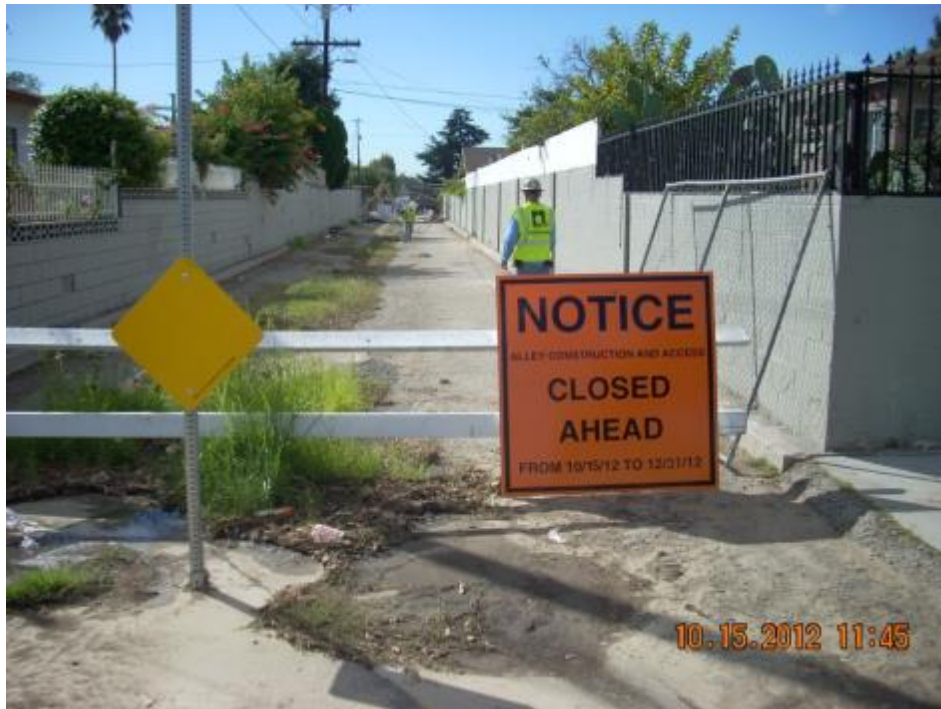
Demolition and removal of asphalt pavement

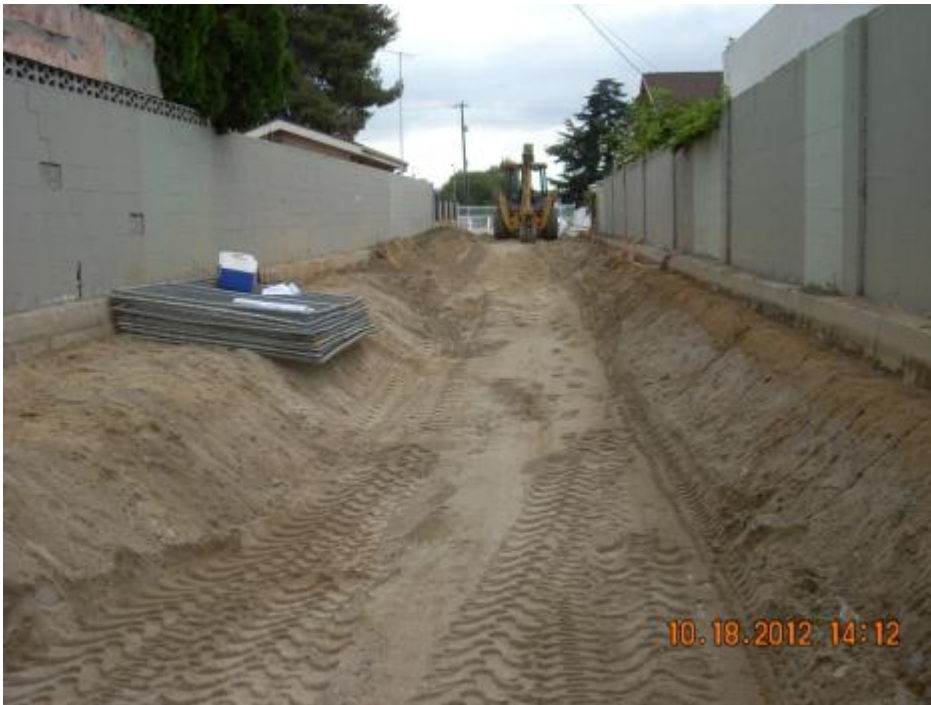
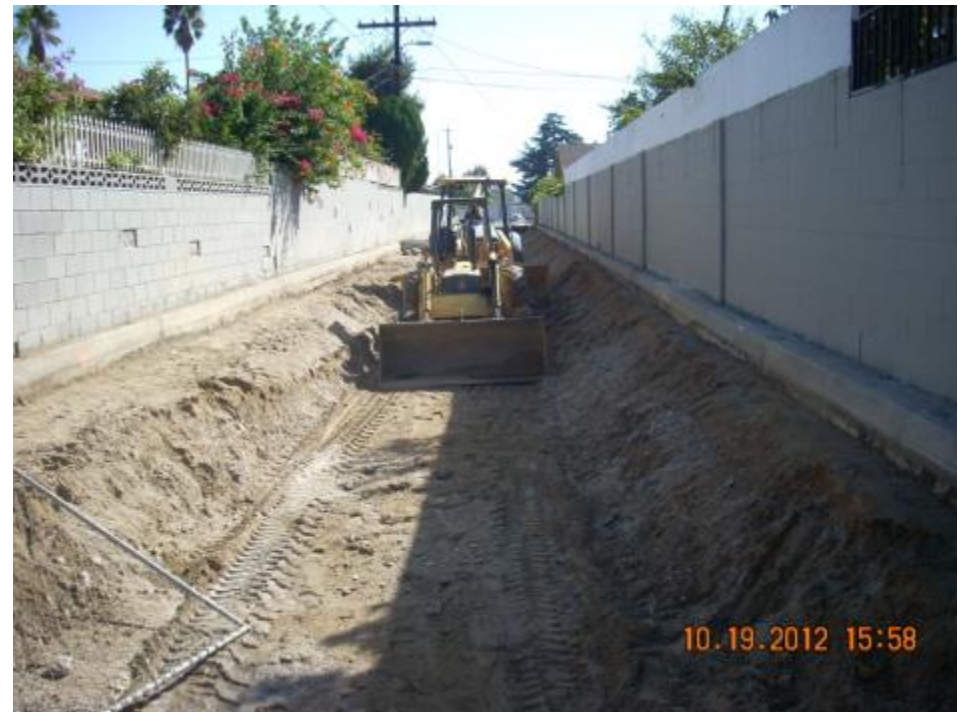
Excavation of infiltration trench

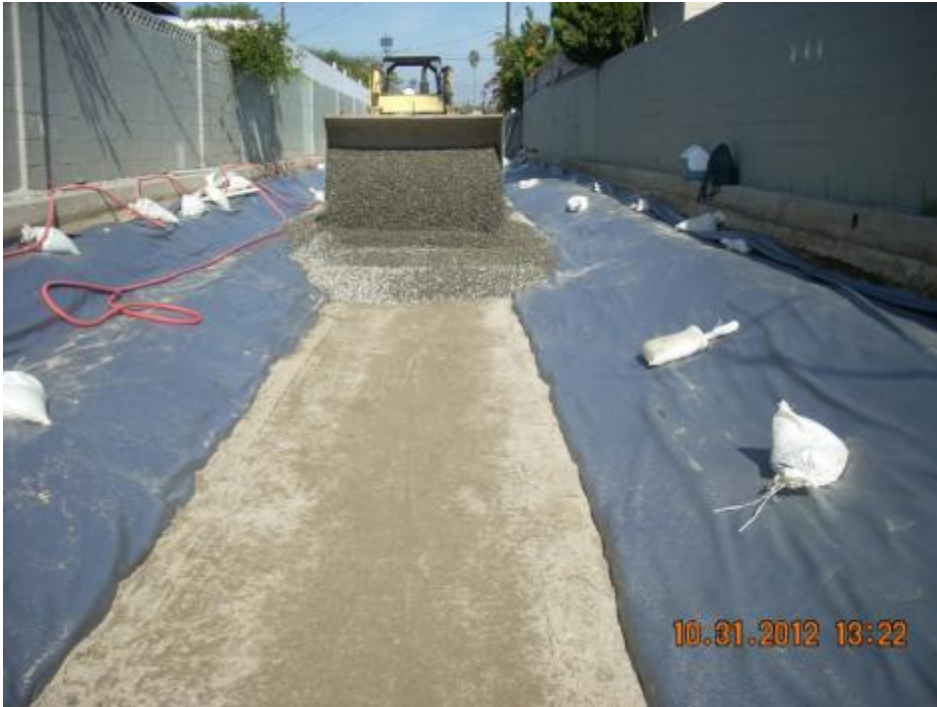
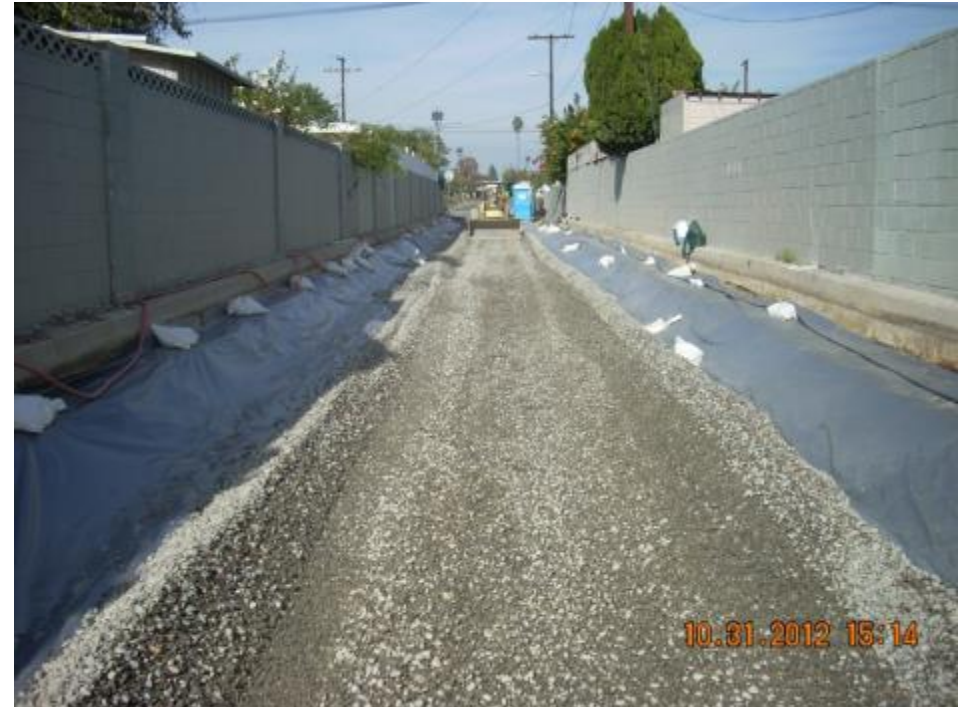
Installation of infiltration trench gravel

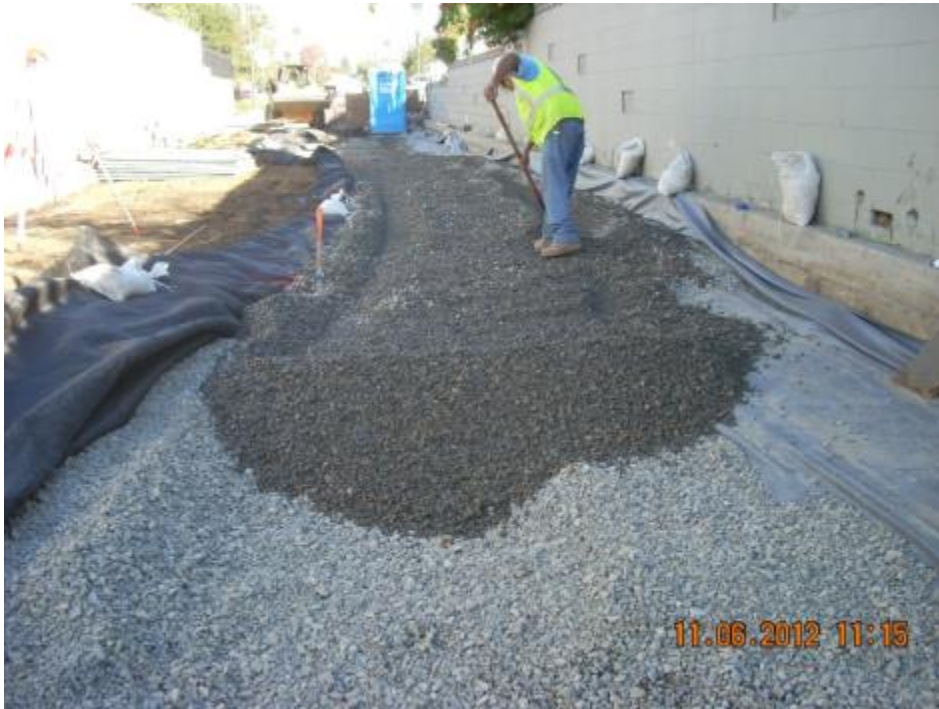
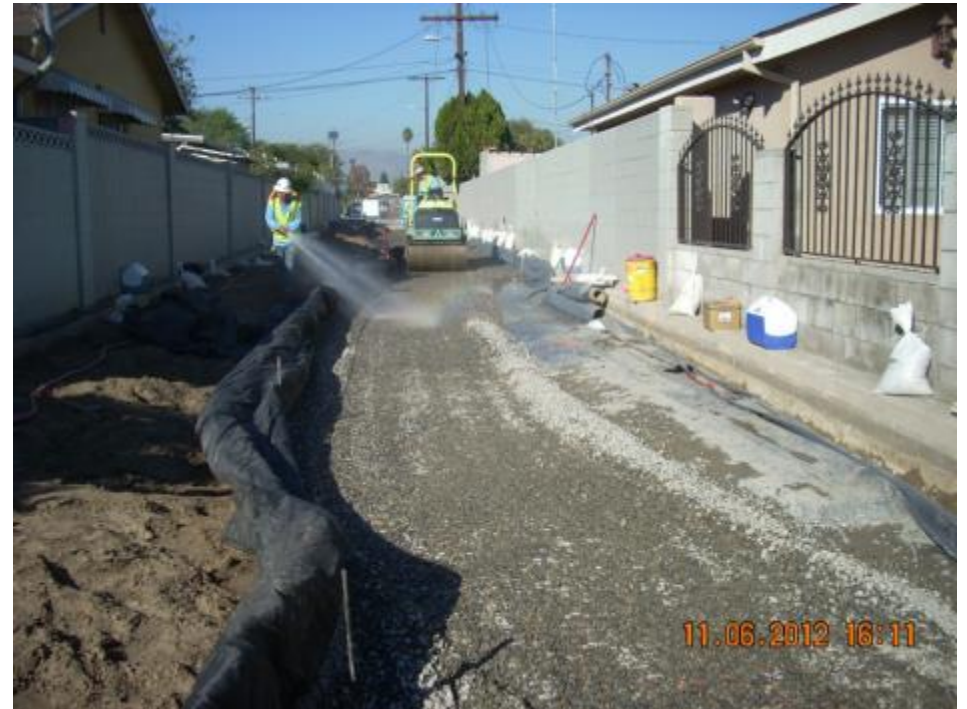
Construction of bio-swale, infiltration trench, and pathway continued.

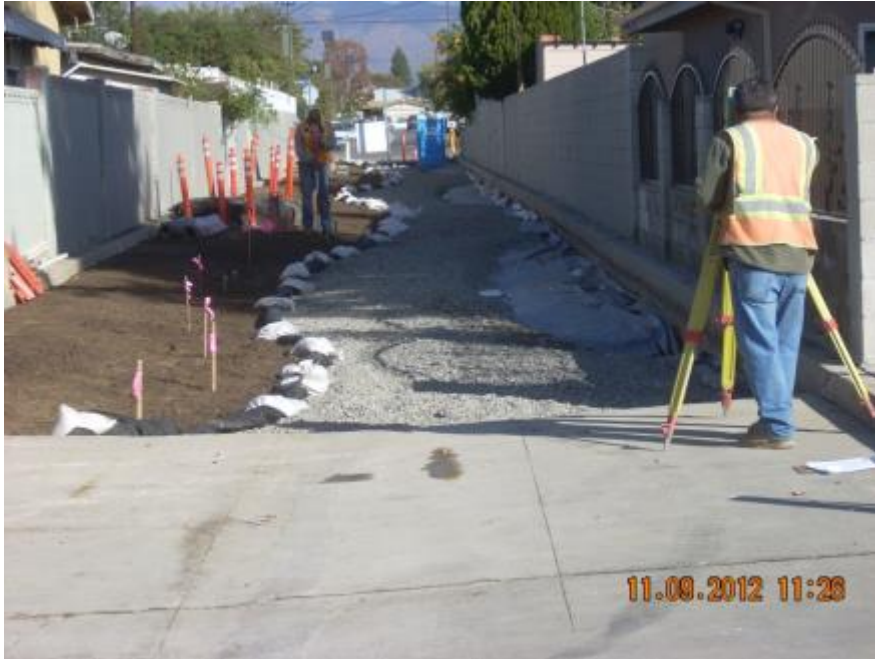
Survey for pathway elevation points

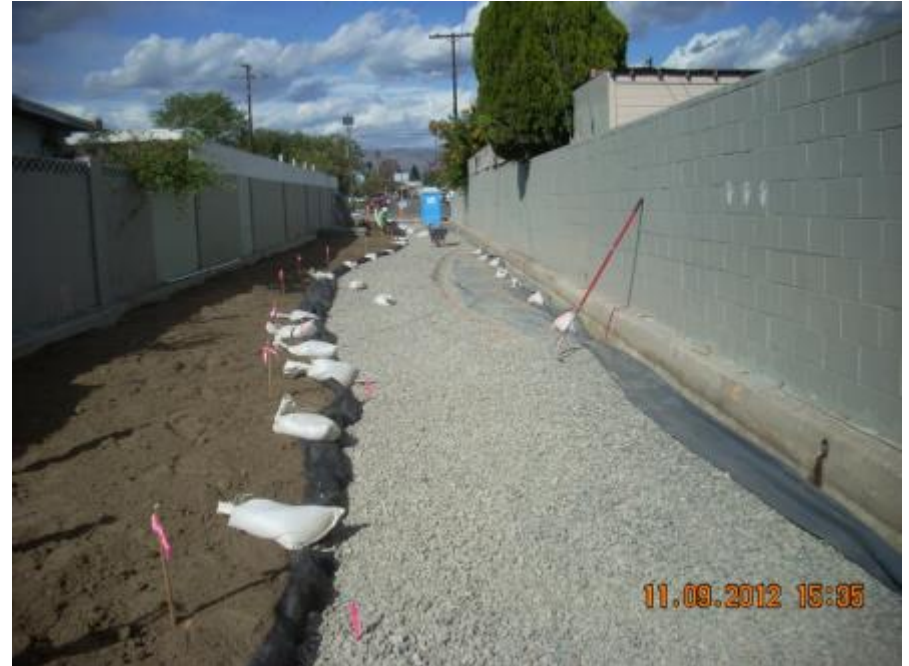
Base layer for pervious concrete pathway

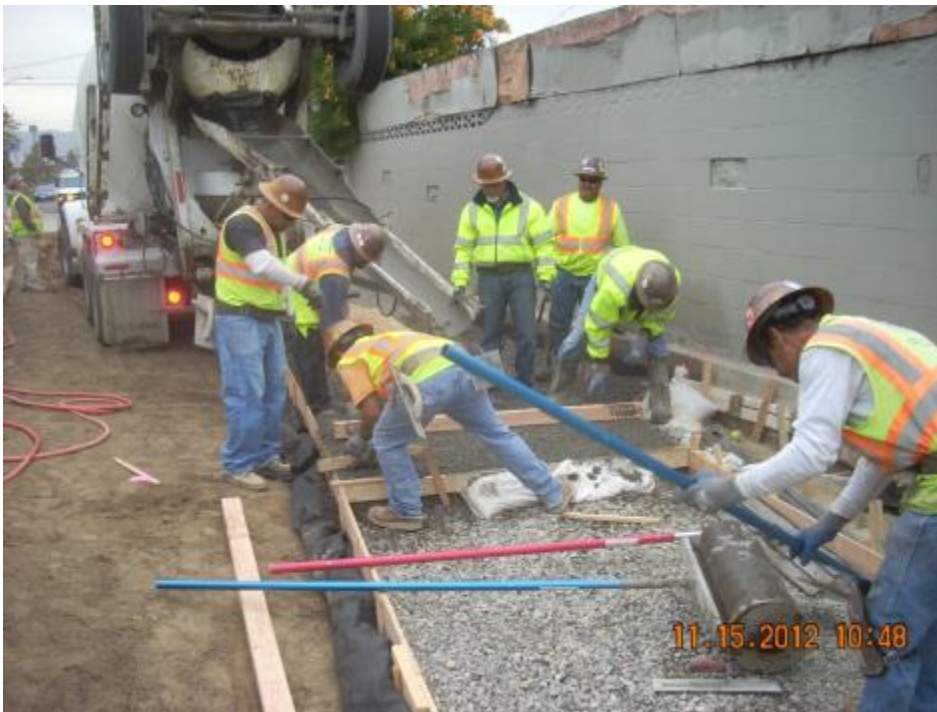
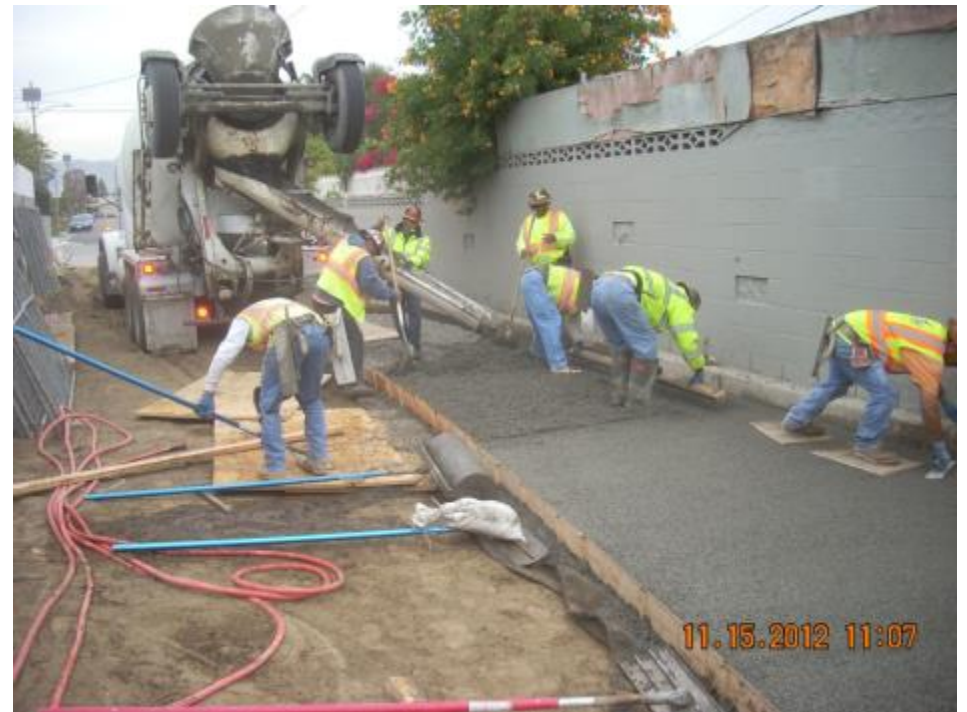
Construction of pervious concrete pathway.

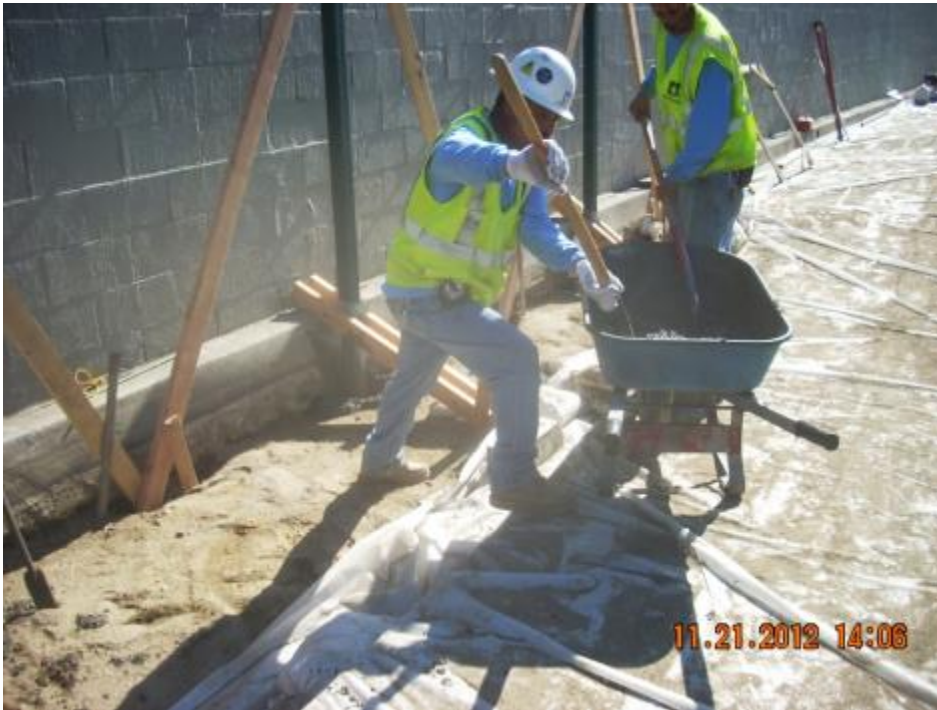
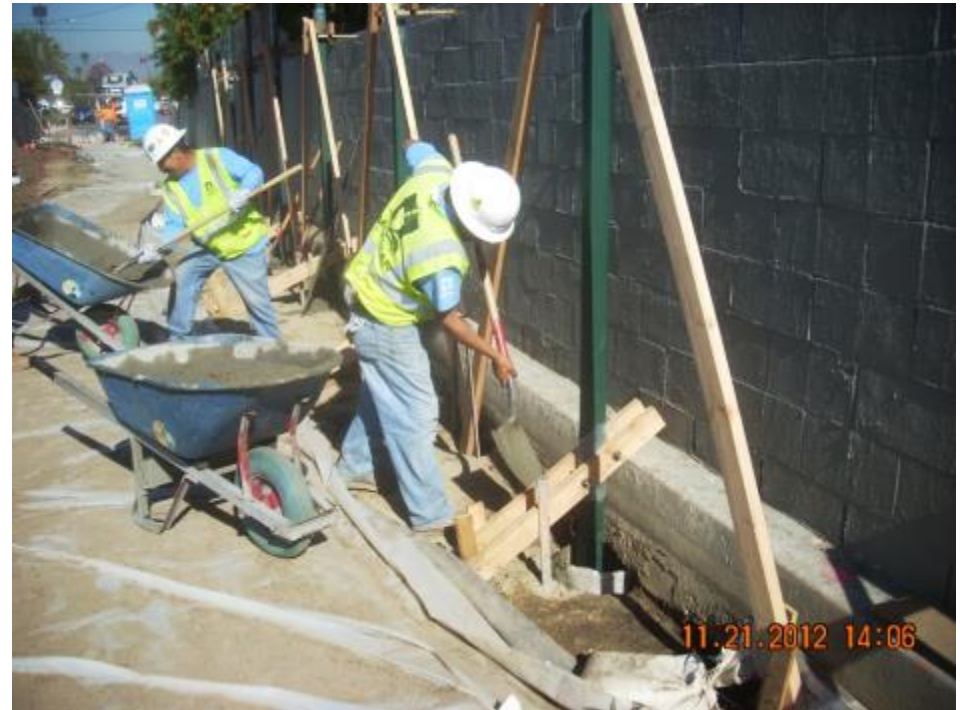
Concrete for green screen footings.

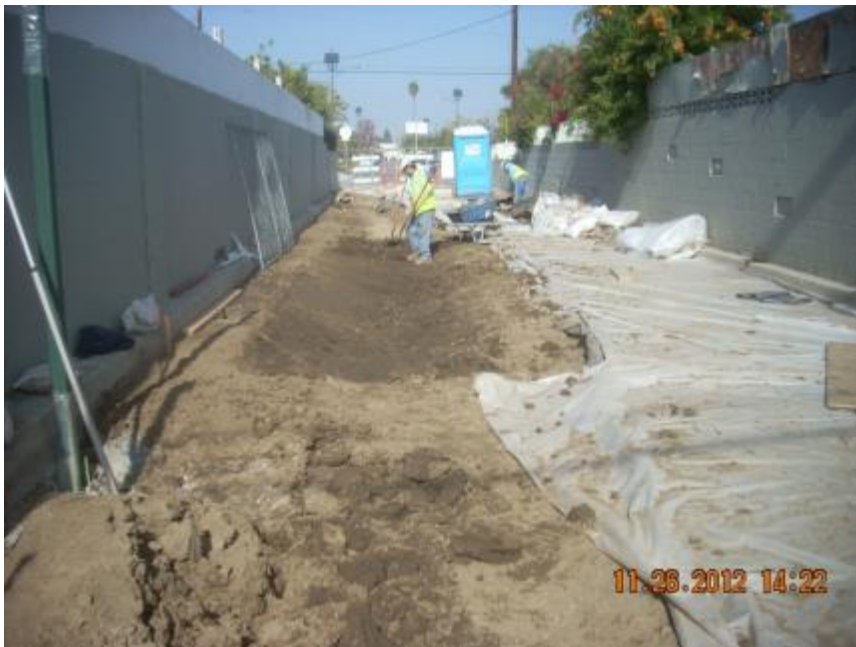
Fine grading for bio-swale

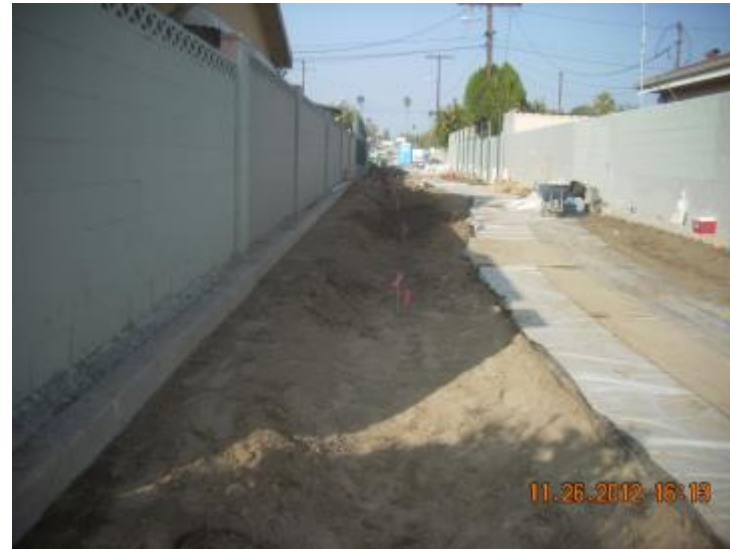
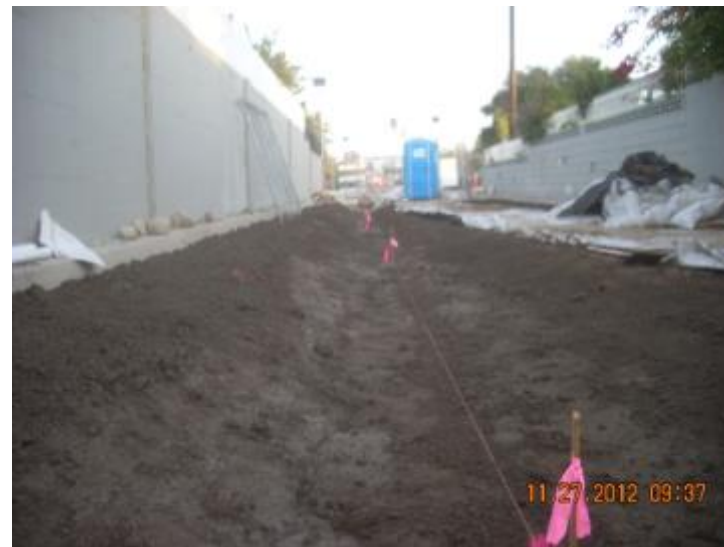
Elevation points set for bio-swale

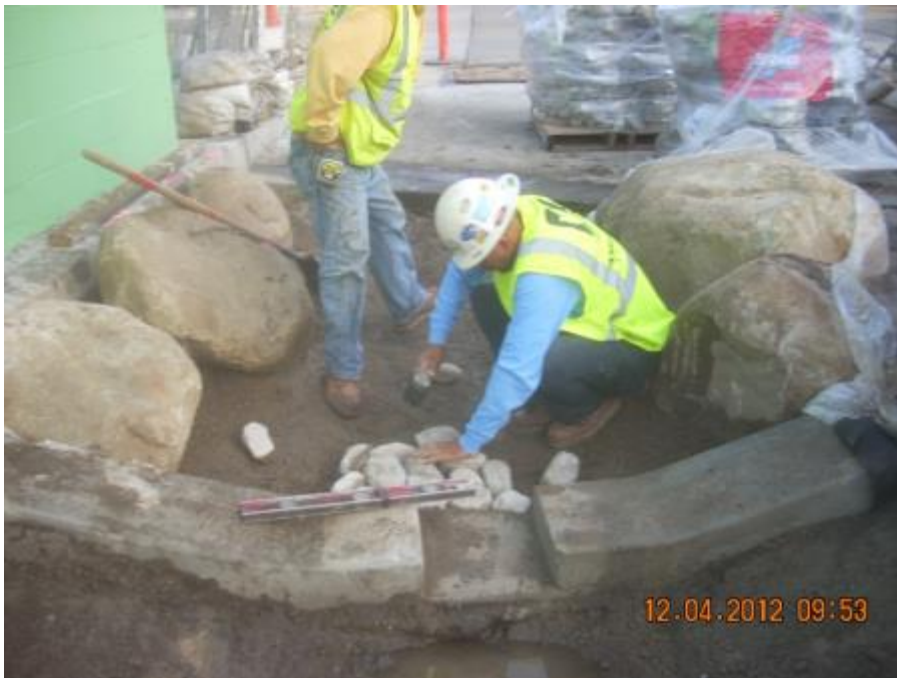
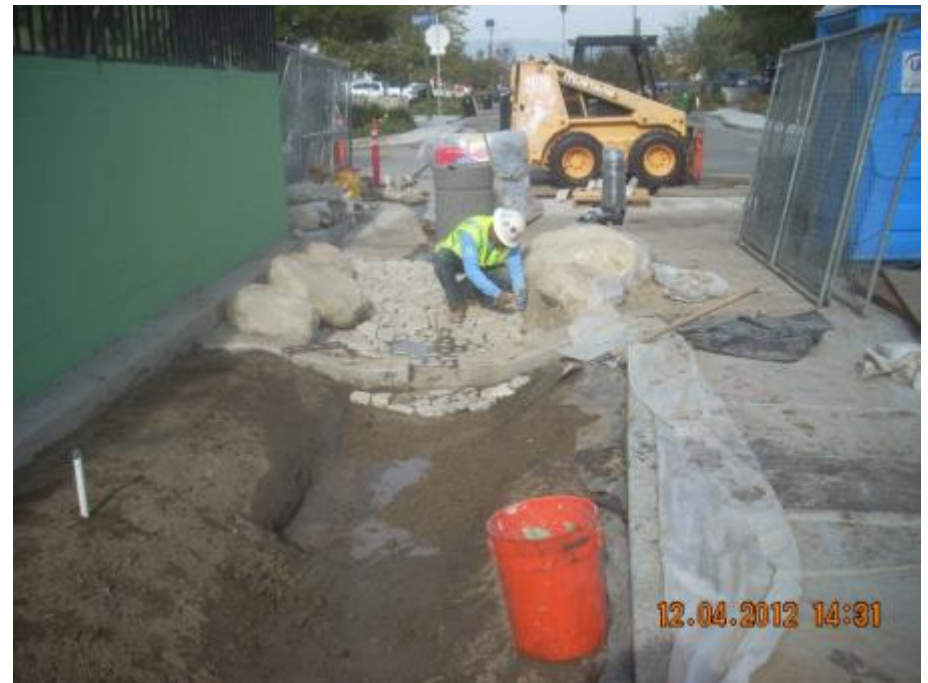
River rock cobble for bio-swale forebay.
