This presentation premiered at WaterSmart Innovations

CREATIVE WATER SOLUTIONS

Cooling Towers and Chillers

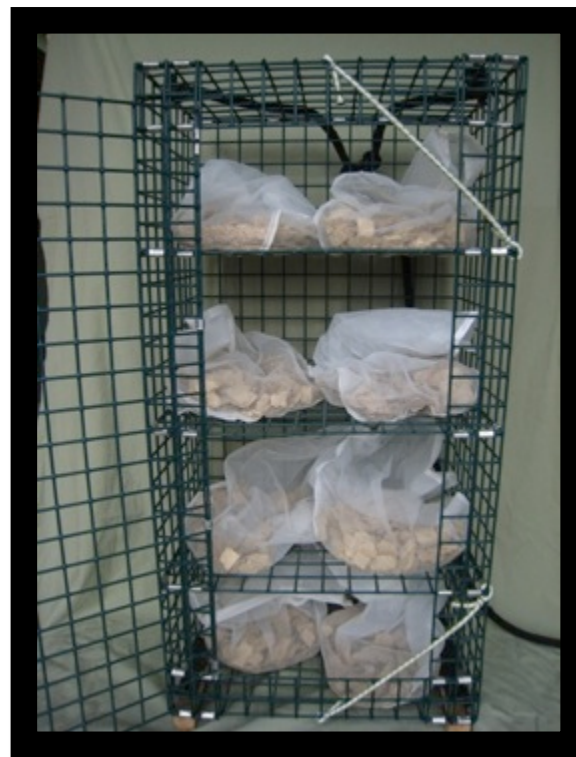
Submerged Contact Chamber

- PoolMoss® and ProMoss™ are exposed to water using a contact chamber
- Contact chamber is submerged in flowing water
- Flow within the tank allows exposure of the PoolMoss® and ProMoss™ leaves to the water

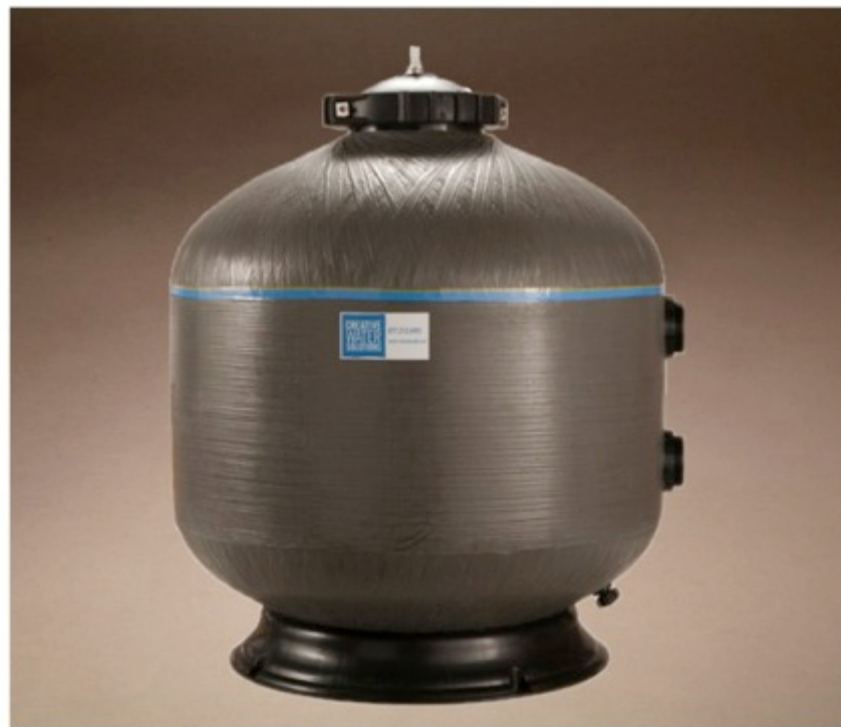
Non-Surge Tank Application

- Installed off line
- Maintain 15 Gal/min flow
- Plumbed across an existing pump or an auxiliary pump

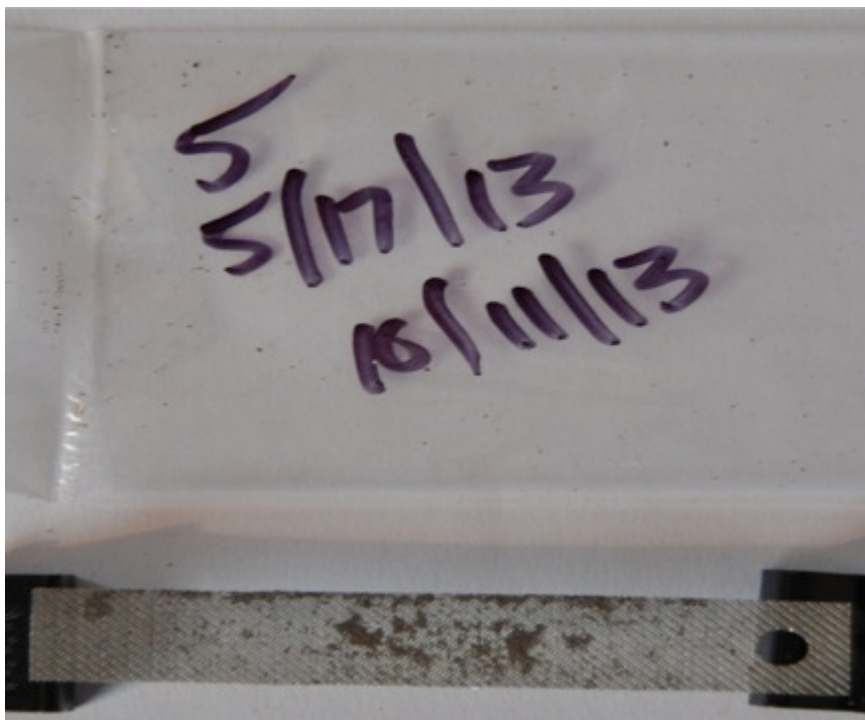
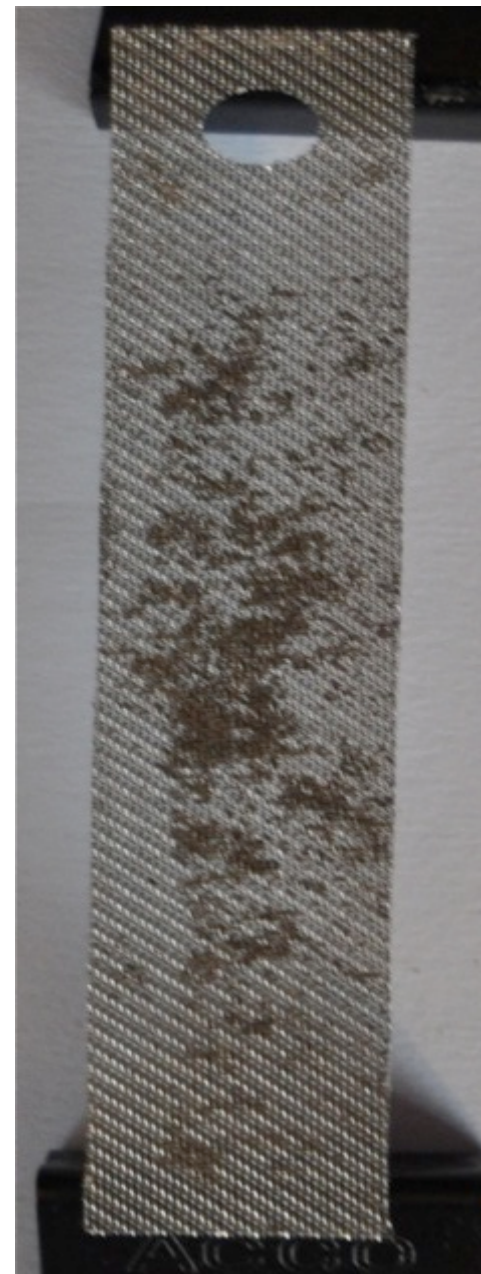
Cooling Tower Example

Organic Contamination
No Moss

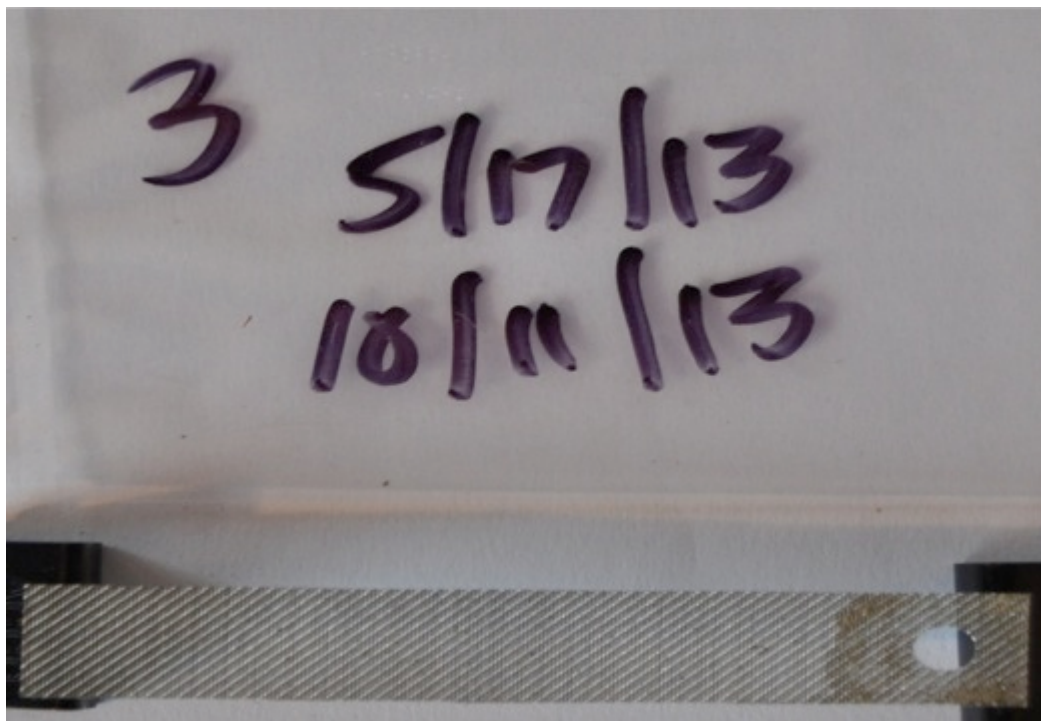
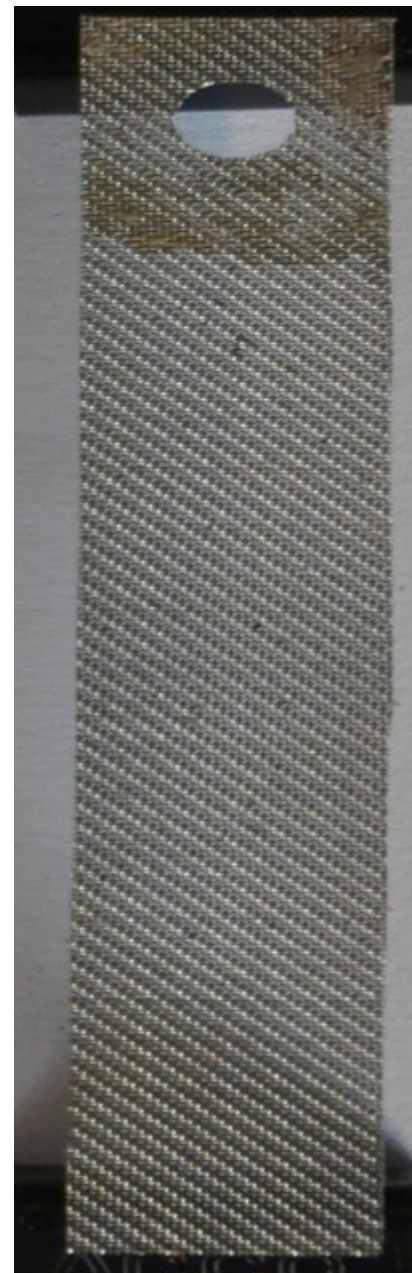
Cooling Tower Example

Organic Contamination
ProMoss™

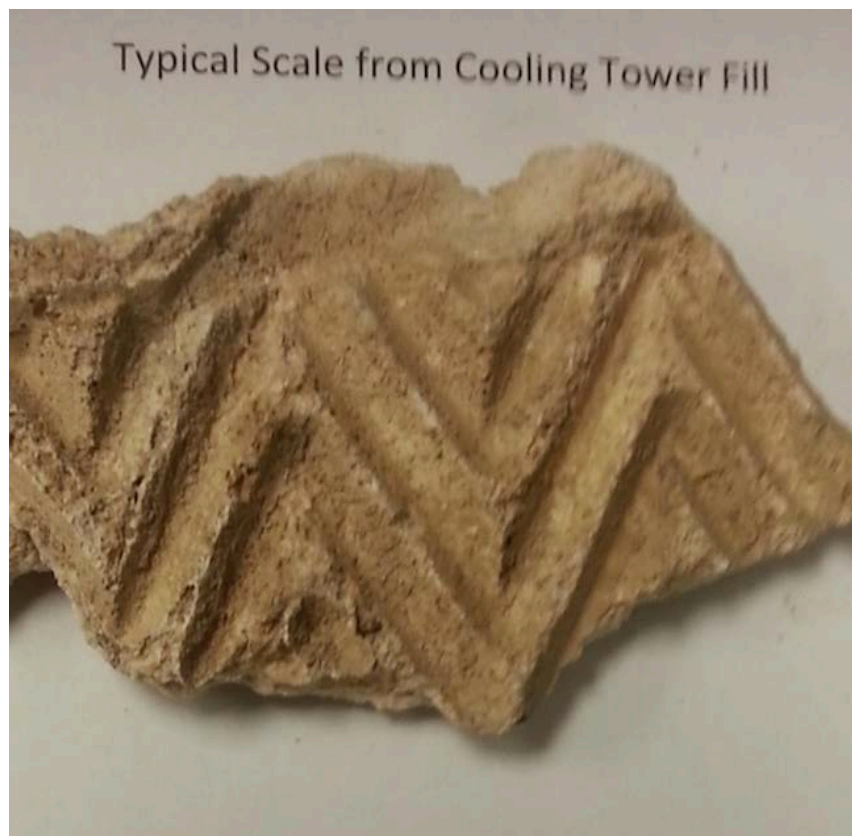
ProMoss™ Effect on Scale in a Cooling Tower Rochester, NY

Scale without ProMoss™

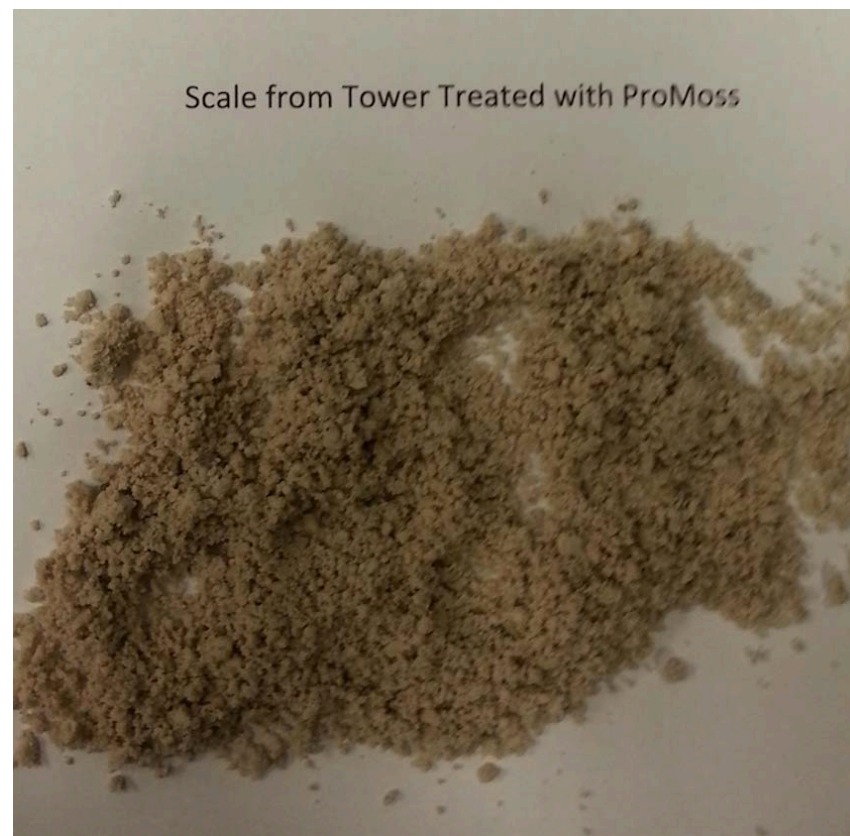
Scale with ProMoss™

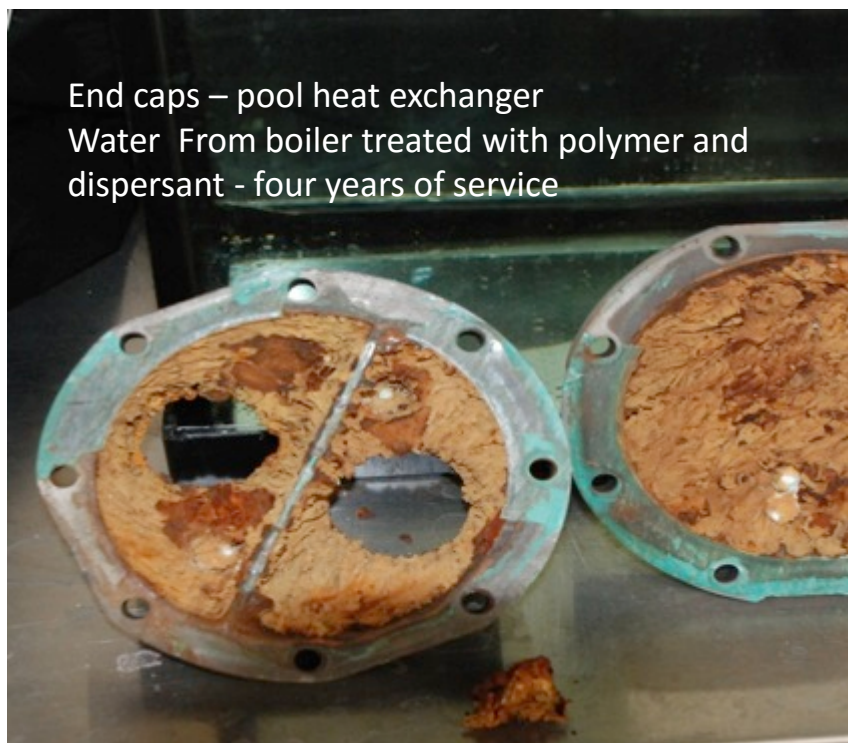
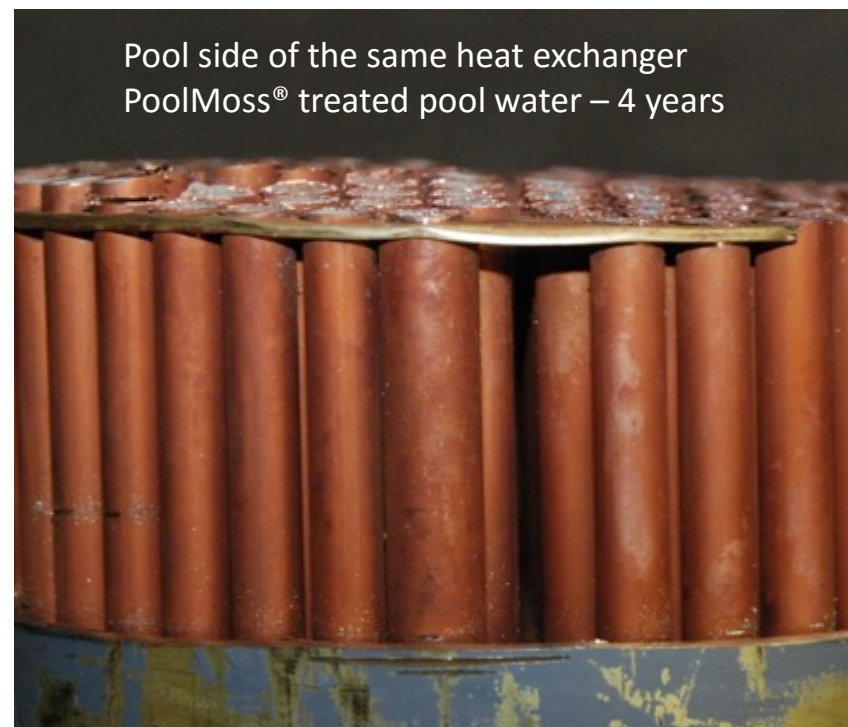
Effect of ProMoss™ on Scale

Field Results

Heat Exchanger Indoor Pool

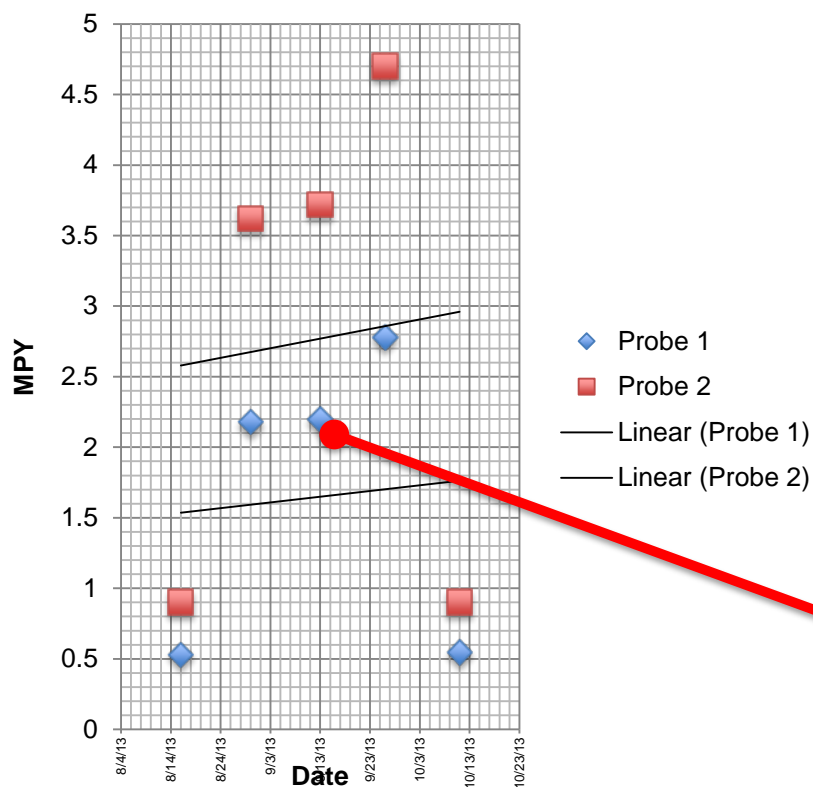
90% Reduction in Corrosion for Copper

• Tower without Moss

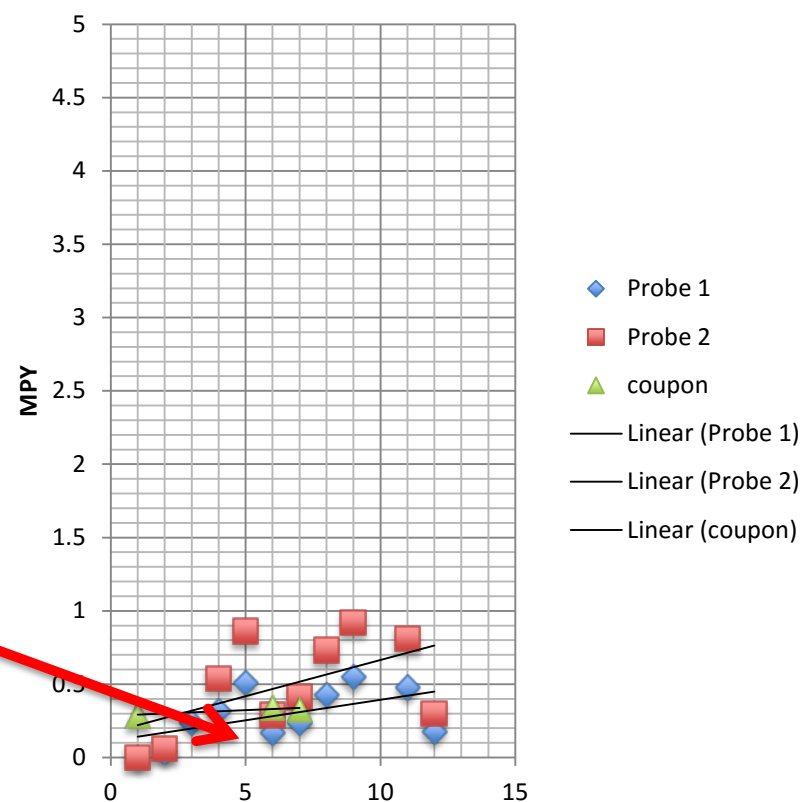
• Tower with Moss

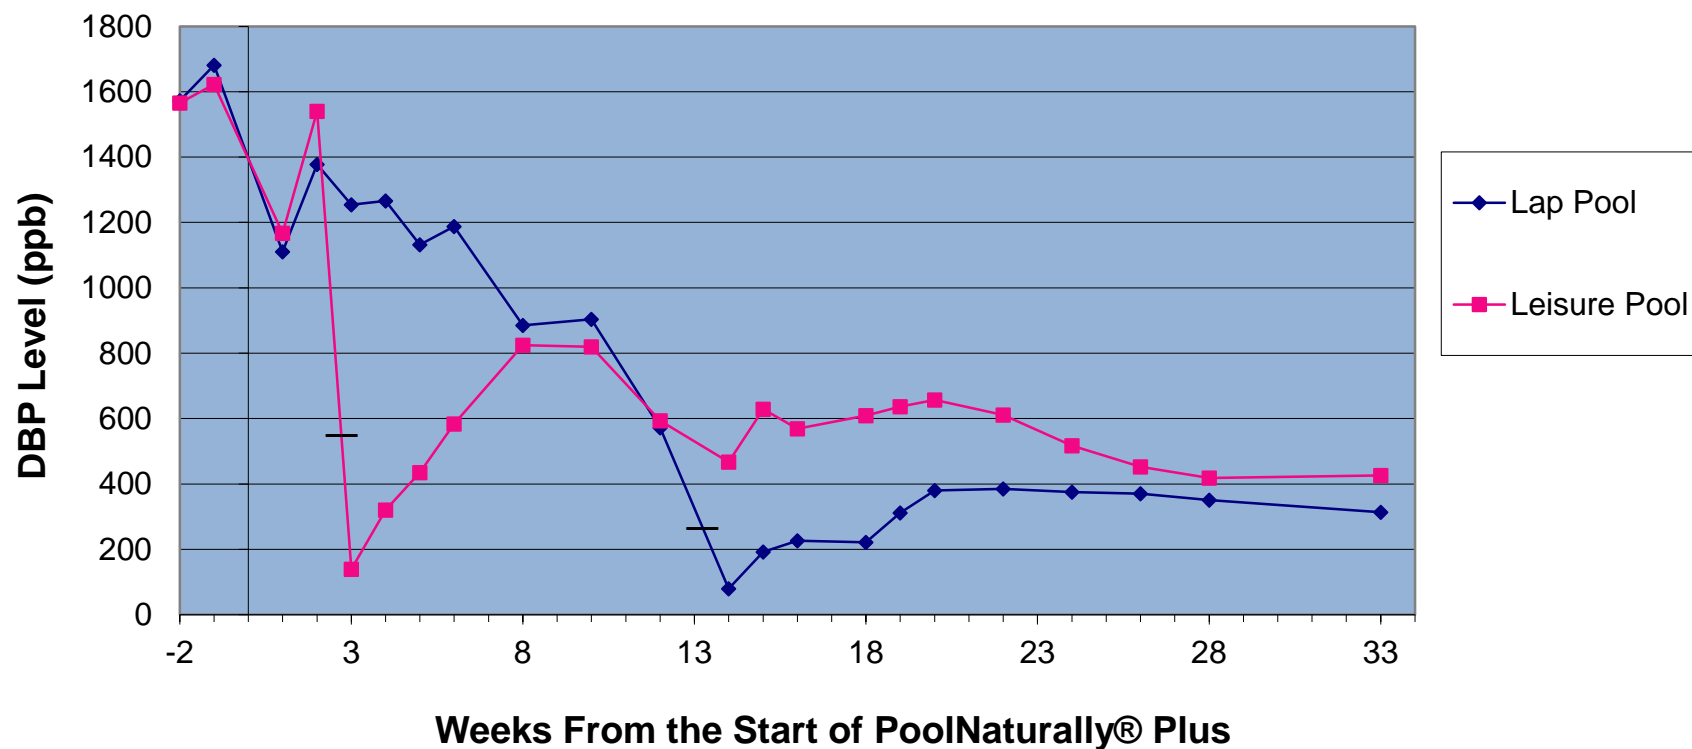
Effect of PoolNaturally® Plus on DBP Levels in Pool Water

— Pool was drained/refilled

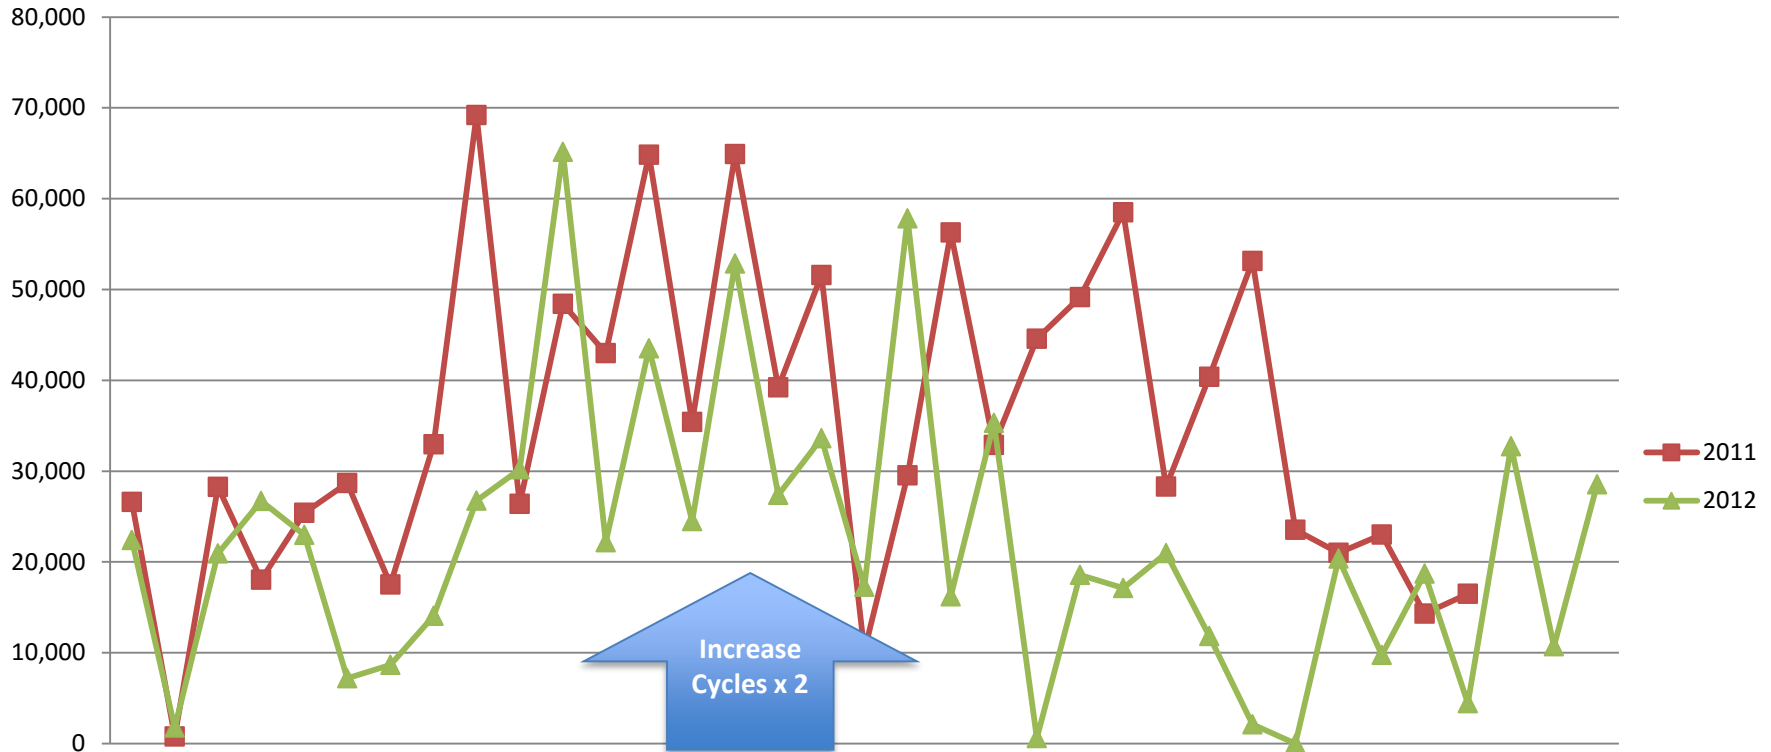
Hinckley, MN Tower #3 Water Use Comparison

**T Turbidity
C Corrosion -
Galvanized**

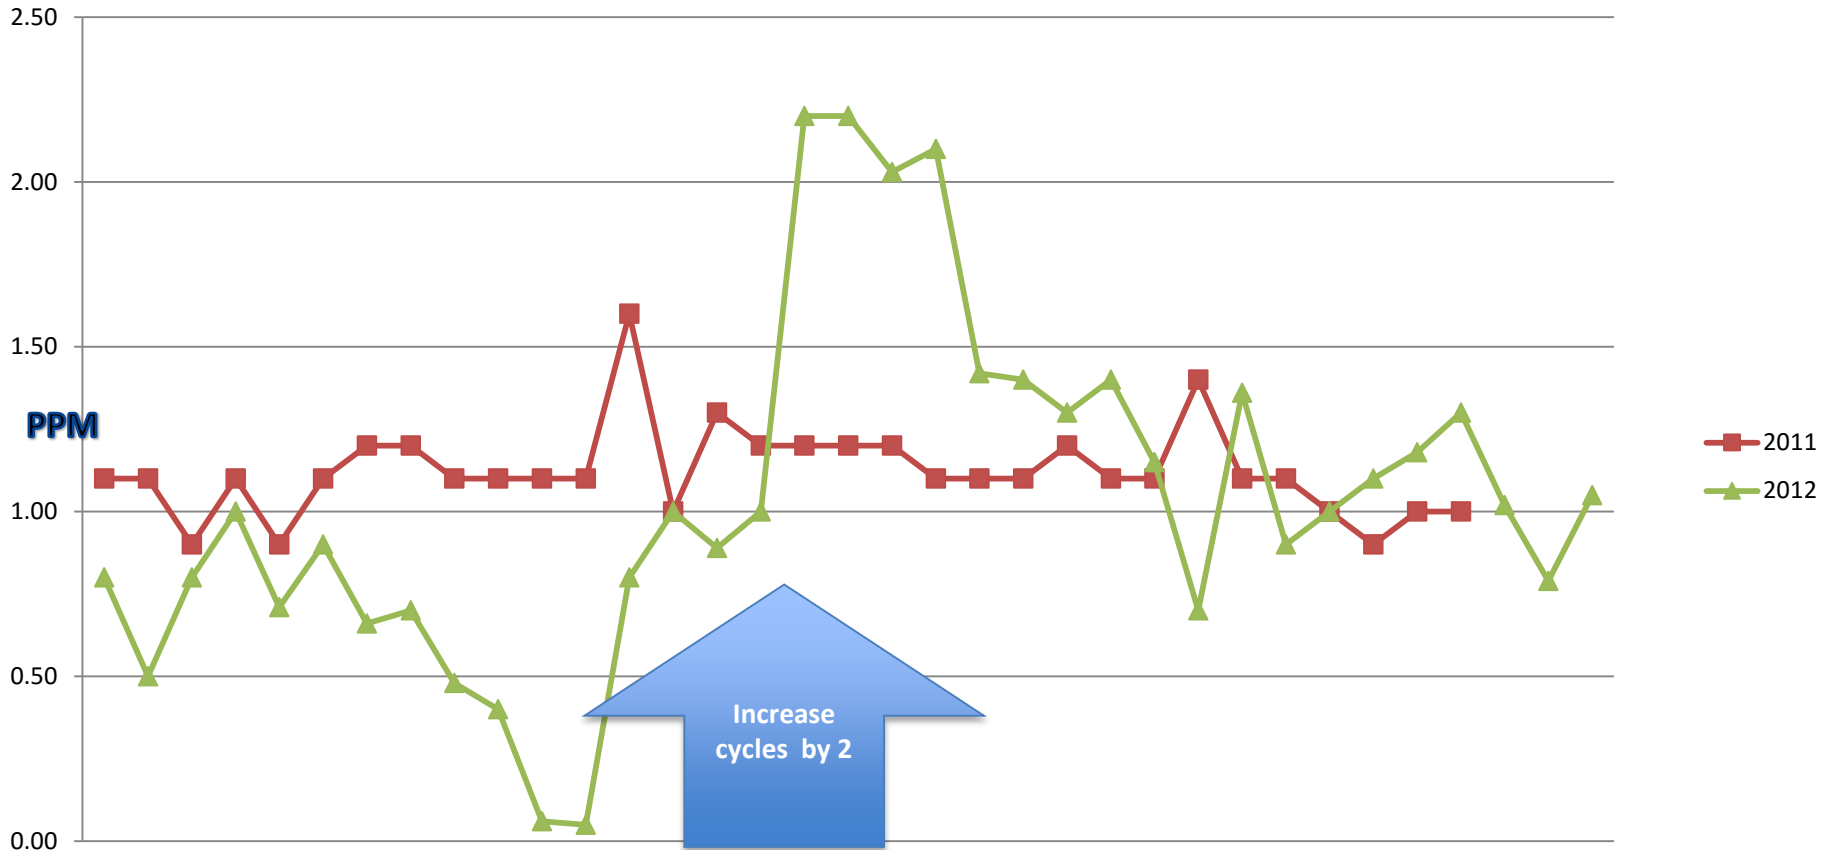
Hinckley, MN Tower #3

Corrosion Inhibitor Concentration

2012 ProMoss™

Observation Points June to September

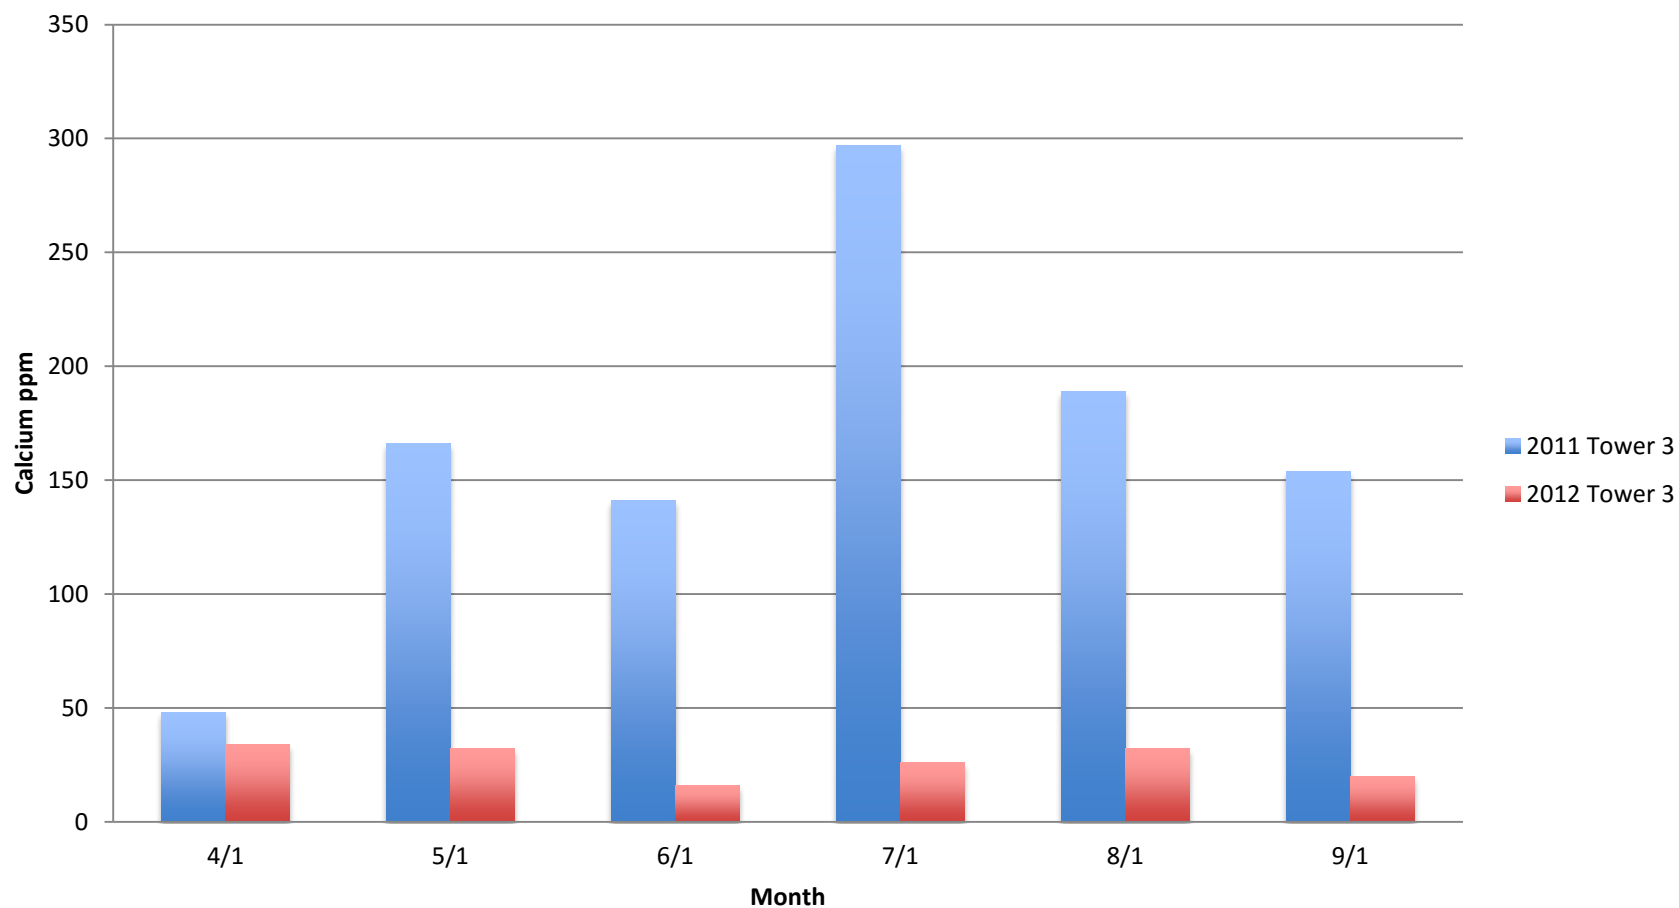
Tower 3 Calcium 2012 ProMoss™

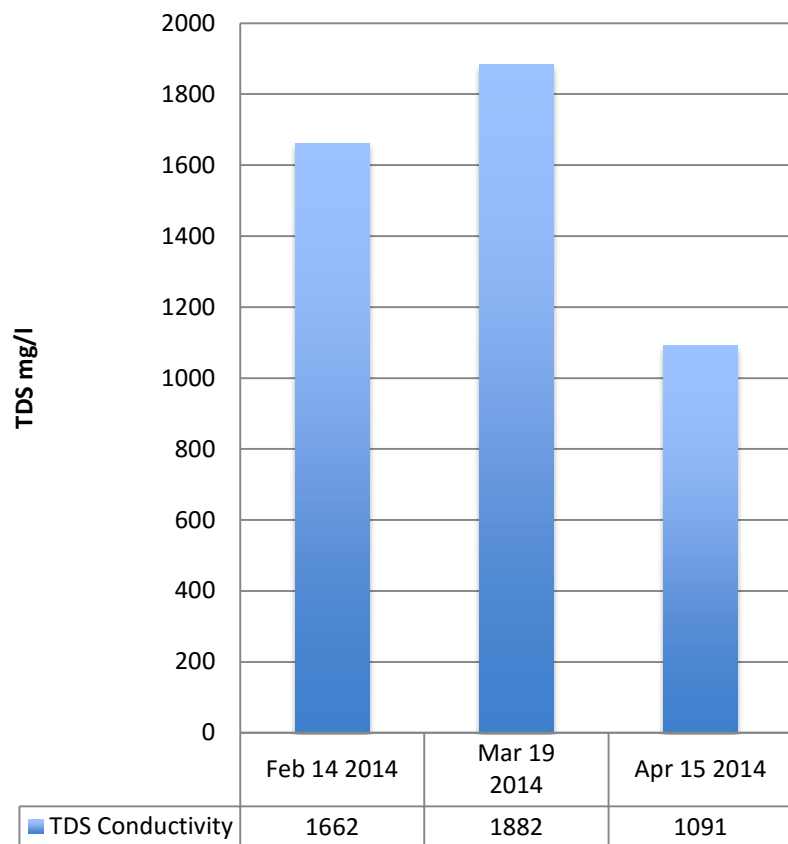
TDS Conductivity

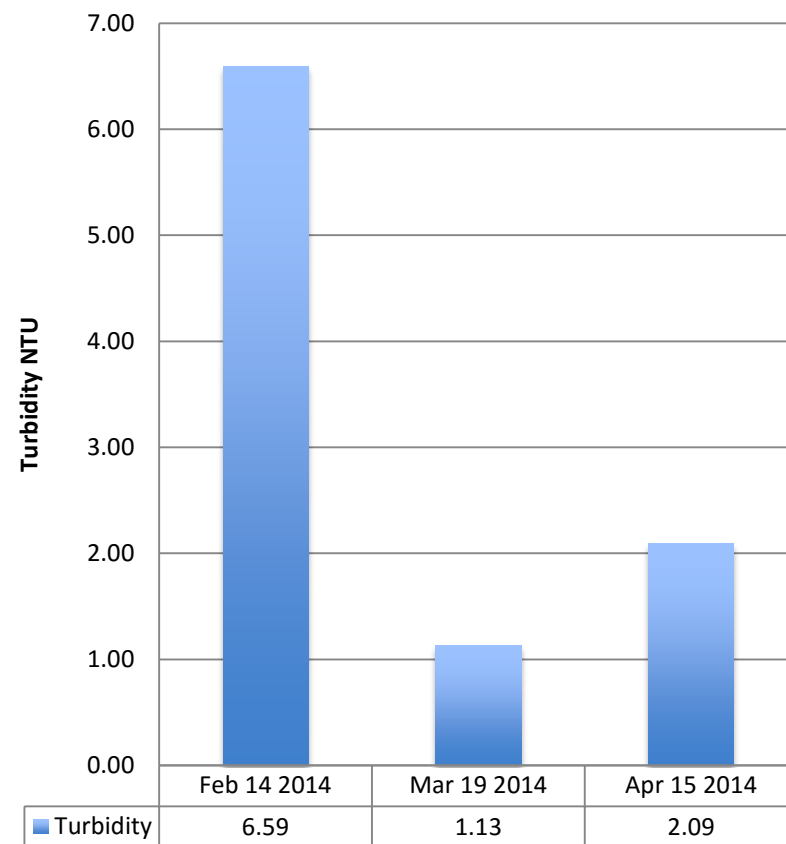
Turbidity

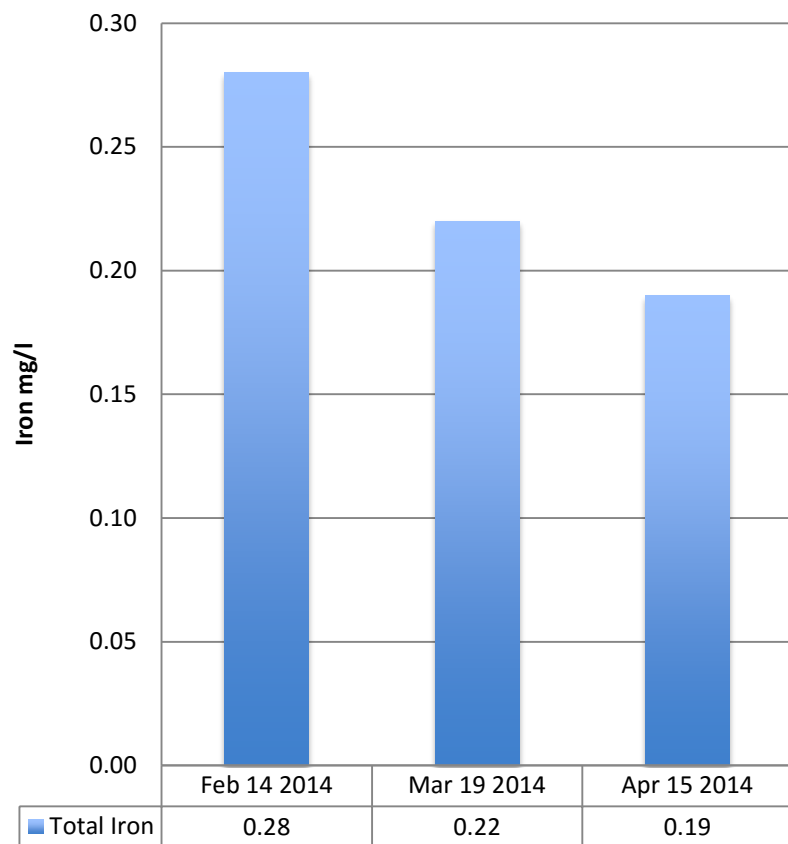
Total Iron

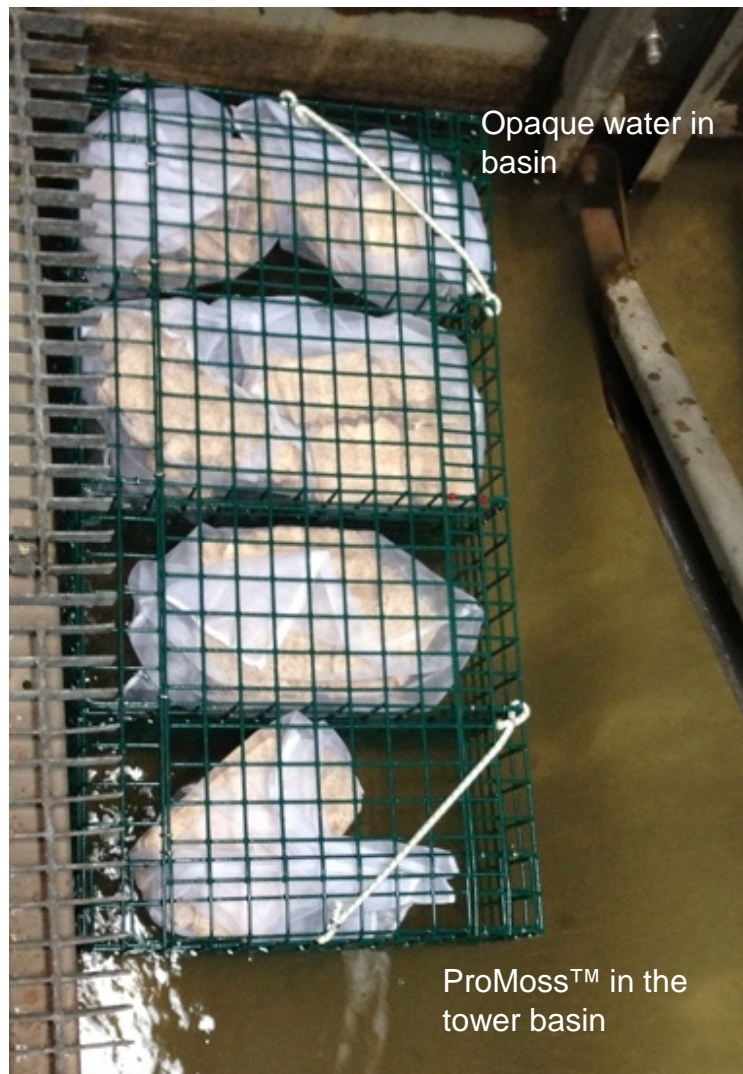
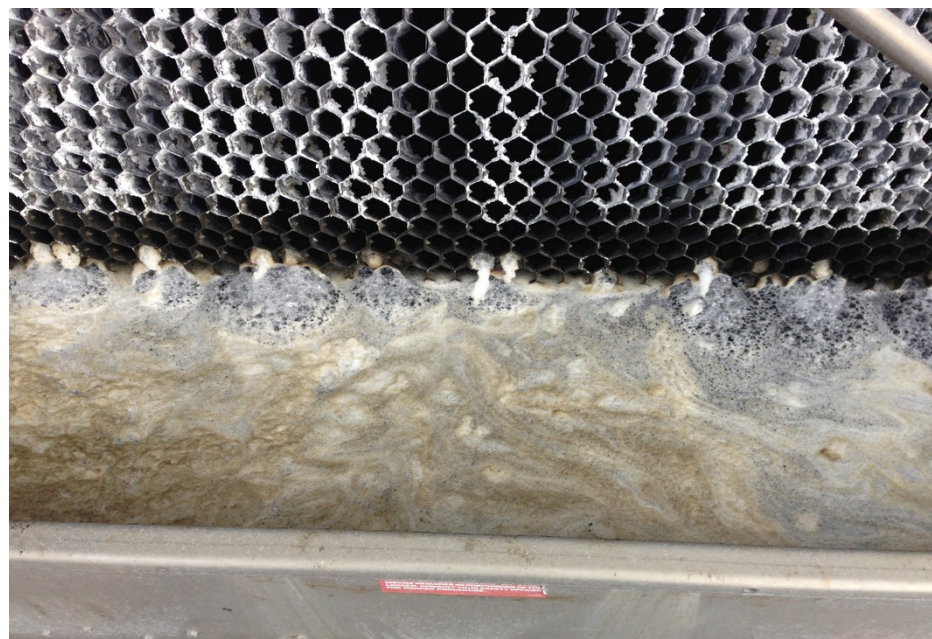
Foaming in return water (note foam coming from the media)

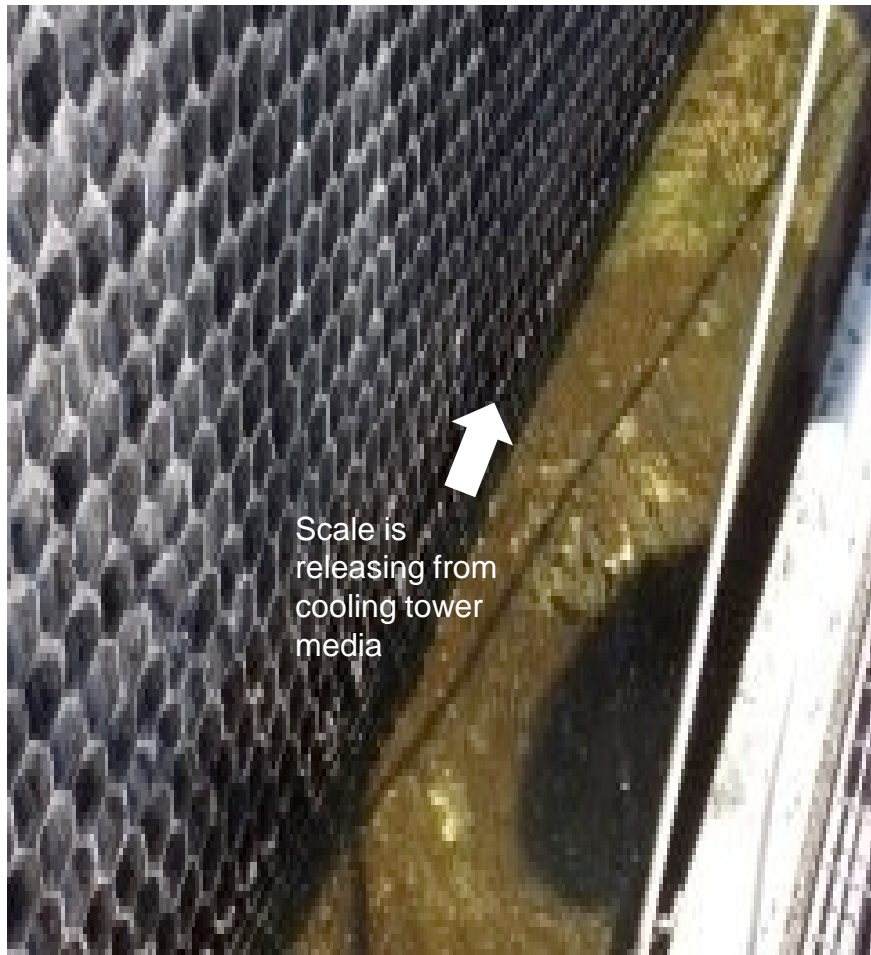
Scale is
releasing from
cooling tower
media

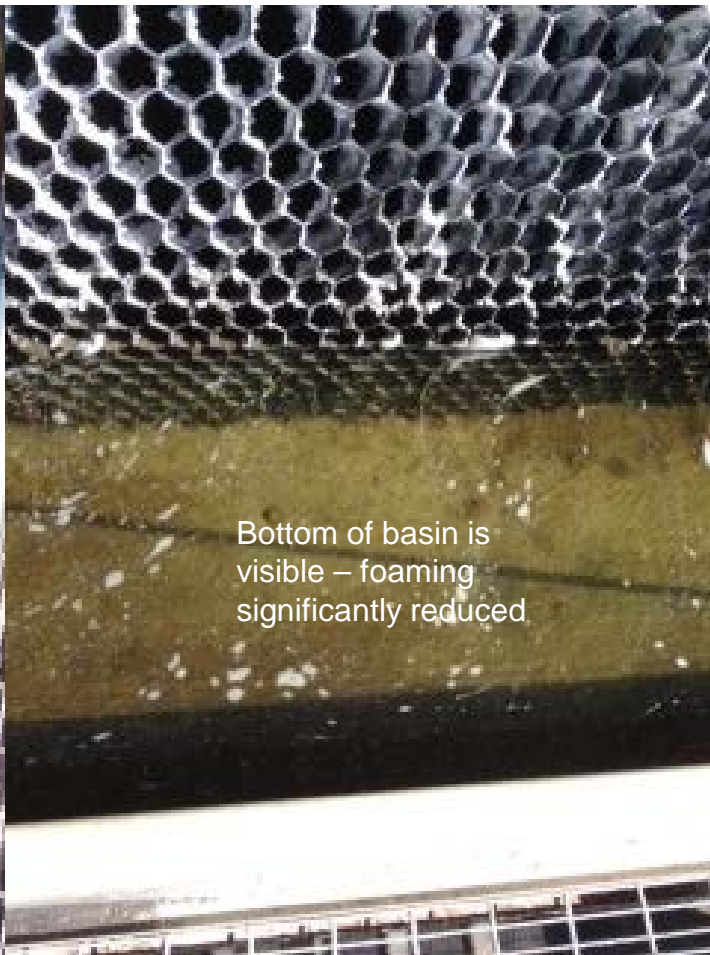
Bottom of basin is
visible – foaming
significantly reduced

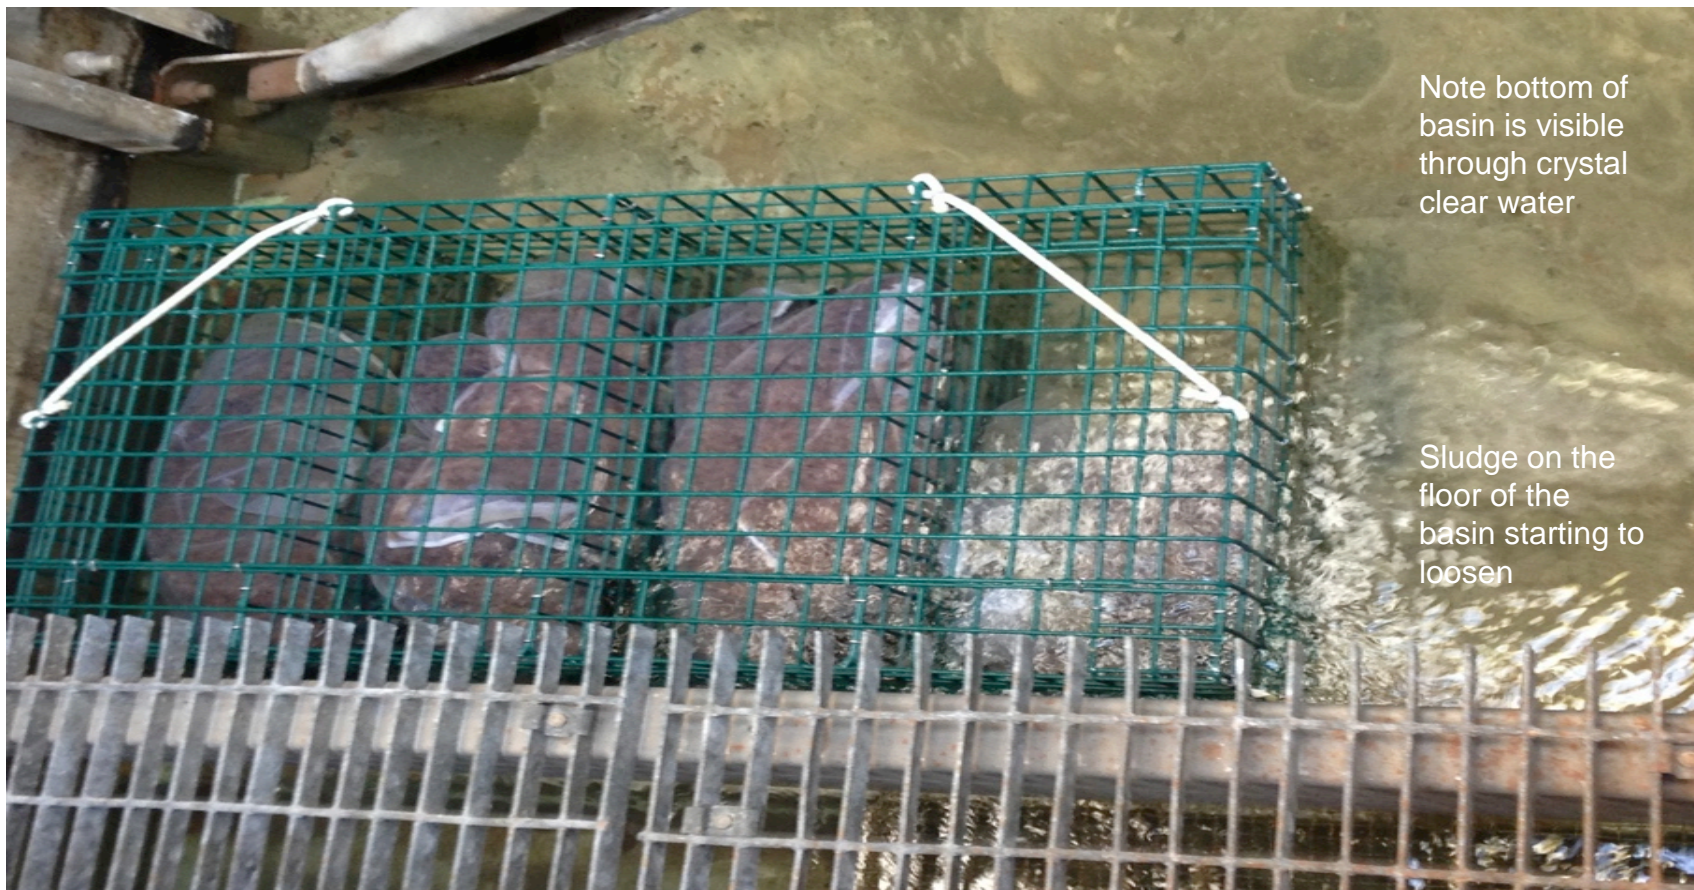
Note bottom of basin is visible through crystal clear water

Sludge on the floor of the basin starting to loosen

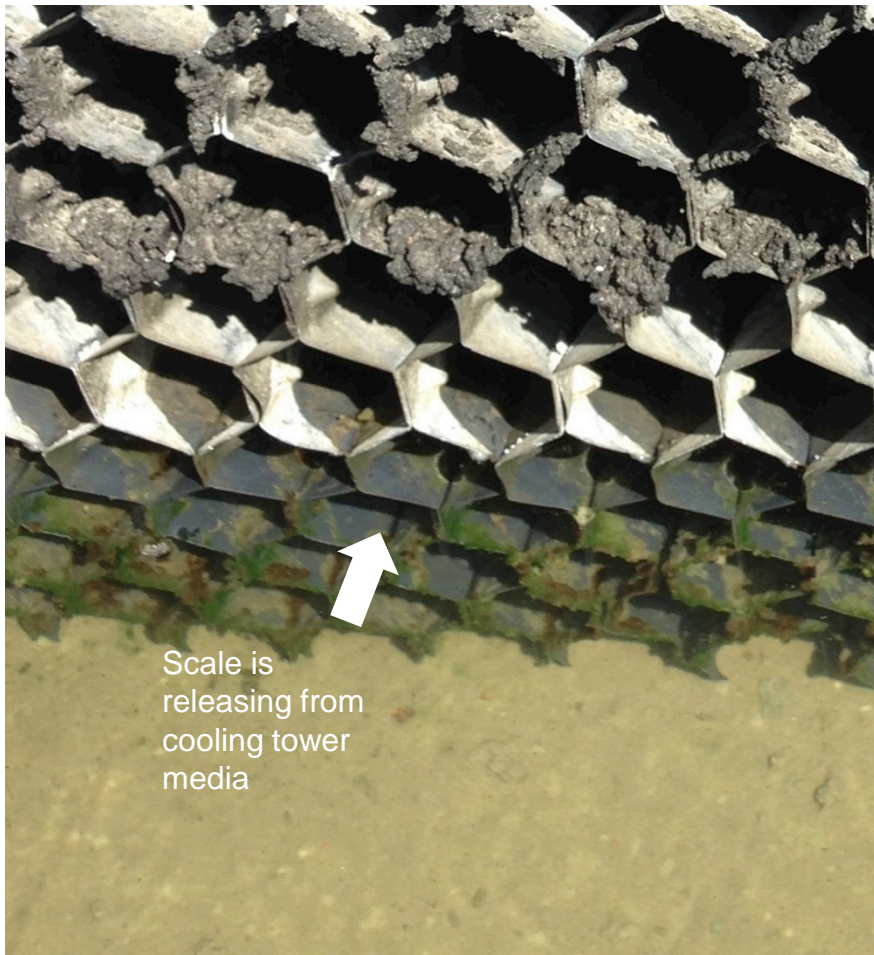
Scale is
releasing from
cooling tower
media

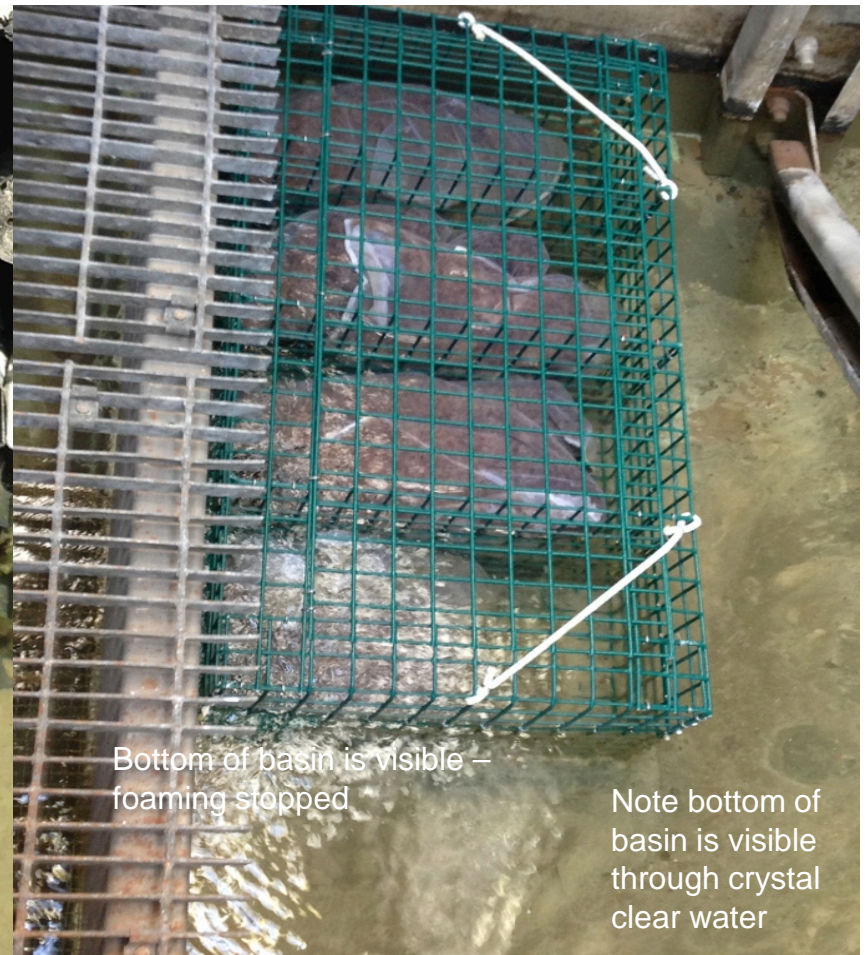
Bottom of basin is visible –
foaming stopped

Note bottom of
basin is visible
through crystal
clear water

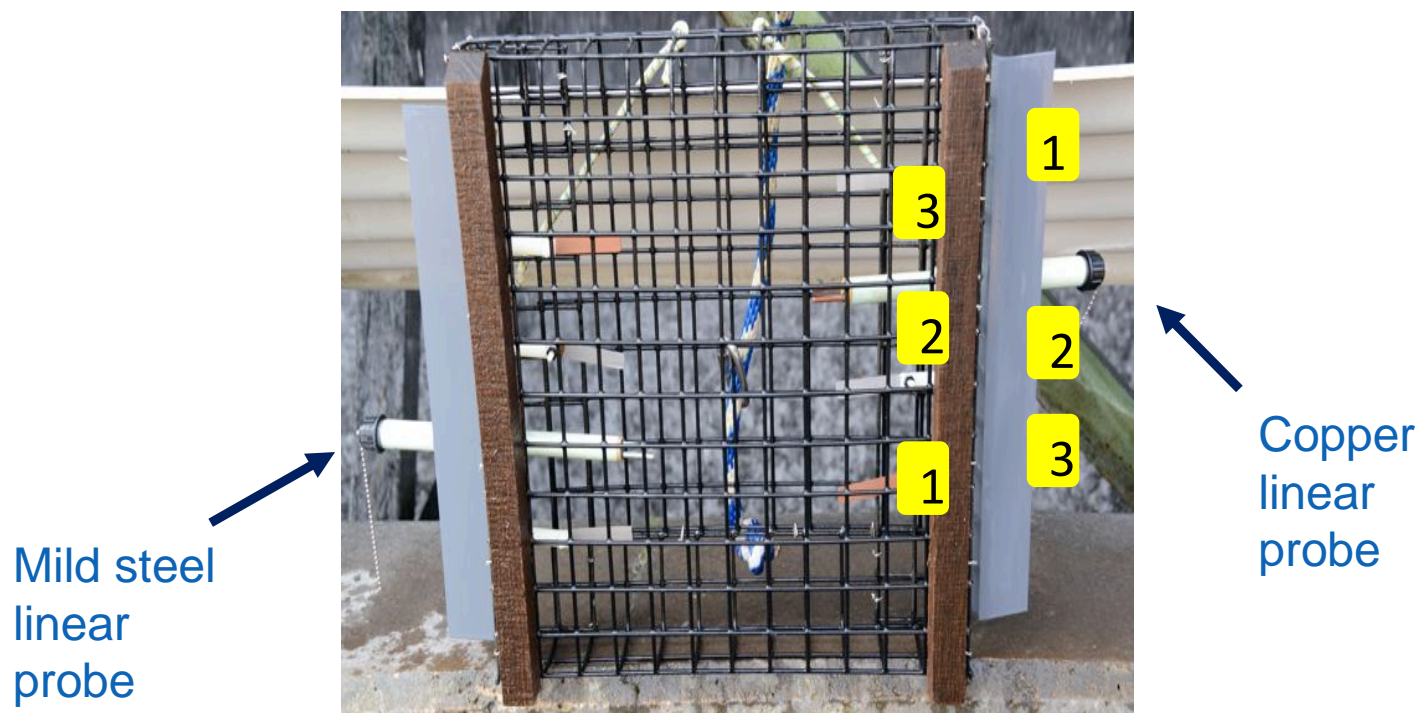
Test cage

1. Organic contamination coupon
2. Mild steel coupon
3. Copper coupon

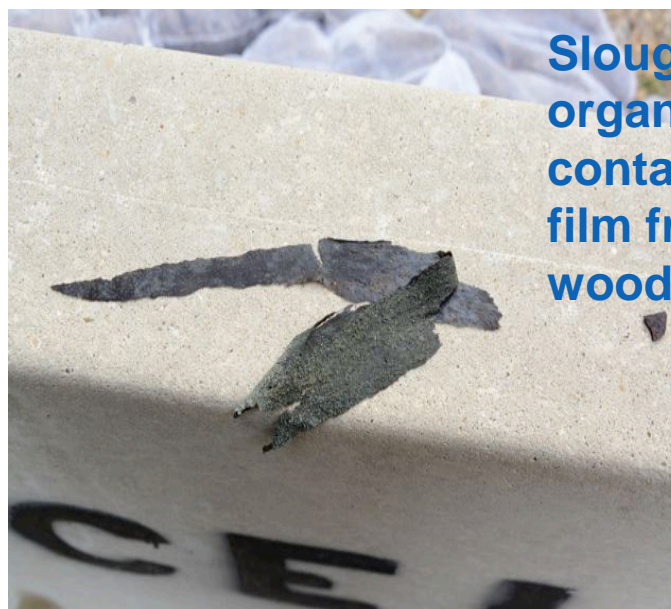
**Sloughed off
organic
contamination
film from the
wood**

Tower 3 - Sept 12, 2014
