This presentation premiered at WaterSmart Innovations

CREATIVE WATER SOLUTIONS

Cooling Towers and Chillers

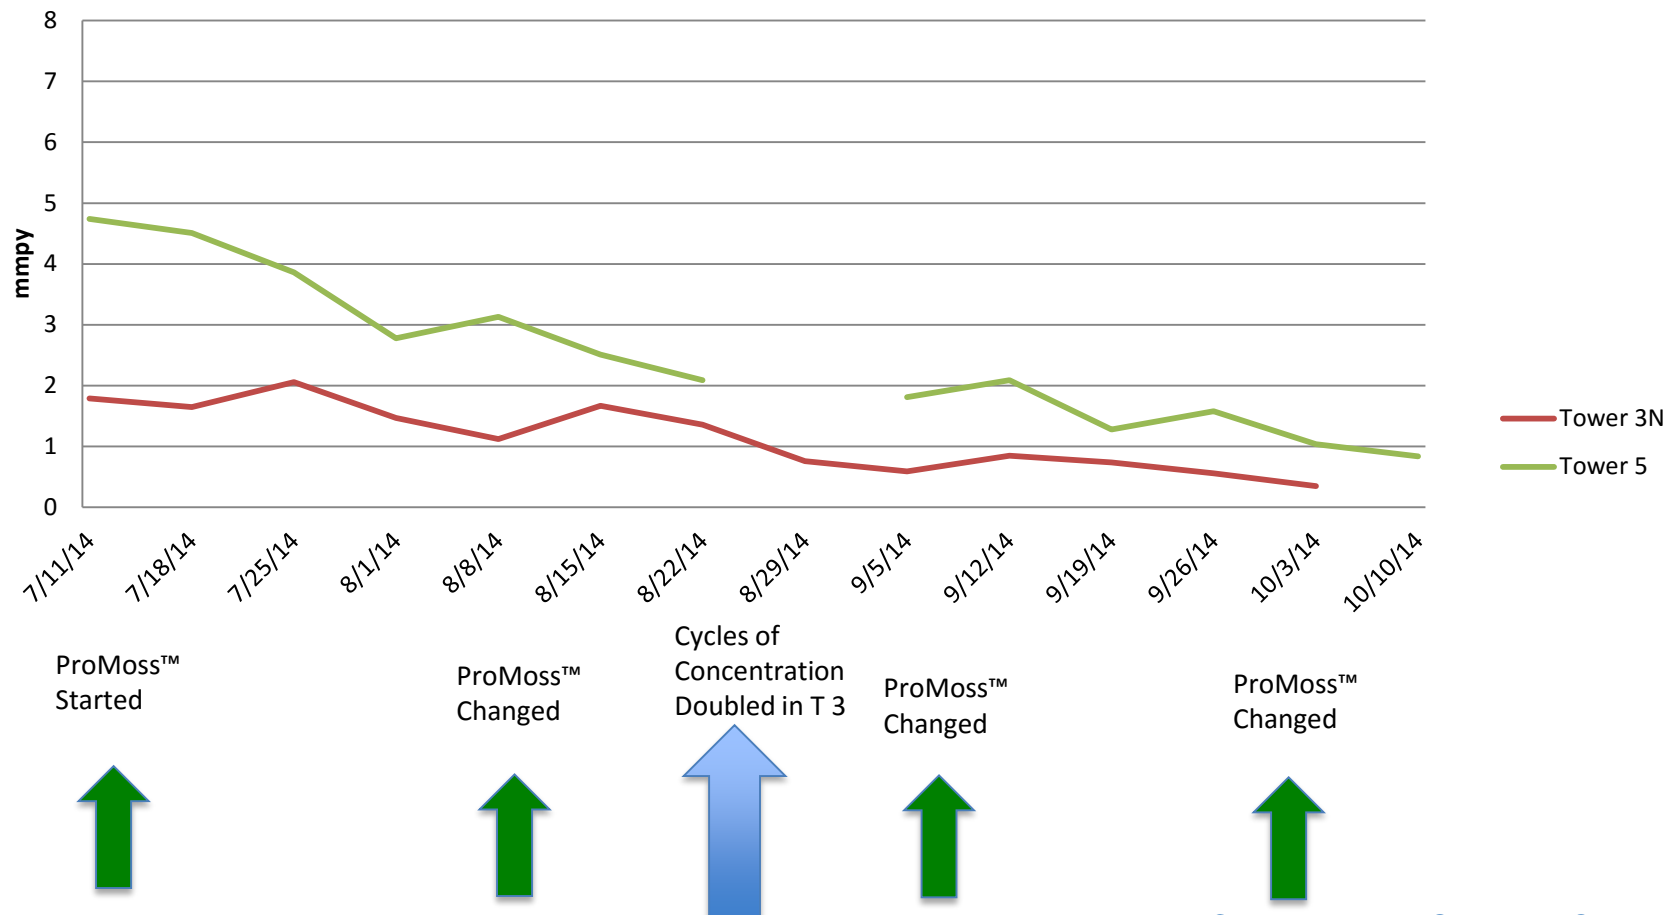
7000 Ton Cooling Tower

Mild Steel Corrosivity (North)

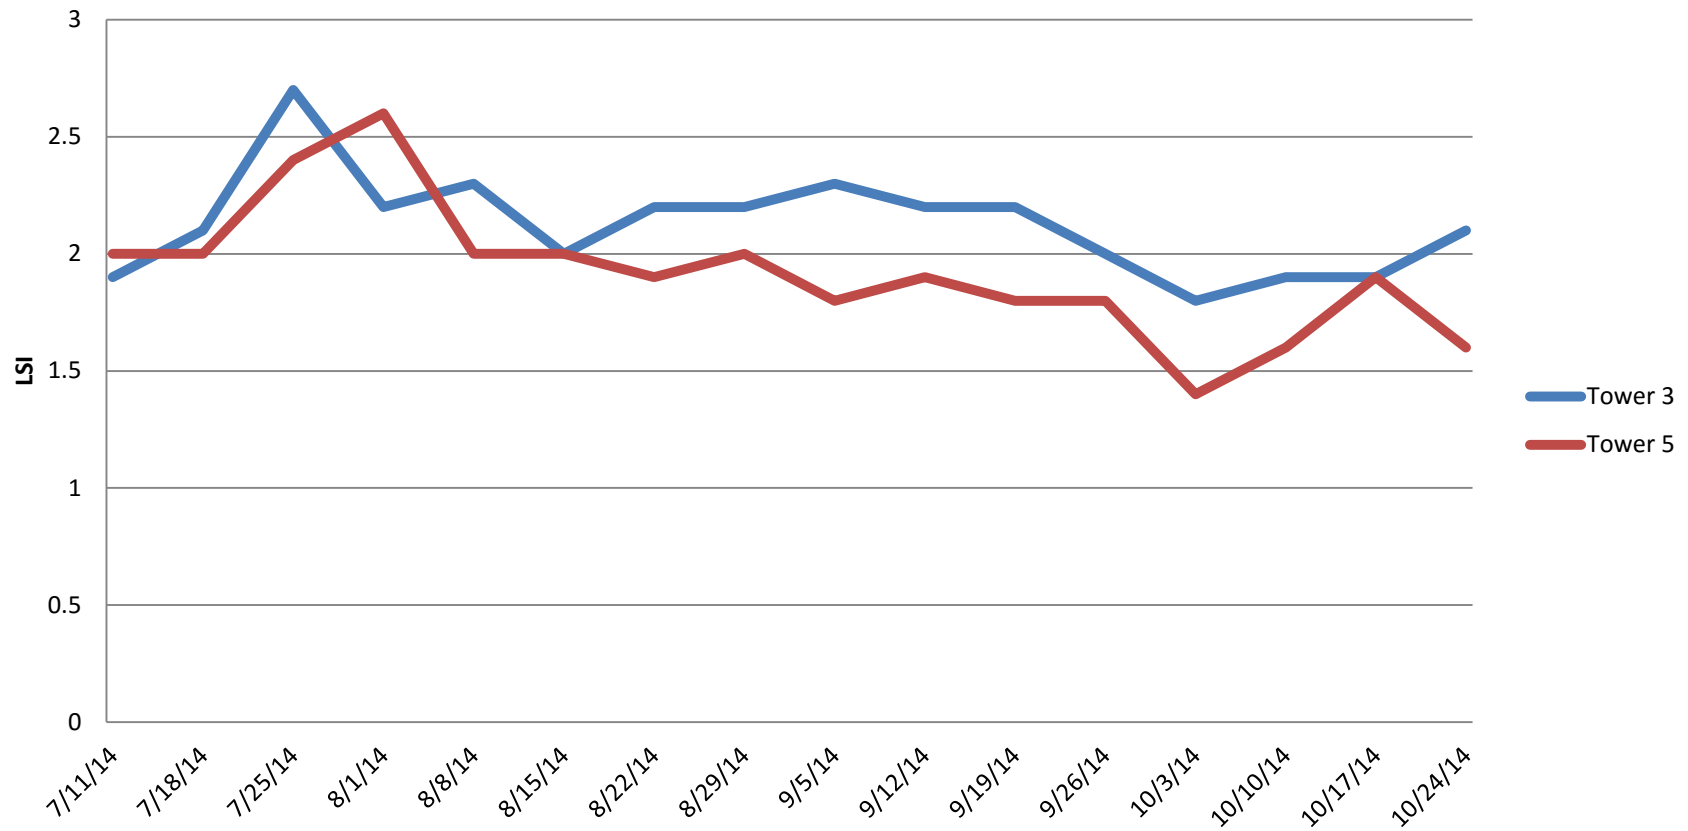
7000 Ton Cooling Tower Langlier Saturation Index

LSI Calculation

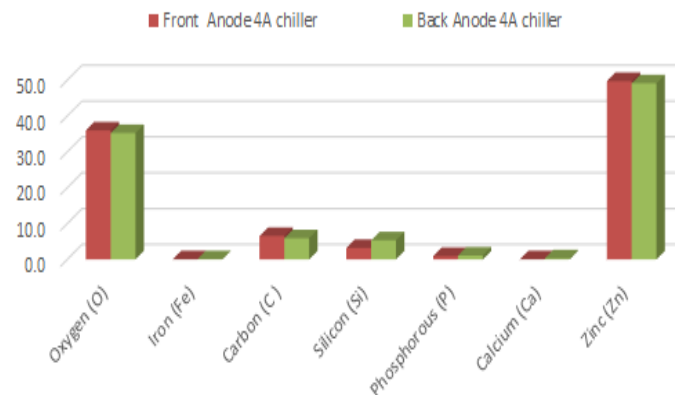
Elements from chiller samples (mass%)

Element	Front Anode 4A chiller	Back Anode 4A chiller
Oxygen (O)	36.0	35.3
Iron (Fe)	0.047	0.079
Carbon (C)	6.55	5.91
Silicon (Si)	3.20	5.34
Phosphorous (P)	0.946	1.09
Calcium (Ca)	0.046	0.287
Zinc (Zn)	49.8	49.1

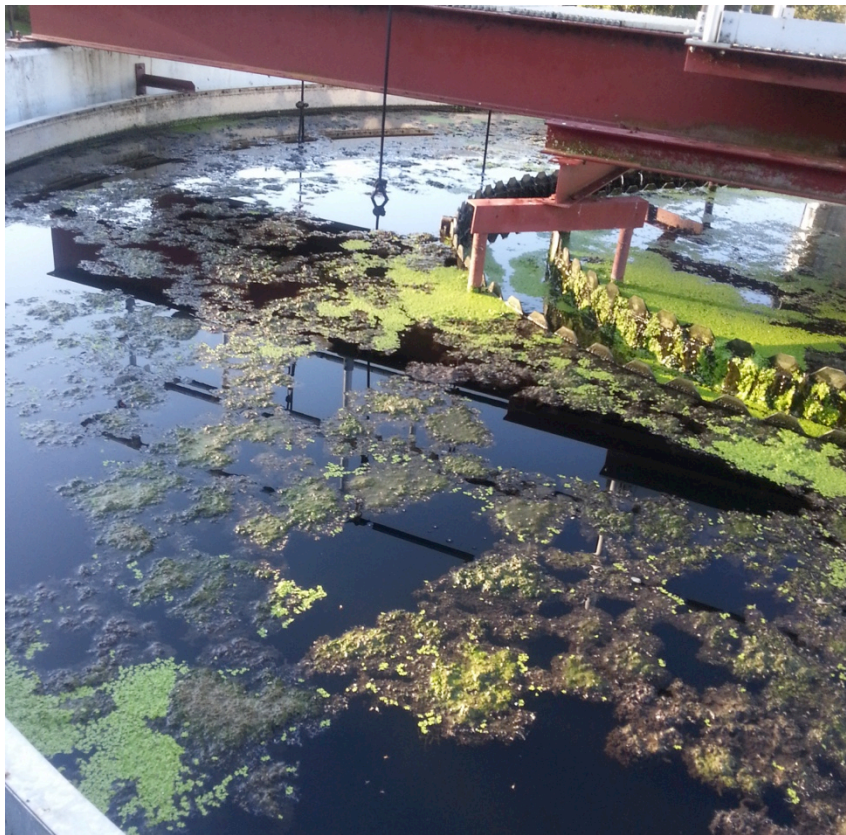
Clarifier Without ProMoss

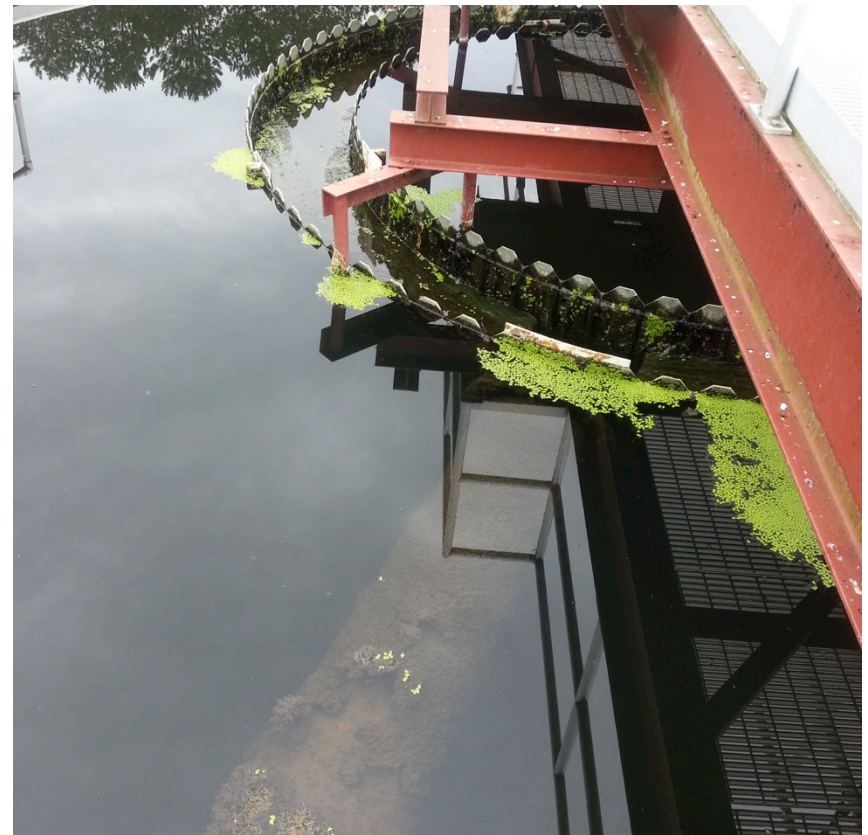
Clarifier With ProMoss
