Digging Deep Into Non-Revenue Water Reduction Beyond Water Audits

Brian Skeens, CH2M

Joe Thurwanger, Aqua America

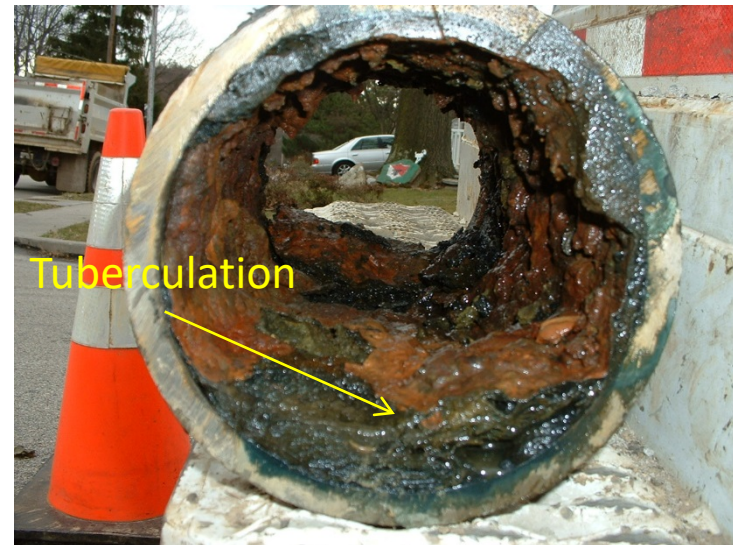
Thin-Walled Unlined C.I.P.

- Installed in the 1930s and 1940s
- Approximately 100 miles was cleaned and lined before analysis showed pipe was problematic
- Very high break rate, especially in winter

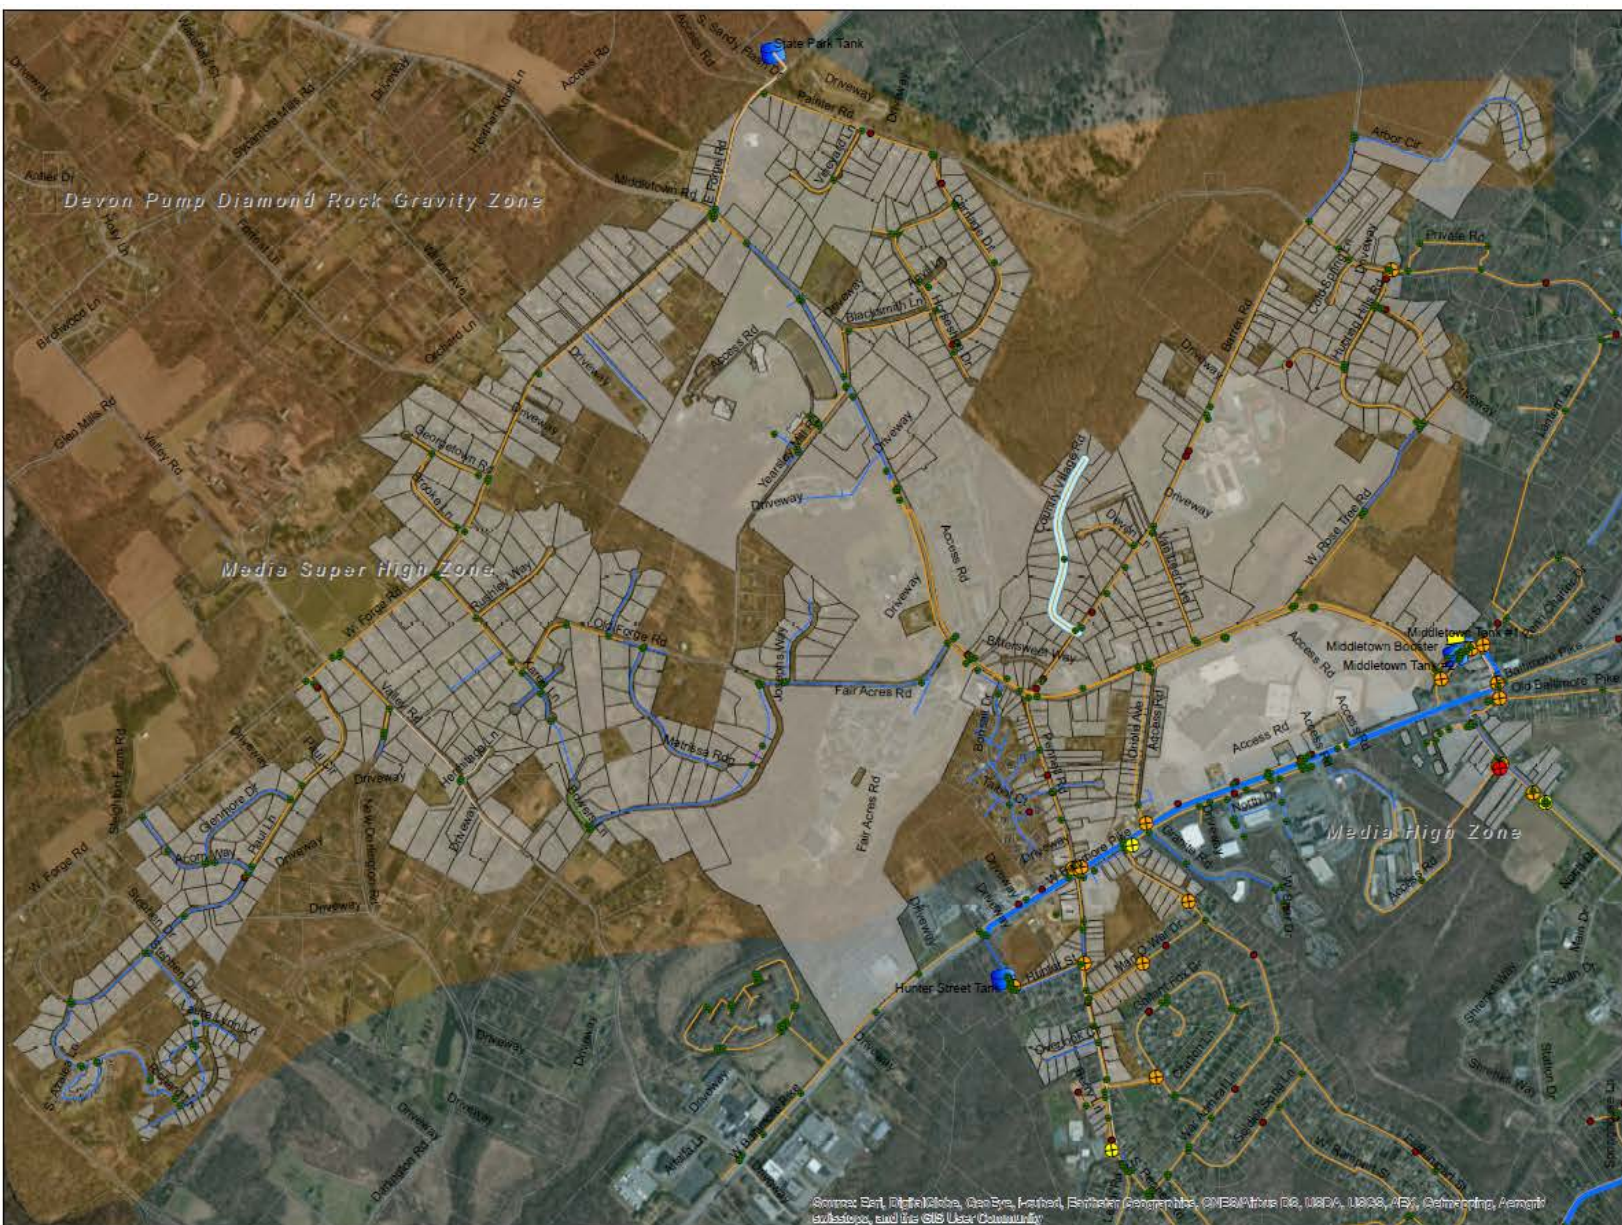
Proposed DMA 1

- Objective – review potential locations to implement DMAs and recommend process to implement
- Analysis performed – study 12 potential candidate locations, prioritize them based on ease of implementation, potential value from observations to be extrapolated
- Recommendations
 - Top two DMA candidates identified
 - Specific procedures outlined to implement, monitor, evaluate DMA

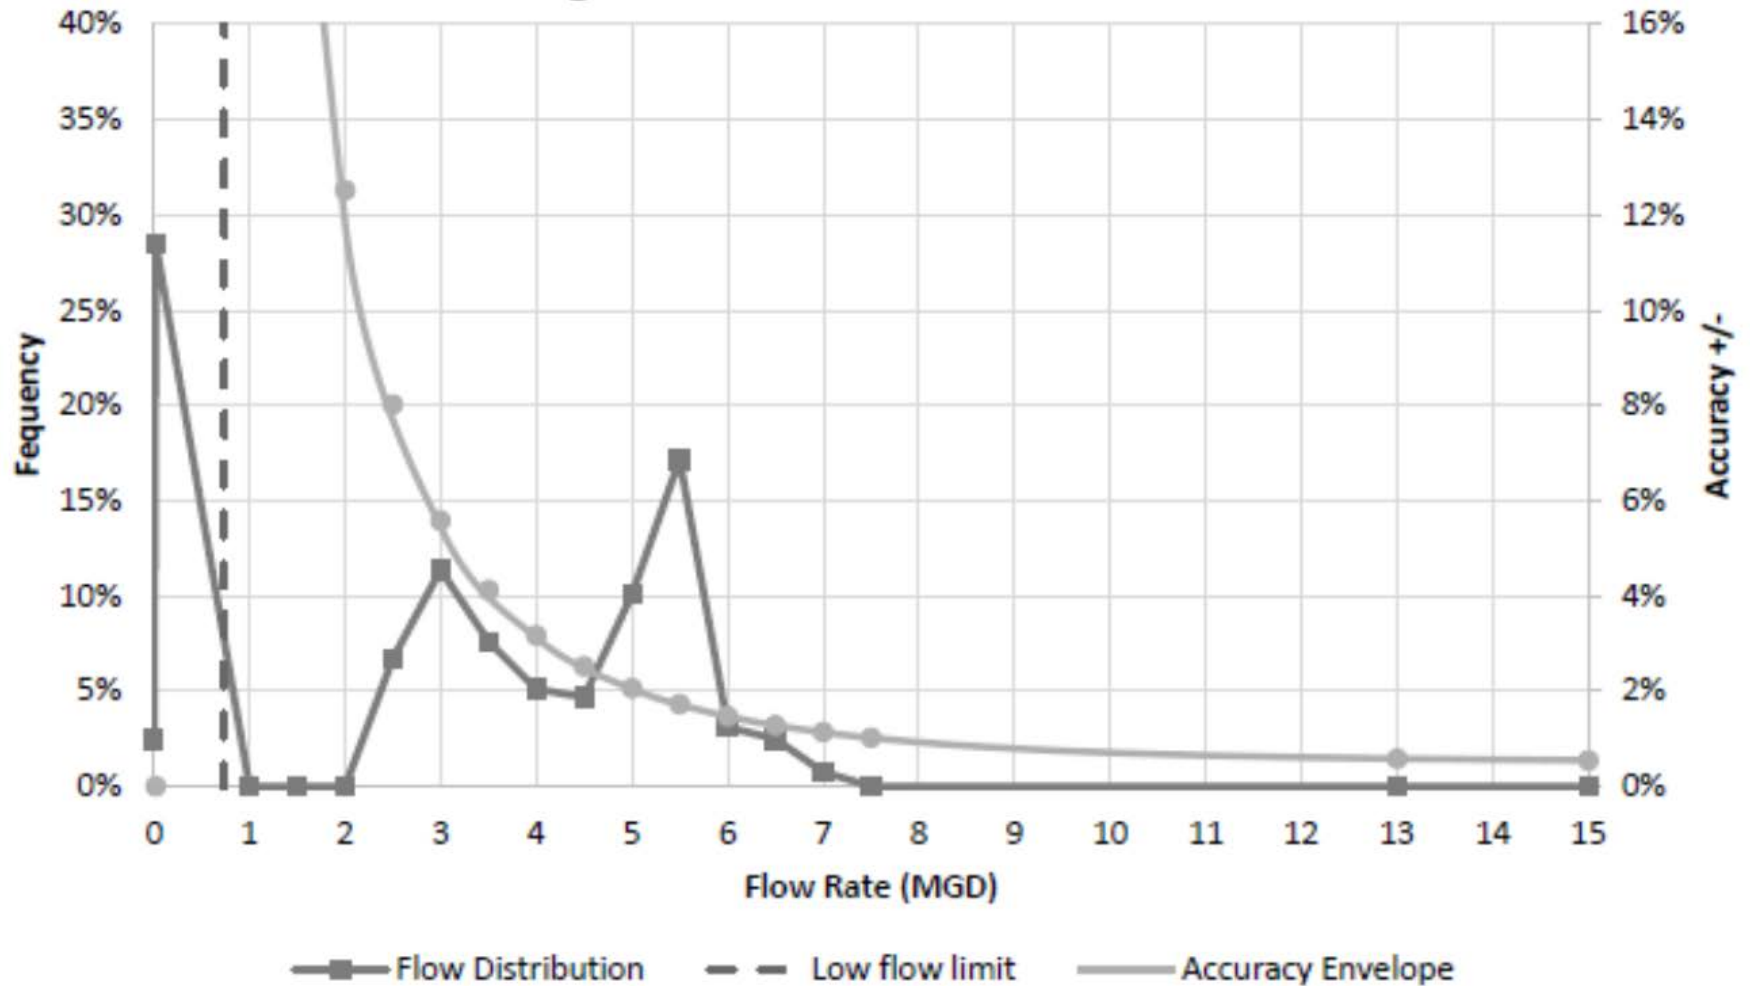
Pickering East - Diamond Rock Sendout

- Objective – Review design and installation details for all production sendout meters to calculate potential uncertainty volumes and prioritize testing and repair (all venturi meters)
- Analysis performed – review accuracy of each component of flow meter system: primary element, secondary device, and installation conditions, calculate uncertainty volumes based on historical flows. Ranged from 0.5% to 3.7% with a total uncertainty volume of 350 million gallons annually
- Recommendations
 - Improvements to 11 of 23 meter systems (some with multiple improvements), prioritized by uncertainty volume
 - Low flow cutoff
 - Modify calibrated span
 - Upgrade DPT with upgraded technology (improved accuracy)
 - Relocate flow meter to improve flow conditions
 - Replace flow meter

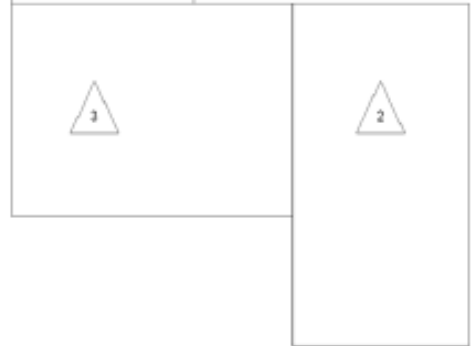
AQUA - PICKERING WEST WATER TREATMENT FACILITY PUMP STATION A			
		PUMP 7 - VENTURI SCHEMATIC			
SIZE			DWG NO		REV
SCALE	NTS	SCHEMATIC	SHEET		1 OF 1

1	VENTURI
2	VERTICAL 90 DEGREE BEND
3	HORIZONTAL 90 DEGREE BEND
4	DISCHARGE HEADER (PUMP 7 ONLY)
