Multi-Family/HOA Water Use Analysis: A Conservation Decision-Making Tool

Hillery Francis

Southern Nevada Water Authority

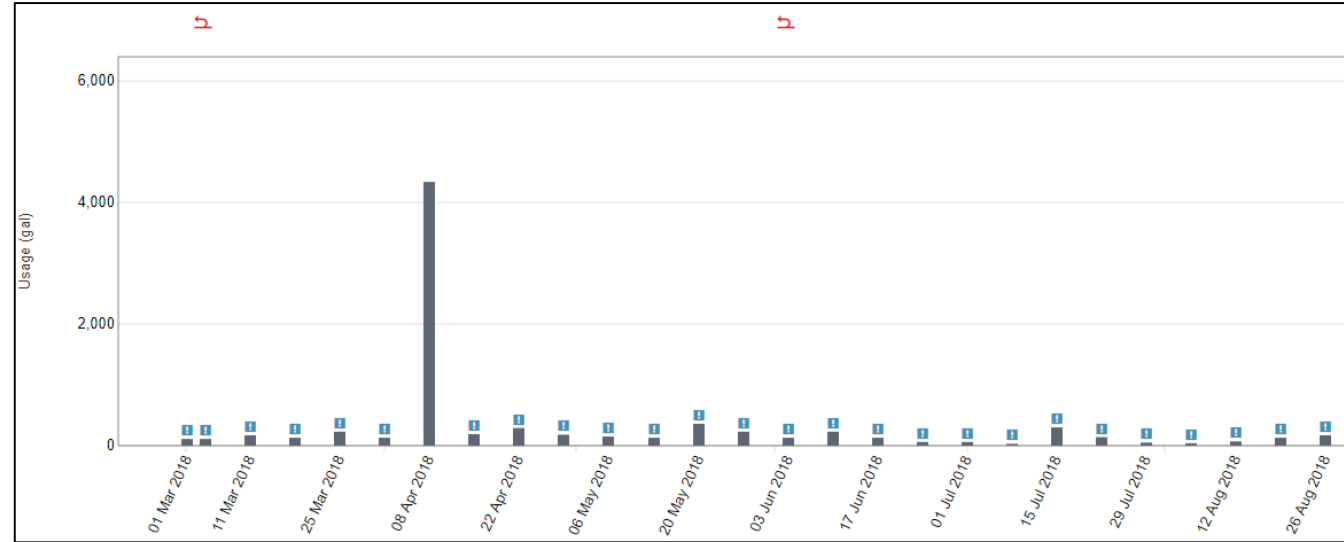
Inputs

- 5 years of water use history
 - Consumption
 - Meters (location and ID)
 - Trickle indicators (iTron)

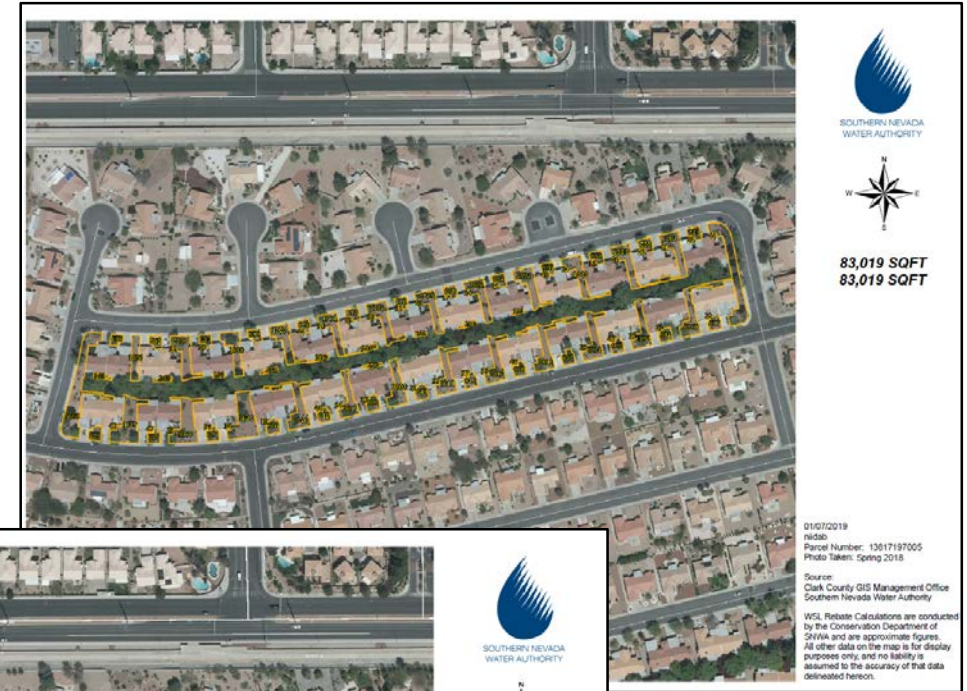
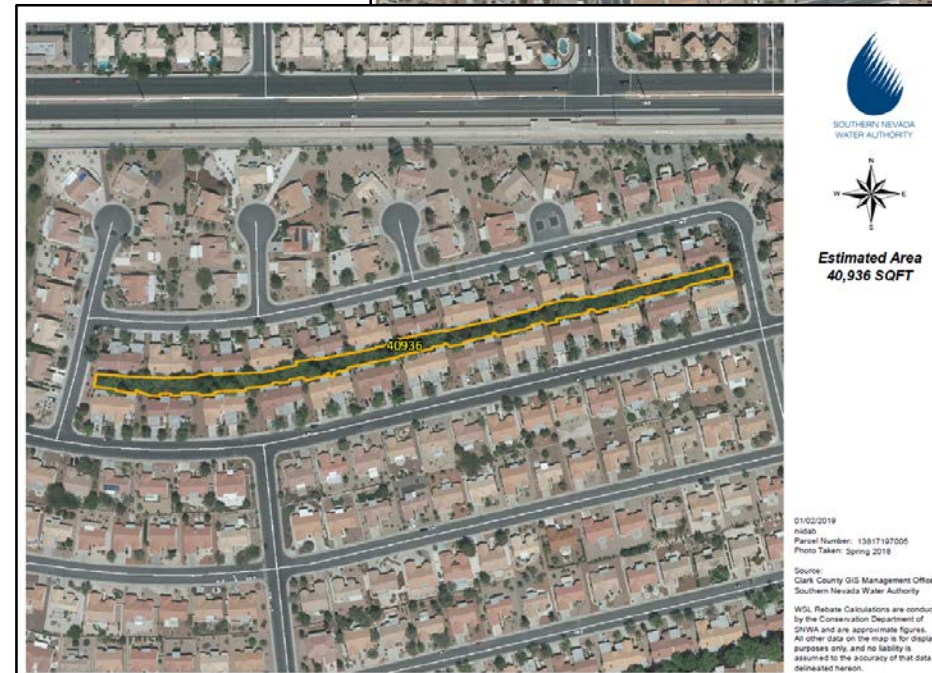
Inputs

- Landscape area and type
 - Estimate based on aerial imaging
- Historic evapotranspiration (ET) rates

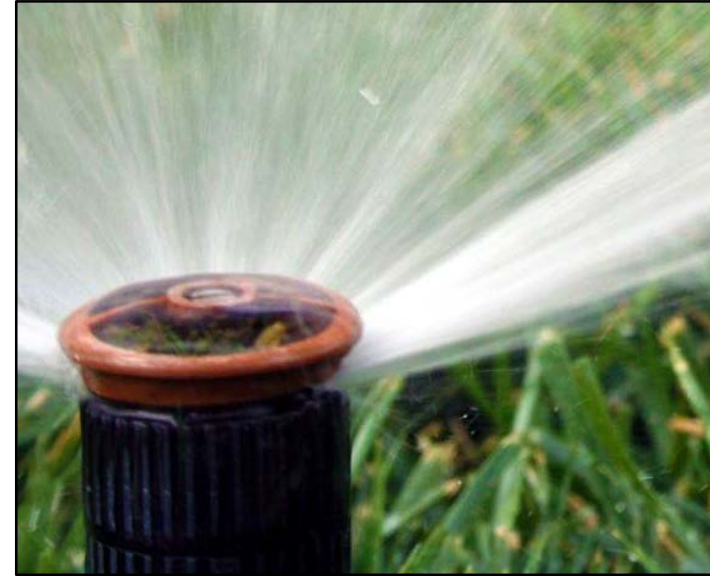
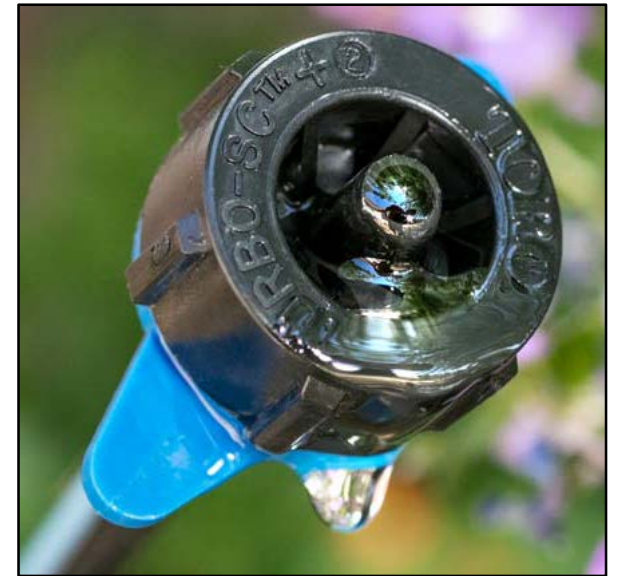
Inputs

- Irrigation system efficiency
 - Assumption based on landscape type and method of irrigating (spray vs drip)
 - More spray, lower efficiency
- Crop coefficient
 - Assumption based on landscape type
 - Look at ratio of turf vs xeric
 - More turf, higher crop coefficient

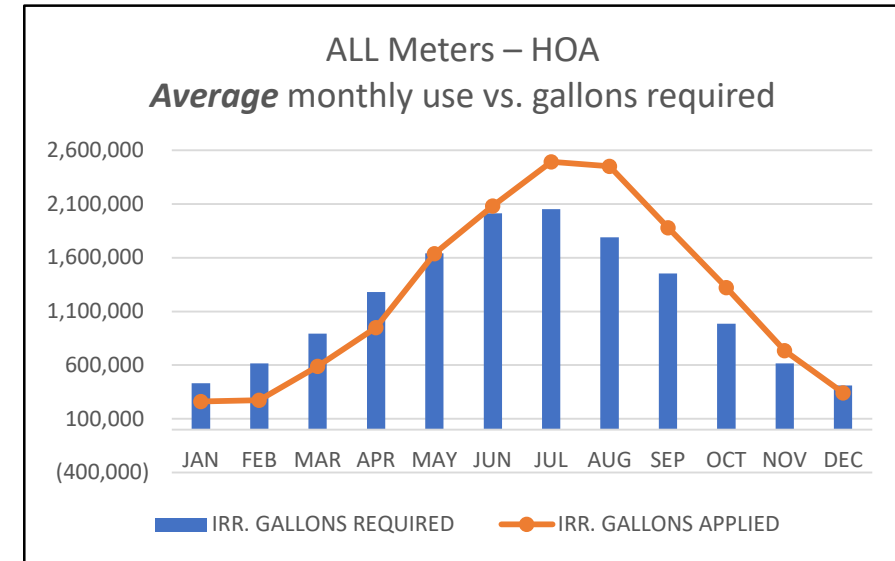
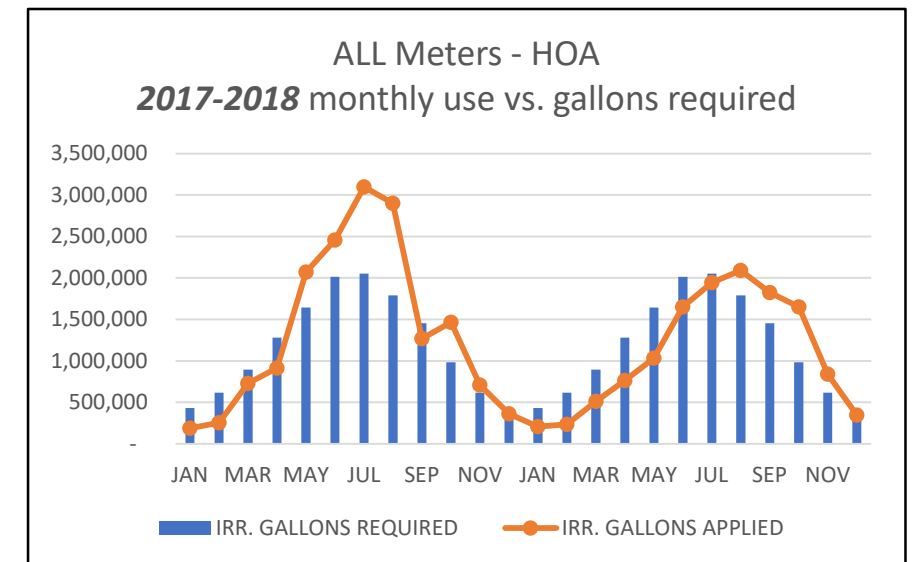
Output

- Irrigation patterns
- Comparison of irrigation required versus irrigation applied
 - Average over study period
 - Monthly, yearly snapshots
