So You Want to Do Leak Detection: Stories from Our First Year

Rachel Davis, Water Loss Control Programs Supervisor Municipal Water District of Orange County

Kim Manago, Water Systems Optimization

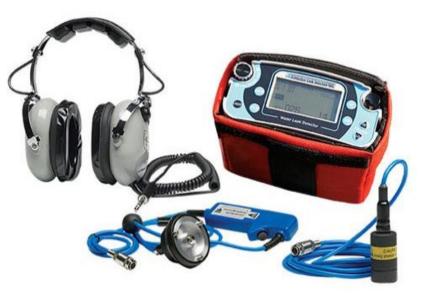
Leak Detection Equipment

Original Equipment: Subsurface Instruments LD-18

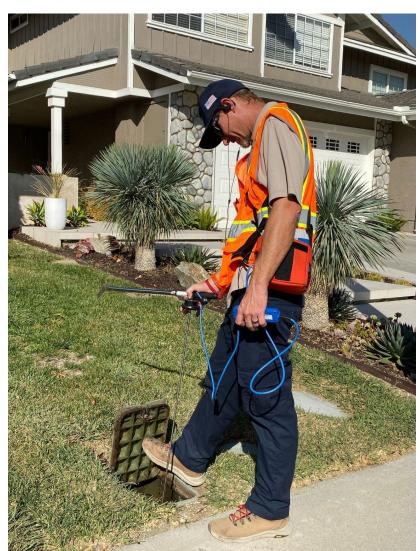
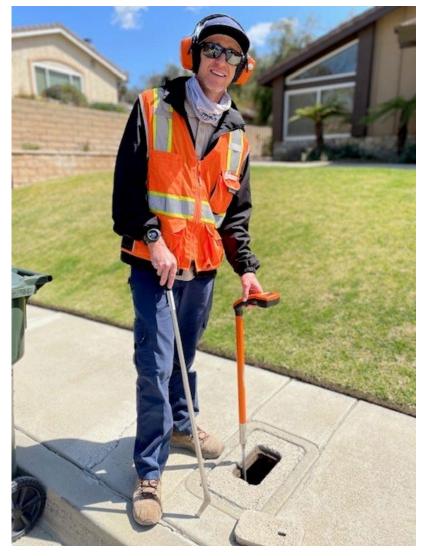
New Equipment: Sewerin

AquaTest T10

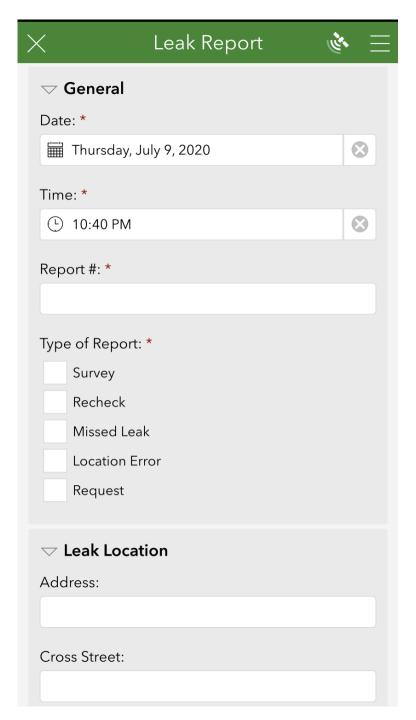
Recording and Tracking Results: Survey123

- Collect Leak Data
- Capture GPS location
- Quick Setup
- Customizable
- Mobile App

- Mobile application streamlines documentation of suspected leaks and locations
- The more information you collect, the better!

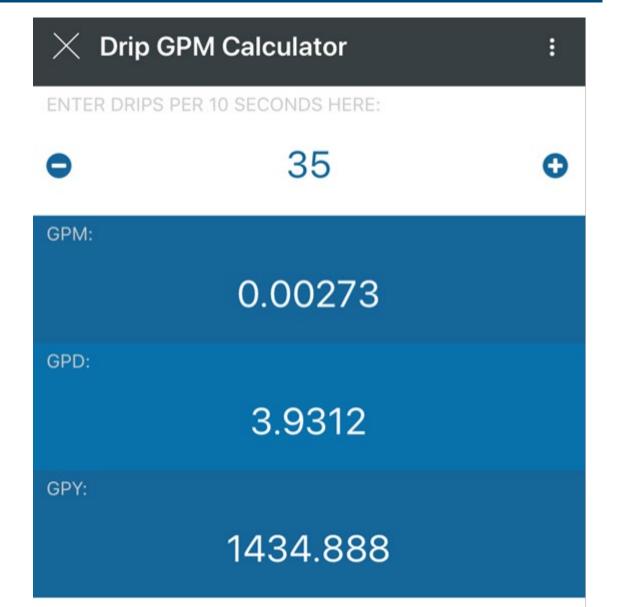
Our Own App??

× Gra	ms GPM Calculator	
ENTER G	RAMS PER MINUTE HERE:	
0	125	•
GPM:		
	0.03302150641	
GPD:	47.55096922	
GPY:	17356.10377

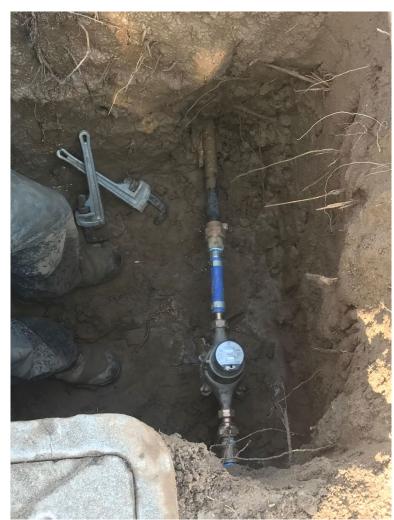
After Survey: Agency Repair Data

MWDOC requests repair information from agencies to confirm suspected leak and document leakage flow rate

FIELD DATA COLLECTION FORM	MWDoc MesaWater			
LEAK REPAIR	Leak Report Number:			
Leak Address:	Was a leak found: ☐ Yes ☐ No			
Leak on: ☐ Main ☐ Service ☐ Meter	Job Foreman/Supervisor:			
Job start time:	Job end time:			
Service Material: □ Copper □ Plastic □ Other: Date of Repair:	Main Material: □ AC □ DI □ CI □ Other: Measured Leak Flow Rate (GPM):			
Was a Contractor Used: ☐ Yes ☐ No	Repair Method:

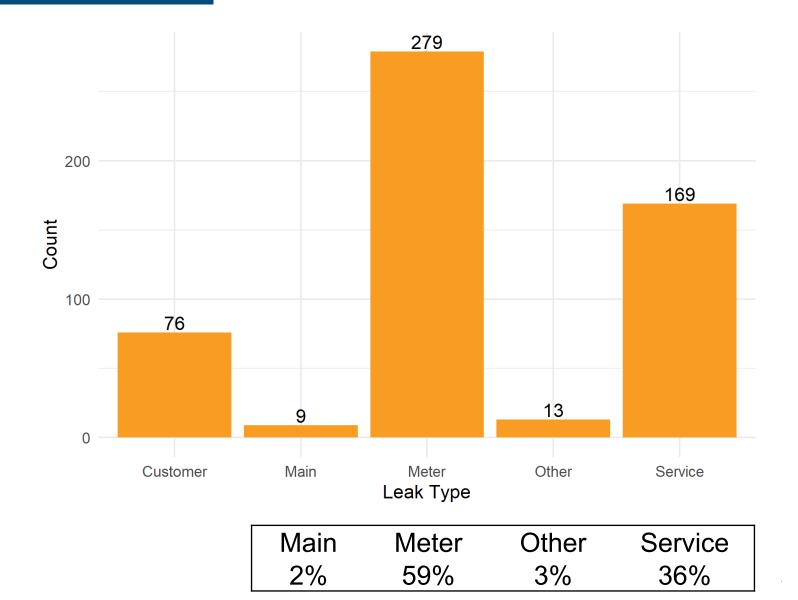
Types of Leaks

Majority of leaks are found on meter and service connections

Main	Meter	Other	Service
Count of Leaks Found	9	279	13	169
MG/Year	30	12	5	57
AF/Year	94	37	16	174
Money Saved (\$/Year)	\$100,886	\$40,357	\$17,234	\$187,587
